CONDITION ASSESSMENT OF THE
CARTER TOMBS

Foundation for Historic Christ Church

IRVINGTON, VA

MARCH, 2003

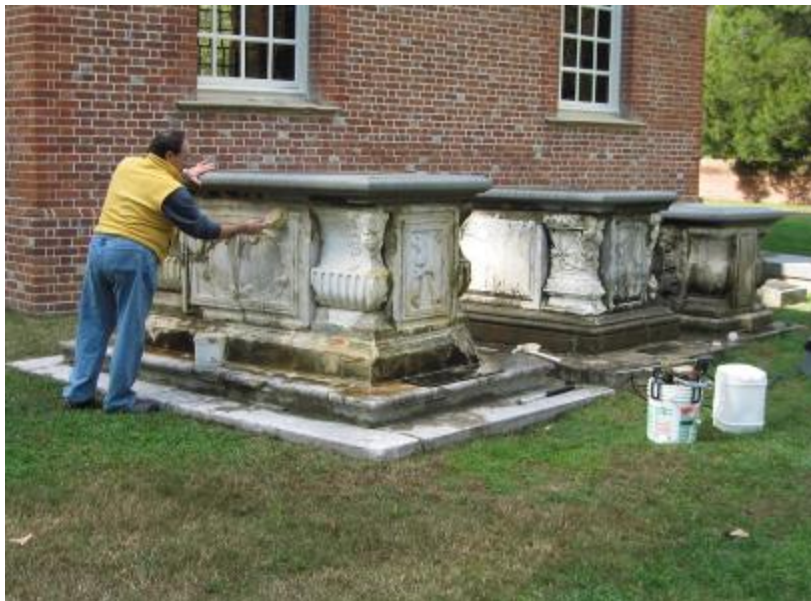
Removal of biological soiling to facilitate inspection, November 4, 2002

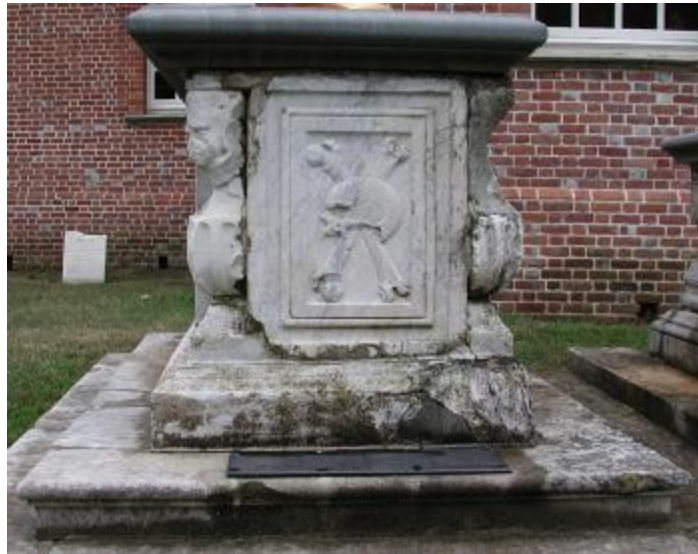
East, Portland limestone. Deterioration, with considerable loss at north end. Most is fill, with some whitewash.

**Robert Carter, east elevation,
November 5, 2002, showing
deterioration of base molding**

The east and west base moldings are in poor condition. They require (either) extensive chemical treatment and filling (especially to re-establish profiles in the area beneath the NE corner), or the installation of replacement elements of new stone.

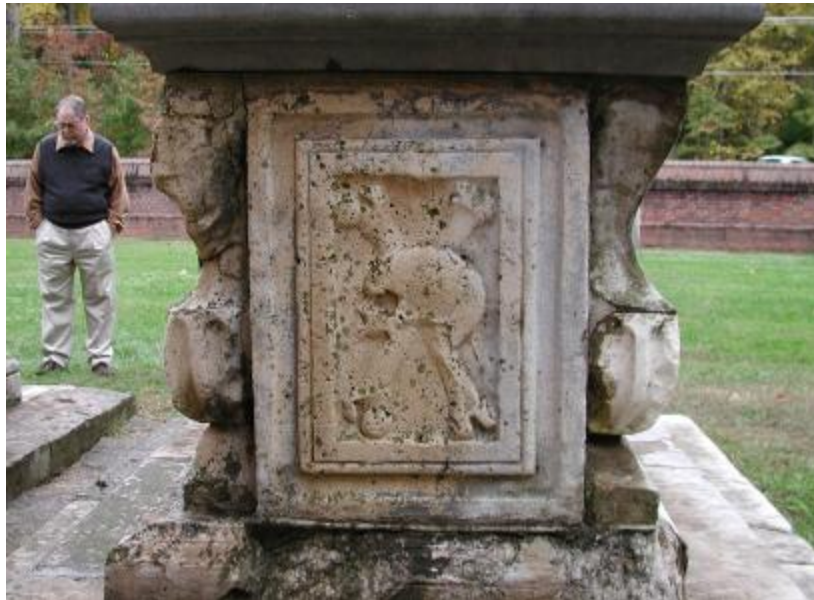
West (short), cast cementitious replica, 1927. Open vertical mortar joints at left and right edges.

Robert Carter, west elevation, November 5, 2002, replica panel

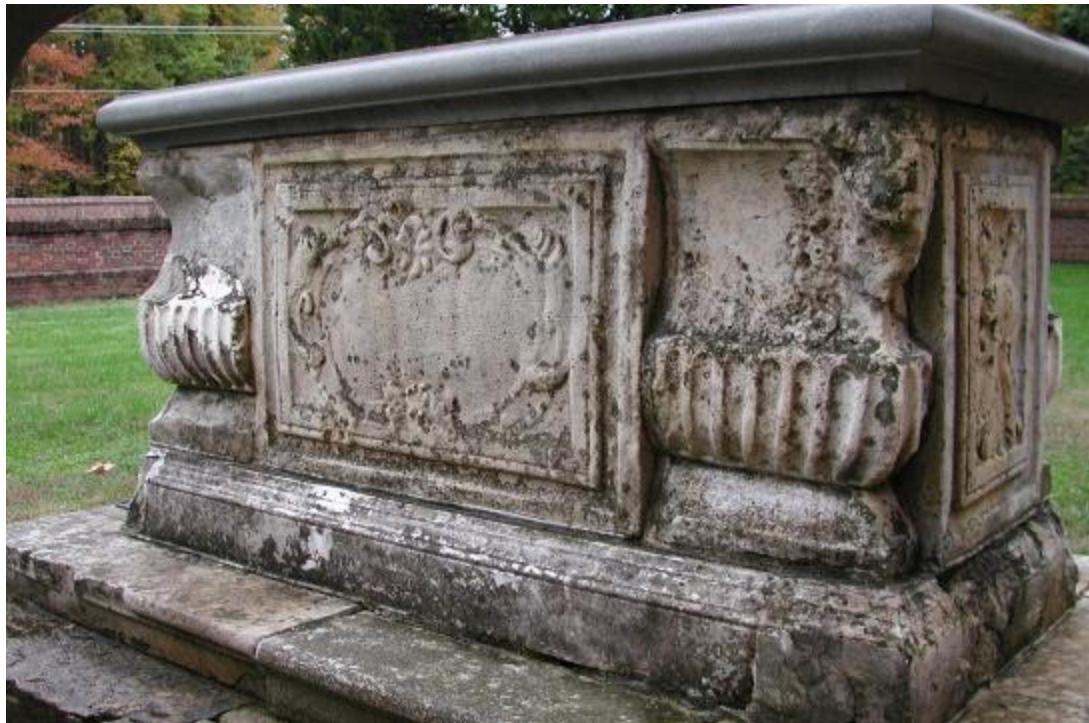
NW, cast cementitious replica of SE corner, 1927 (no head). Of generally poor quality. Open vertical mortar joints on north and west elevations.

Robert Carter, north and west elevations, November 5, 2002, panel and NW corner are replicas

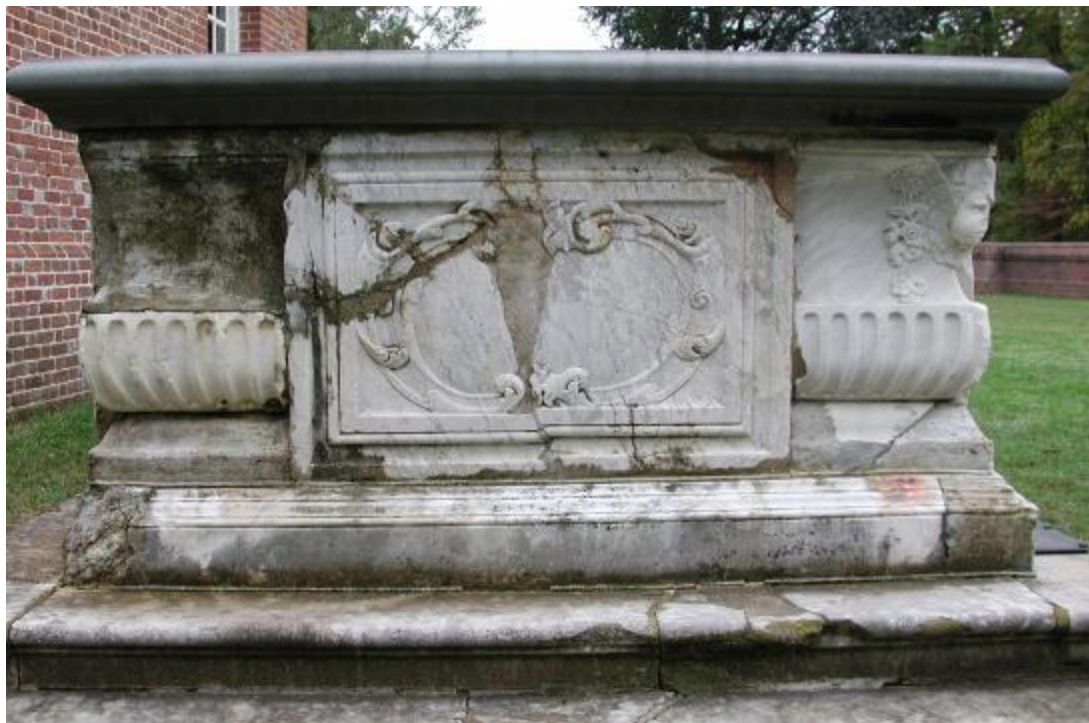
South (long), white marble, pre-1927. Prominent fractures and fills, with fragments poorly fit, as seen in 1927 photograph (#0005). 1927 fills have weathered, discolored and separated; some fractures are open. Two small areas of active surface deterioration. Open vertical mortar joints at left and right edges.

Robert Carter, south elevation, November 5, 2002; note mis-alignment of panel fragments probably assembled in 1927

There are two stone panels (south and east), and two cast replicas. The south panel is in poor condition. It will require the removal and replacement of old fills, crack filling, and localized chemical treatment. Anticipated visual improvement for the south panel, which is particularly prominent, is considerable. Much less work is required for the east panel.

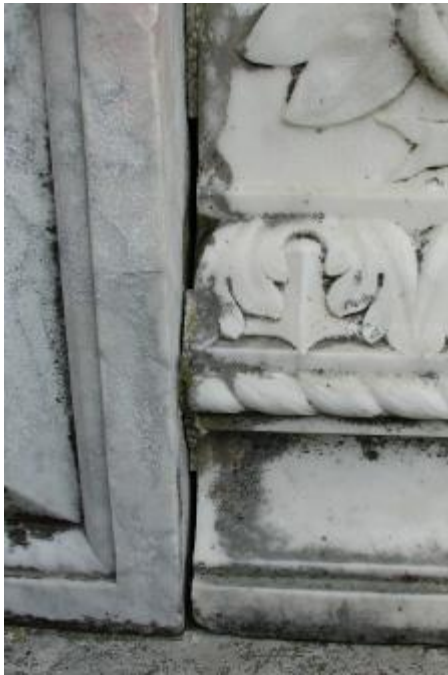
**Open mortar joint (typical),
November 5, 2002**

4.2 All three tombs require additional cleaning and the re-pointing of all mortar joints. The platforms, on which the tombs rest, will require some minor repairs, and the re-pointing of the bed joint beneath the base moldings. (The Robert Carter tomb has an additional bed joint between the two levels of the platform.) Platform head joints should probably be left open to permit drainage of surface water directly into the soil.

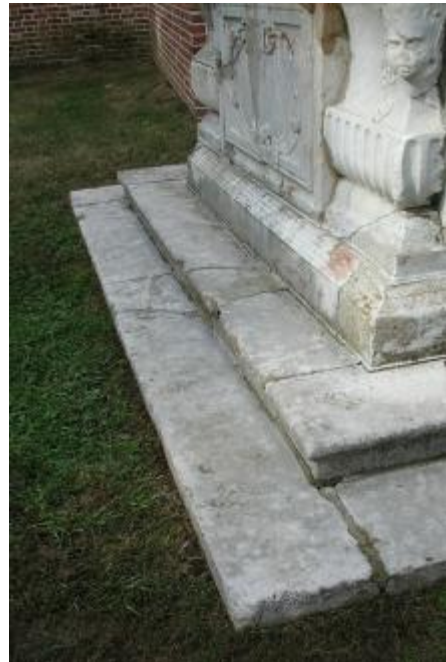
**Platform, Robert Carter, south
elevation, November 5, 2002**
