The Abbey Memorial, Enfield, Connecticut
Condition Assessment and Conservation Recommendations June, 2011

Introduction

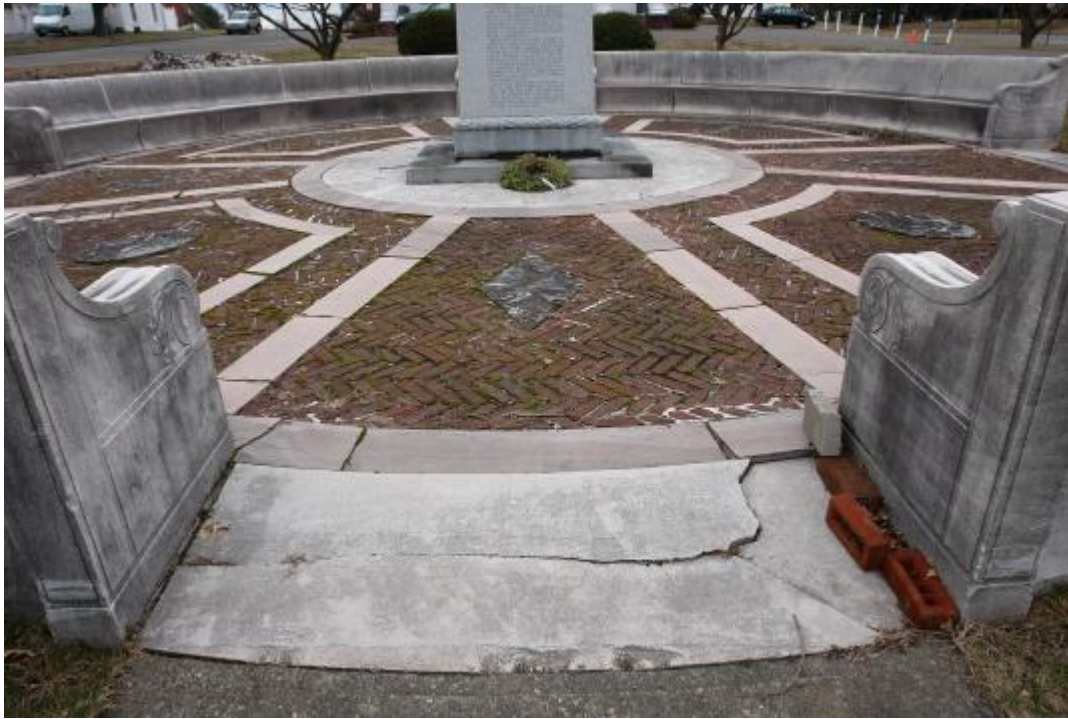
View from West entrance looking towards church

Of major significance is the differential settling of the stone and brick paving. This condition creates a trip hazard and a continued failure of the joints. The lack of evidence of frost shattering to the bricks suggests that they were well chosen high fired pavers. However there has been considerable movement and fracturing of many of the paving elements, primarily on the Northern half. This seems to be associated with cyclical frost heaving, associated with excessive water which may have entered the paved area due to the surrounding topography. See page Appendix 23 for topography map detail of the area.

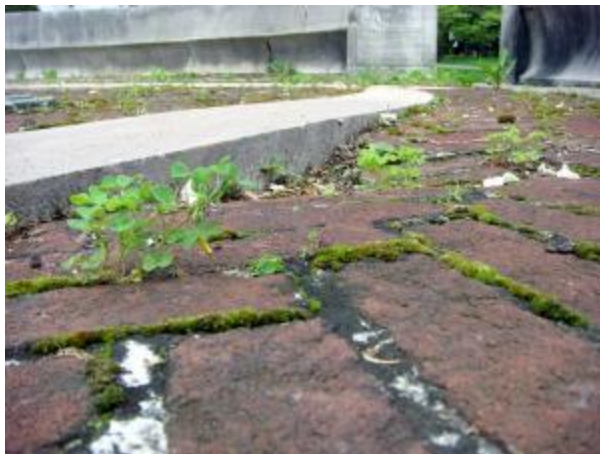
Frost heaving on brick pavers

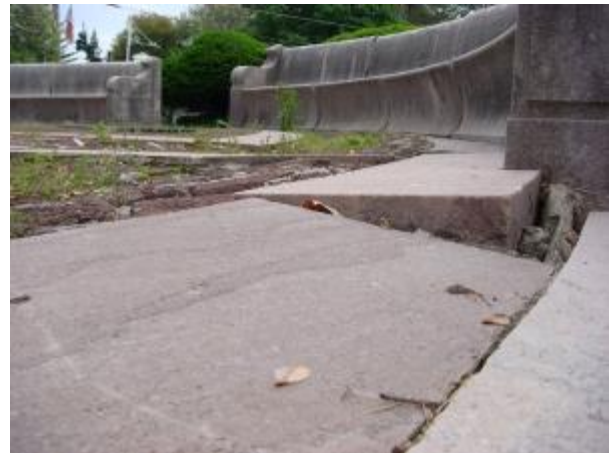
Stone displacement

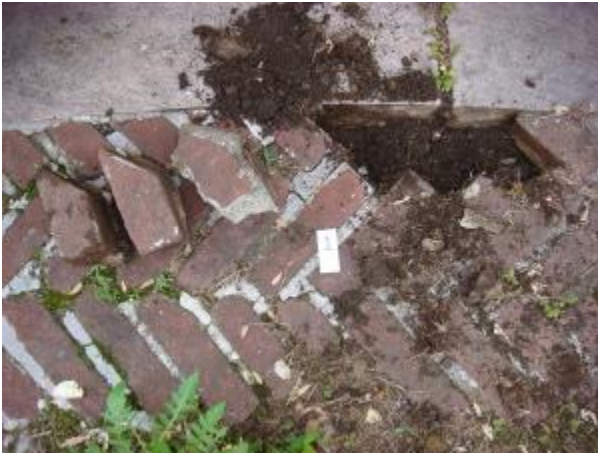
Loose paver bricks

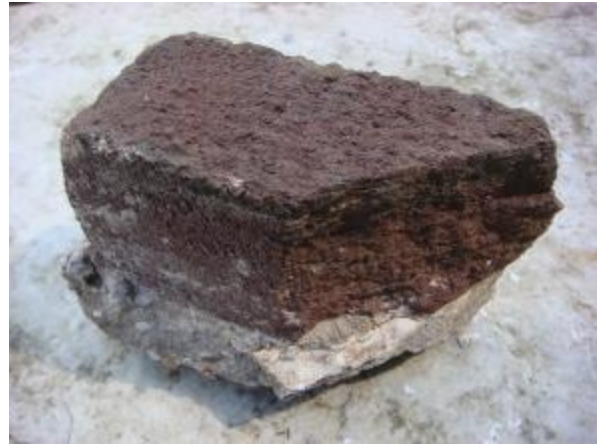
Detail of loose brick. Note setting mortar

A loose brick sample was removed from the North-West perimeter and examined. It was apparent that the paving bricks were originally mortared in two stages. First the bricks were set onto a conventional mortar base laid onto what appeared to be loose pieces of stone, difficult to discern without full excavation, the original base mortar can be seen in the photo above right.

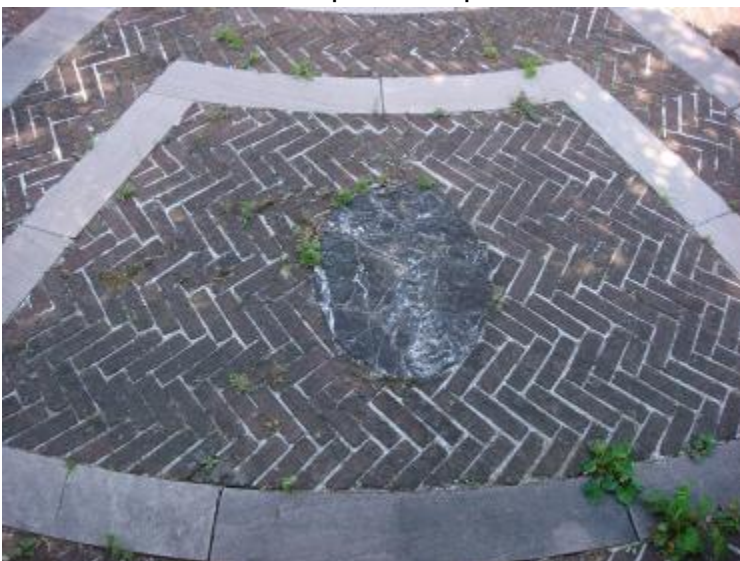
The spacing of the joints and appearance of the mortar in the South-East paving surrounding the oval plaque appears to be original.

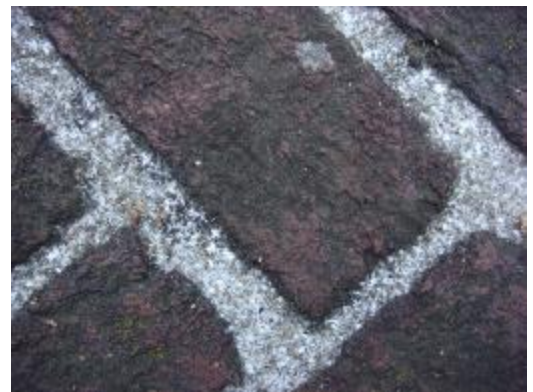
Detail of joints assumed to be original

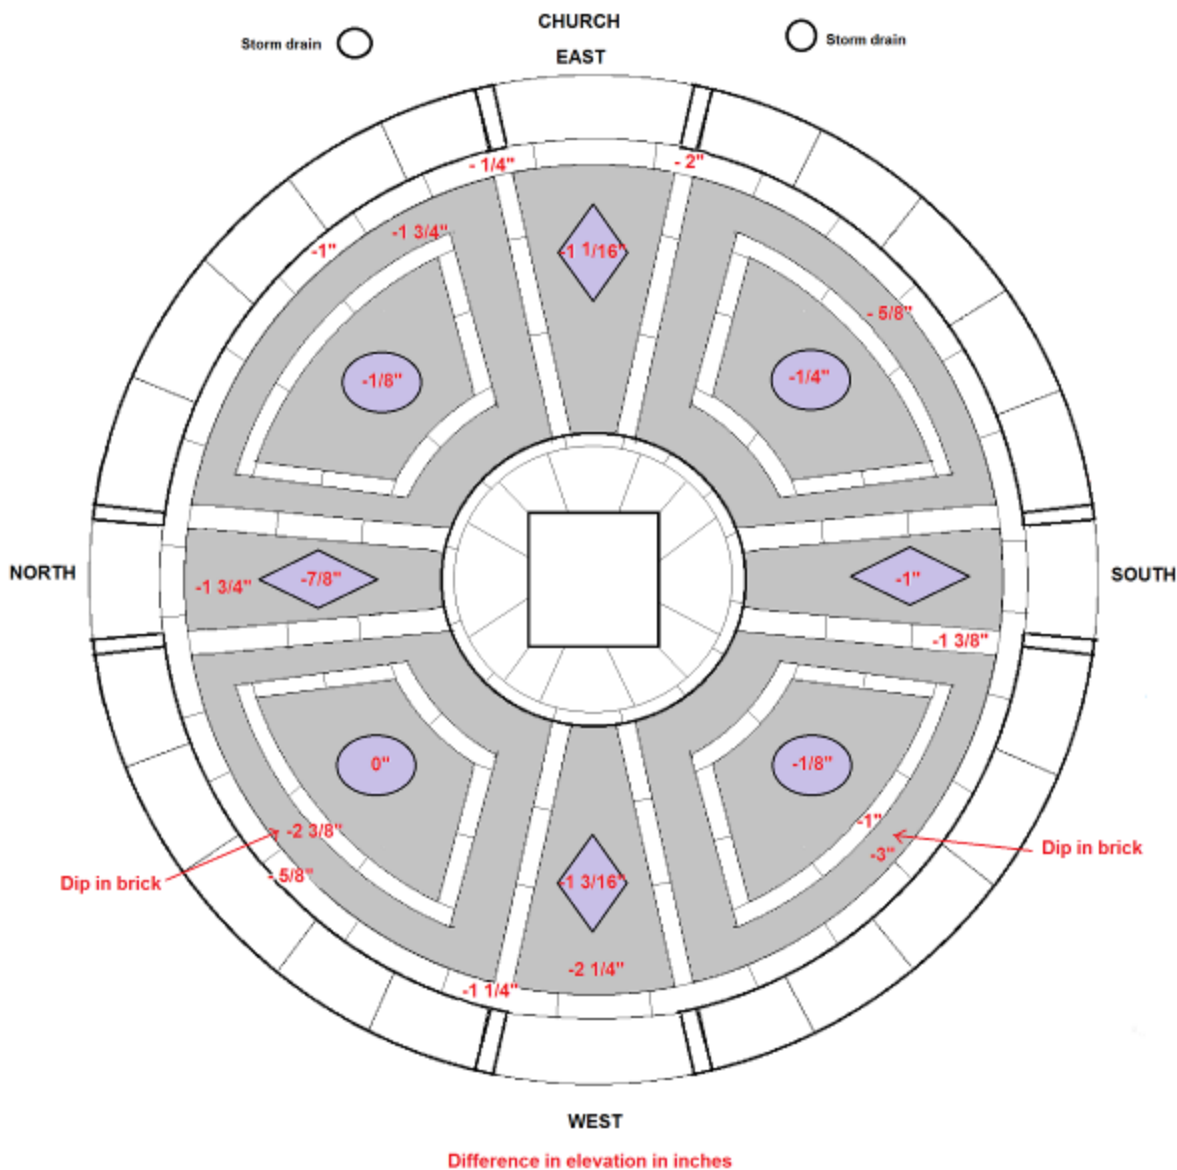
Elevations of the pavement were recorded by laser level and it was found that the oval plaque in the NW quadrant was at the highest elevation of the paving. Differences relative to this oval are noted on the above plan. The difference in elevation of the 4 oval serpentine inserts in the center of each quadrant is only a maximum of 1/4". In an approximate 15 foot distance, this difference is negligible. These ovals are the high points of each quadrant, and were set onto stone slabs which appear to be set onto a concrete foundation. These inserts are most likely still at their original elevation. From this high point, each quadrant slopes down towards the diamond shaped inserts, dropping in elevation approximately 3/4" to just over an 1". The sections of paving with a diamond insert all slope towards the openings in the exedra. All the inset plaques appear to be still at or close to their original elevation. Thus all paving surfaces were initially designed for surface water to run off towards the perimeter exits in the exedra.

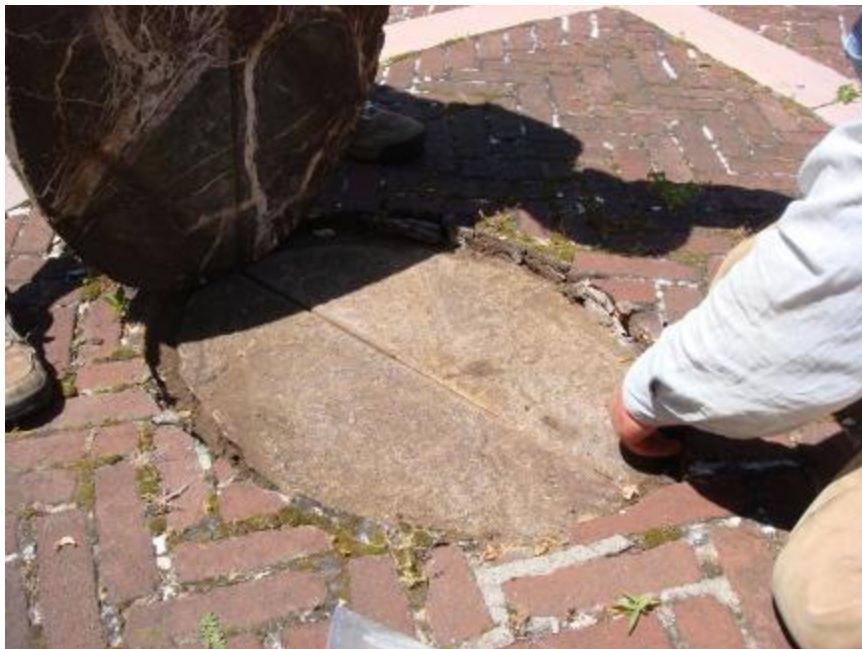
Removal of oval plaque in center of Southwest quadrant to examine setting area. Note stone slab for setting.

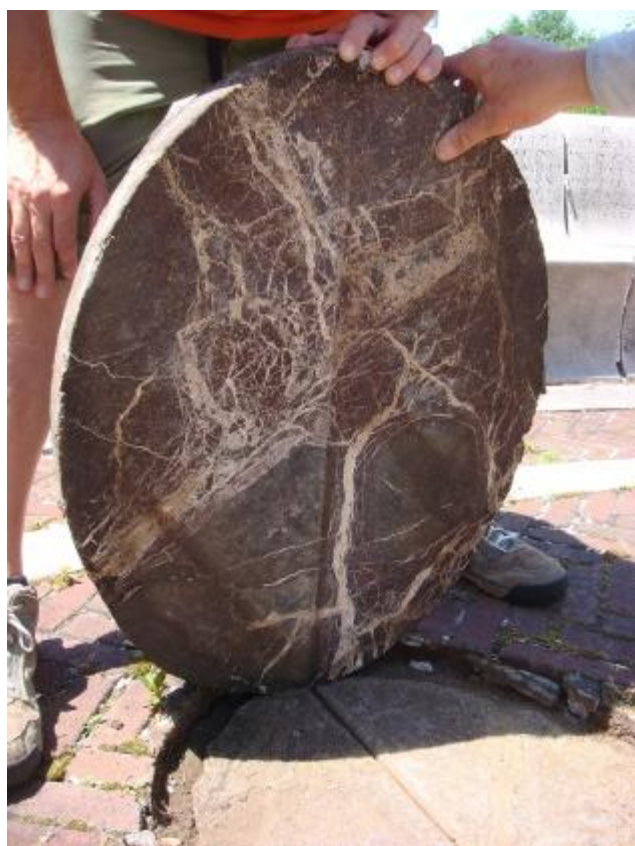
Underside of serpentine plaque

All plaque surfaces, ovals and diamond are extremely weathered. The serpentine plaque in the Southwest quadrant that was removed for inspection is approximately 2" thick. The underside exhibits much less weathering than the exposed surface. While this unexposed surface could be honed and the stone reset with the un-weathered side up, the condition of all the plaques should be inspected to determine if honing all ovals and diamonds is feasible, keeping the final appearance consistent.

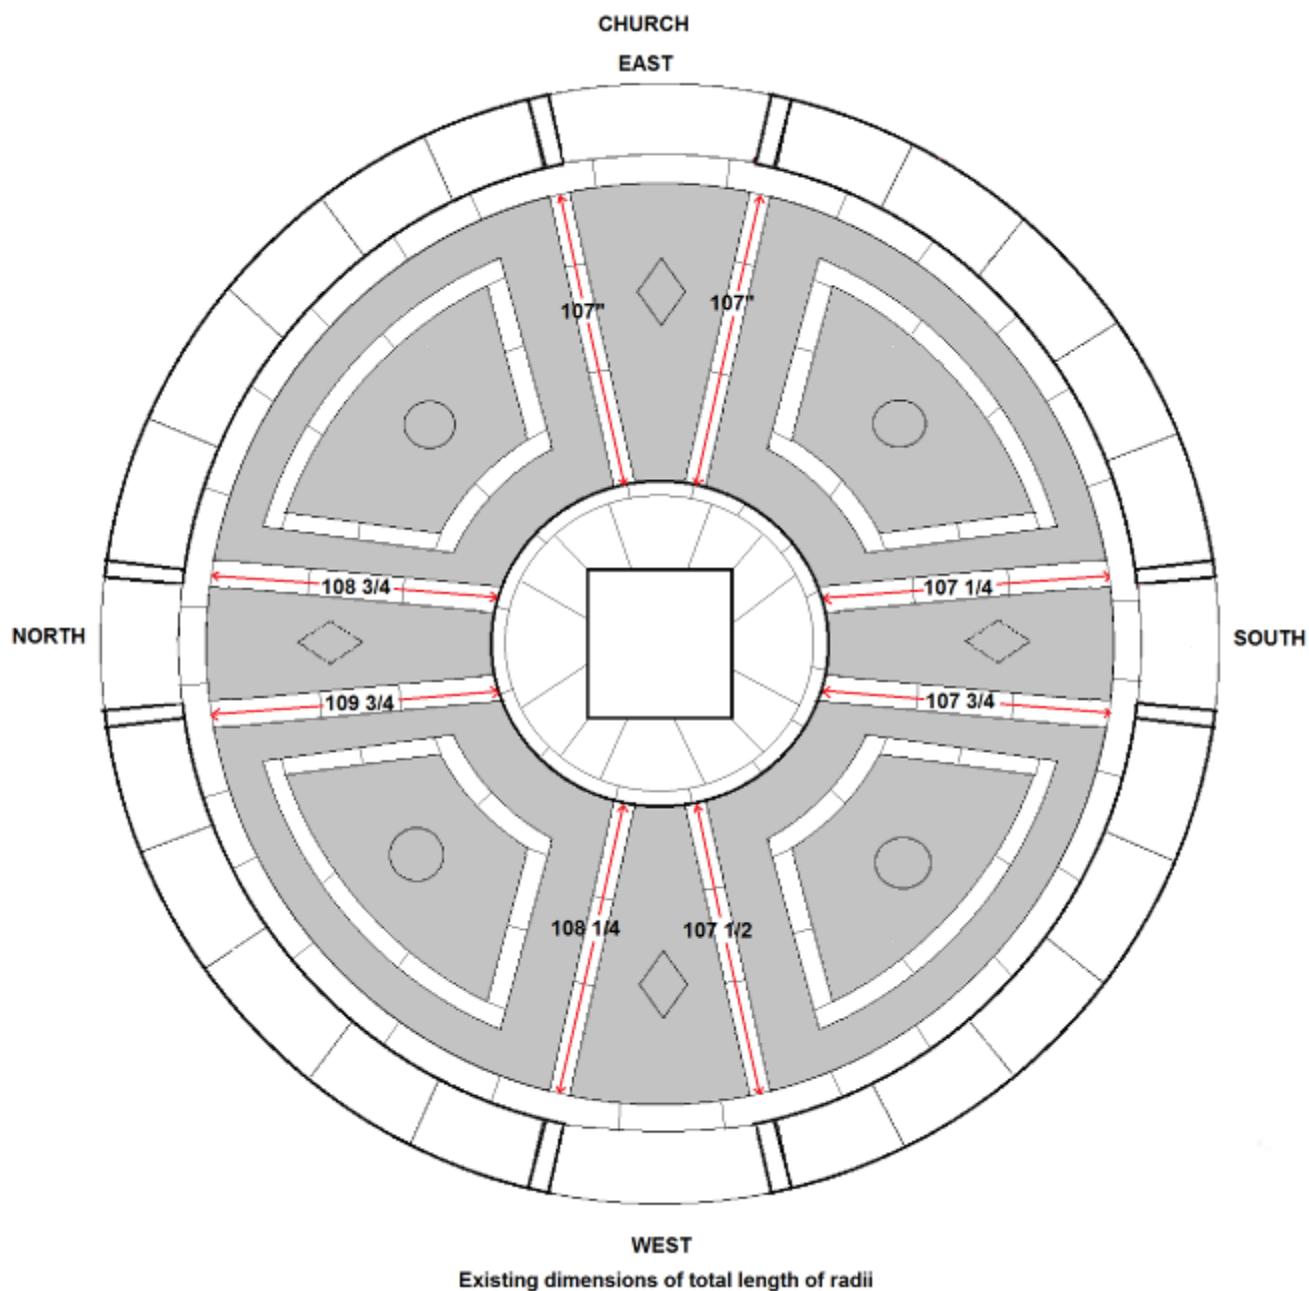
To determine the approximate amount of movement of the pavement and exedra the lengths of the limestone radii were measured and compared. All limestone radii are comprised of 3 separate stones, and the total dimension measured individually, not including joints, only varies approximately $\frac{3}{8}$ " ($105 \frac{7}{8}$ " to $106 \frac{1}{4}$ ").

The above plan notes the total length of the radii including joints. Three of the four radii on the Northern half (including the joints) are $1 \frac{1}{4}$ " to $2 \frac{3}{4}$ " greater than the other radii. This would indicate that the whole Northern side (pavers and exedra) has been displaced approximately this distance.

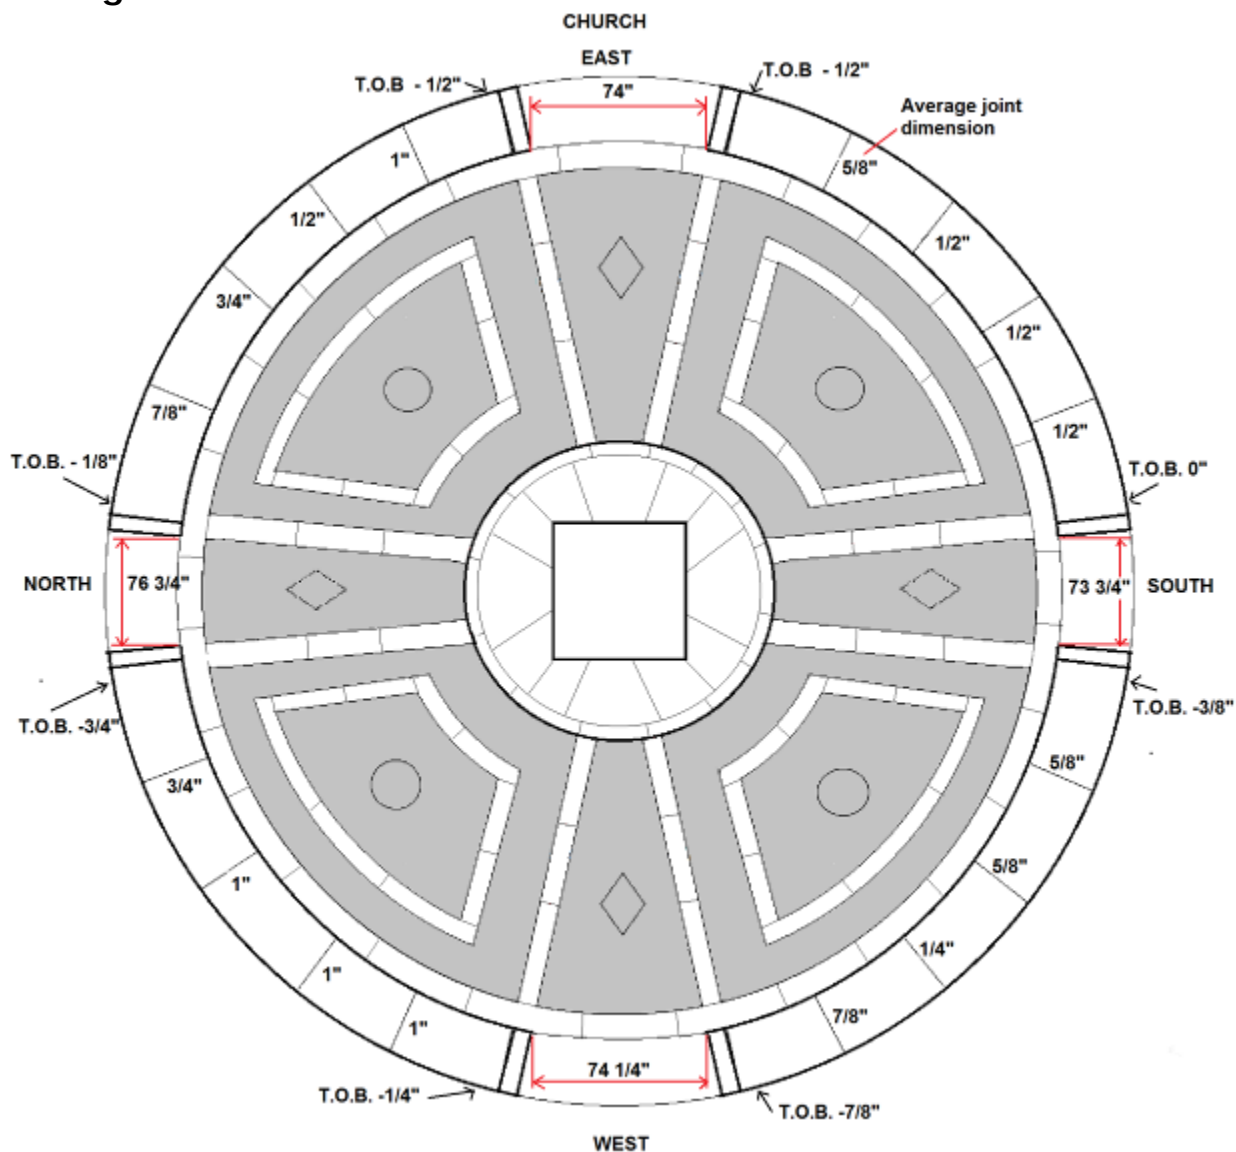
The movement of pavers also caused the exedra units to be displaced. The exedra appears to be set onto a concrete base. The average joint dimensions of the exedra are noted in the above plan. All the units have spread and have wider, open joints than originally planned. The joints on the Northern half are in the 1" range while joints on the Southern side are in the 1/2" range. While all of the exedra units have been displaced outwards, the movement of the Northern half has also caused the North opening of the exedra to be considerably greater than the other 3 openings, approximately 2 3/4" larger than the other openings.

Elevations at the ends of the exedra benches were recorded by laser level and it was found that the Eastern side of the South entrance was the highest point. Differences relative this point, T.O.B. (Top of Bench) varies a maximum of 7/8" with little consistency. Slate shims have been used in the past in an apparent attempt to correct the differences.

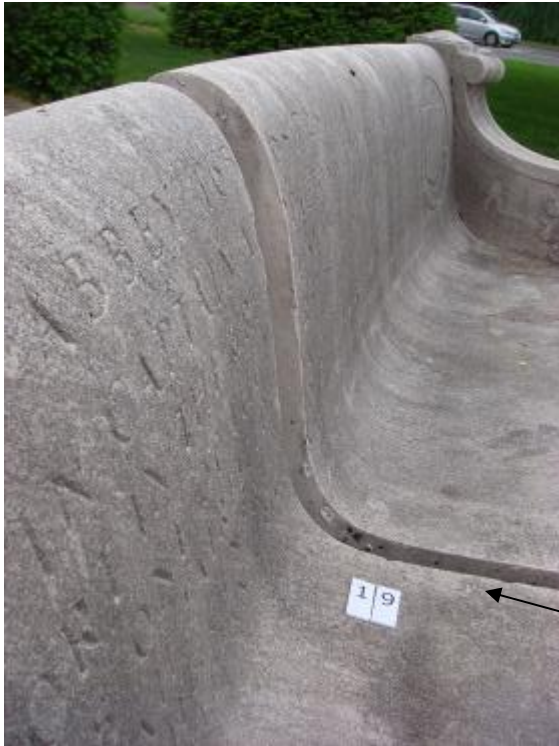
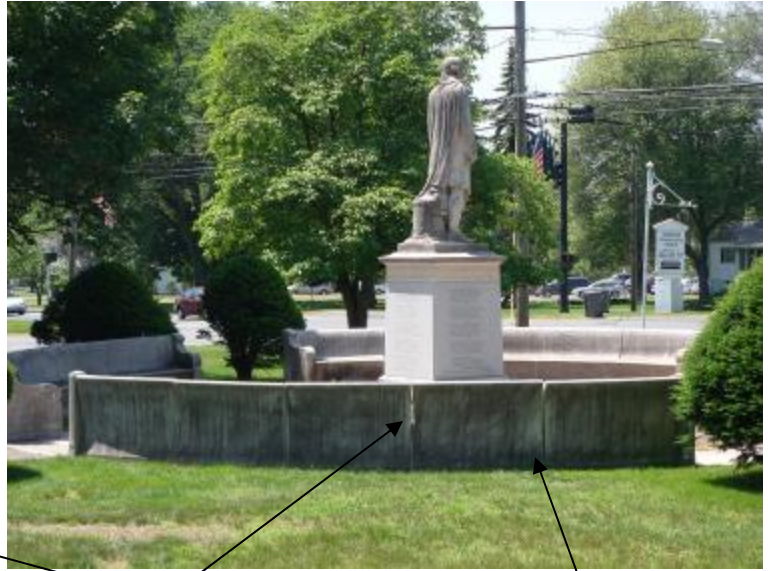
Open joints

The large open joints in the marble exedra and displacement of units is considerable. Each of these units weighs approximately 3000 pounds. There are five units that make up each section of the exedra.

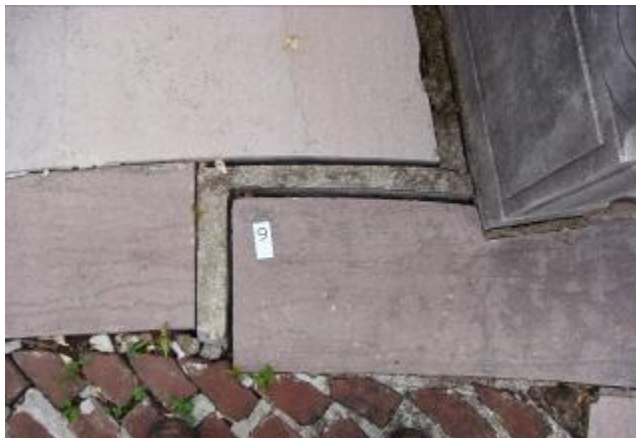
Stone movement and replacement mortar

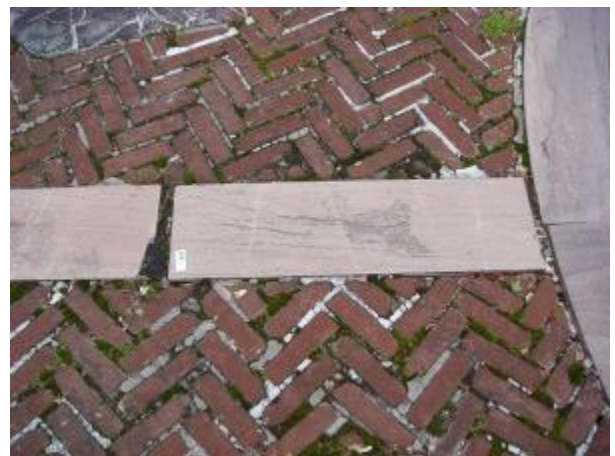
Enlarged joint

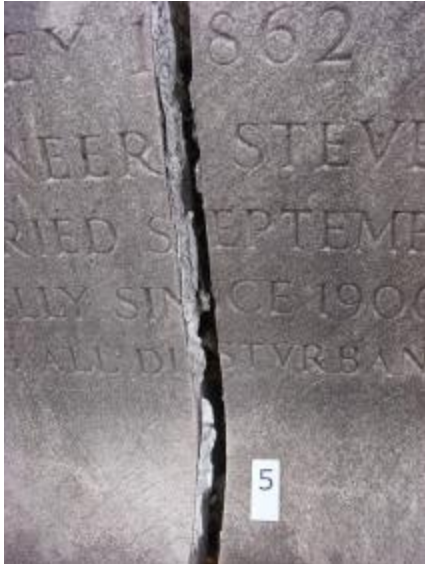
Open joints in exedra with lettering

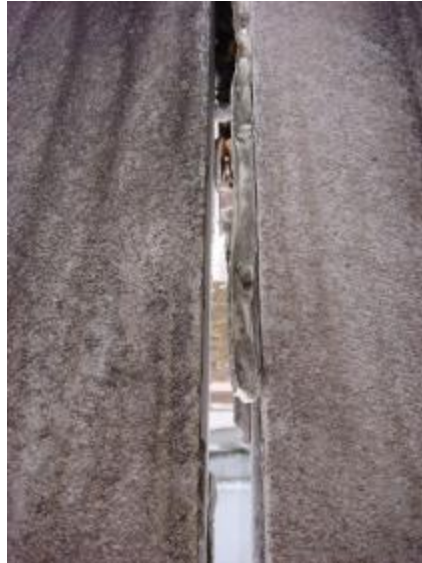
Detail of existing open joints with failed replacement caulking and fibrous backer material.

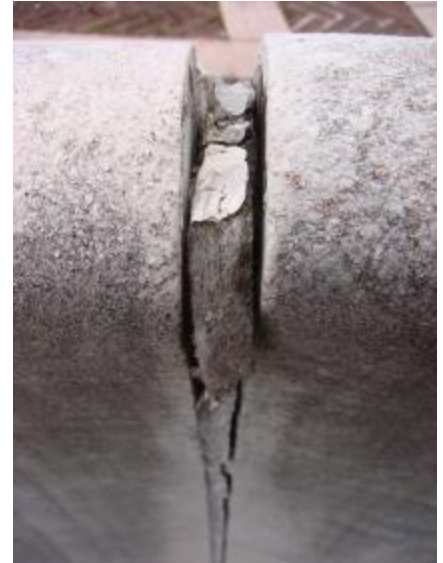
Existing joint opening

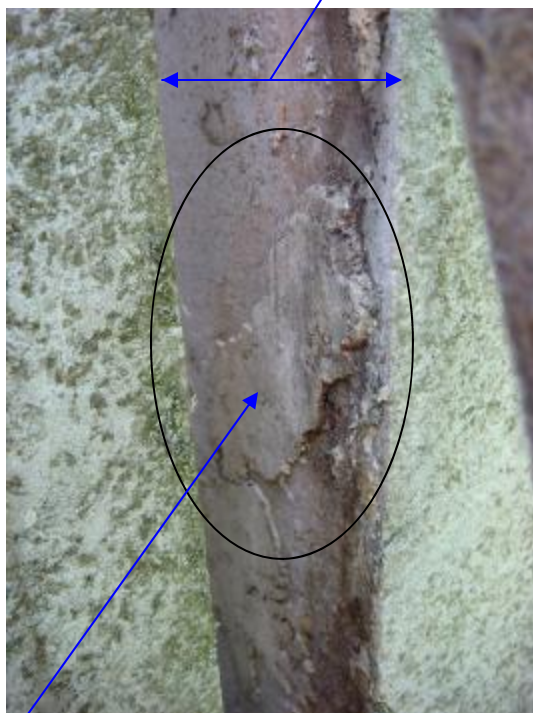
Detail of original thin joint mortar

Examples of original joint mortar from the exedra were scarce; the few pieces found were very thin, ranging from 1/16" to 1/8" in thickness. The spacing of the lettering at the joints would also indicate that the original joints were very thin.

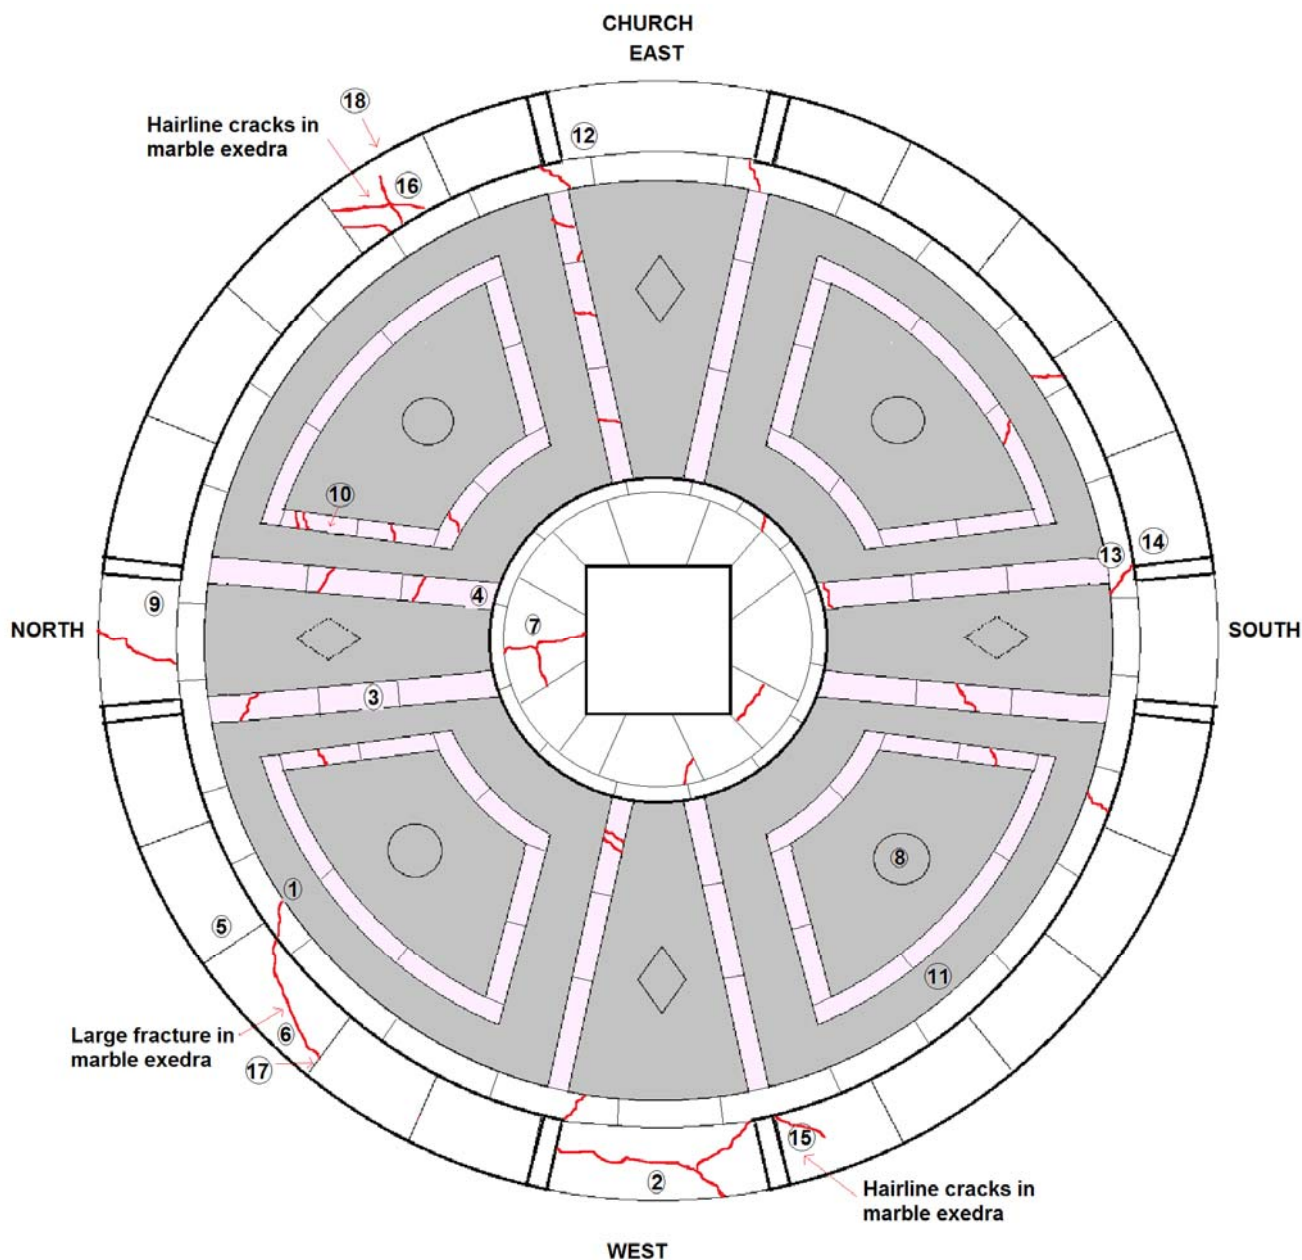
The above plan notes the approximate location of fractures (in red) and photo locations. A sample of the Ross Quarry limestone (pinkish radii and related pattern) at location 13 was removed and found to be 4" thick. It is unlikely that all the fractures were caused by frost heaving.

There are a number of hairline fractures in two of the exedra units and one substantial fracture. The cause of the large fracture to the marble exedra in the North-West quadrant is not known (possible tree or branch damage?)

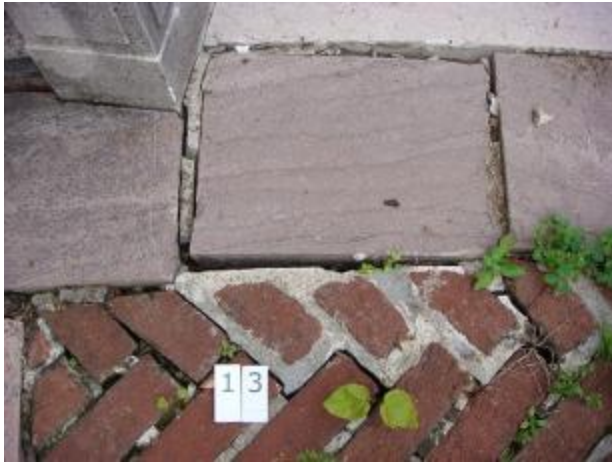
Loose limestone fragment

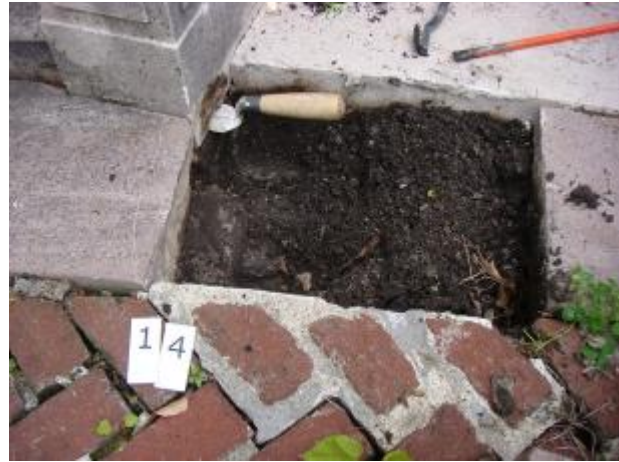
Limestone fragment removed. Note depth of trowel under corner of exedra.

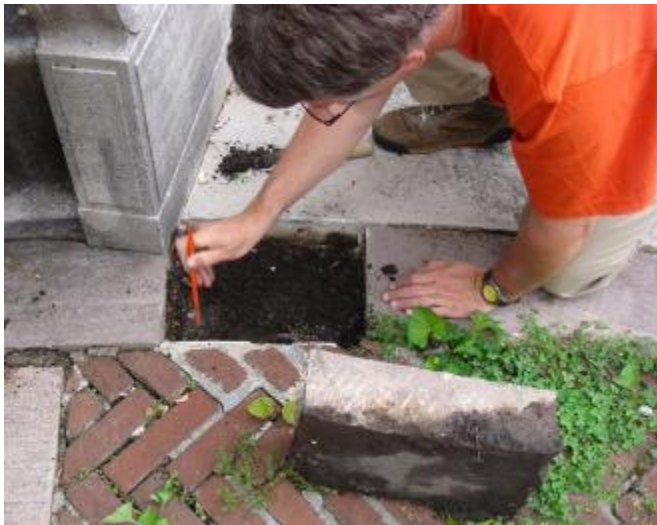
Probing the setting bed

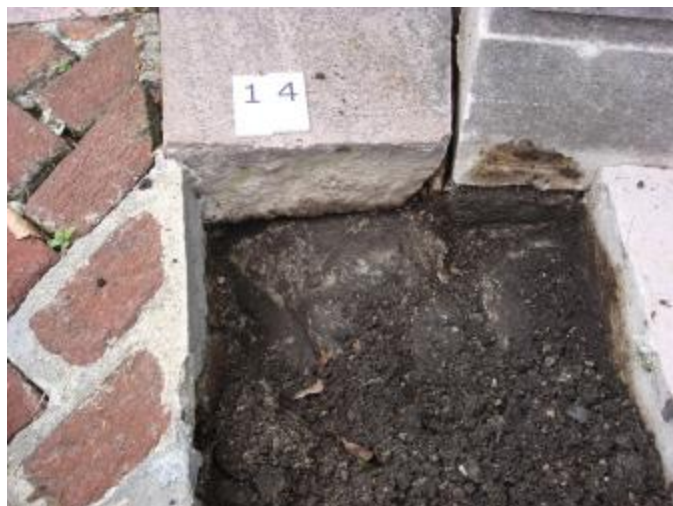
A portion of the Ross Quarry limestone was removed for inspection at the South entrance and was found to be 4" thick. The setting bed was comprised of solid stones with evidence of a decomposed mortar. The loose sample was placed back as found.

Detail of setting area

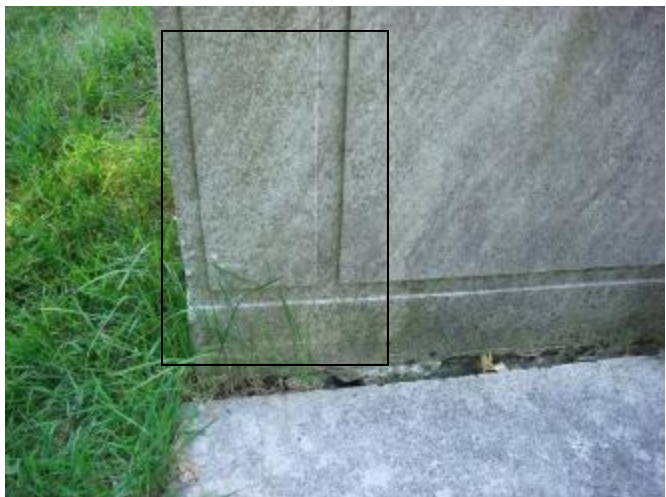
Test area for cleaning.

Cleaning tests were done with D/2 Biological solution (Cathedral Stone, Hanover MD). A contact time of only 1 to 2 minutes will loosen most fungal and algal deposits. It is non-toxic and biodegradable: No special precautions required for handling and storage. Follow manufacturers recommendations for application and disposal.

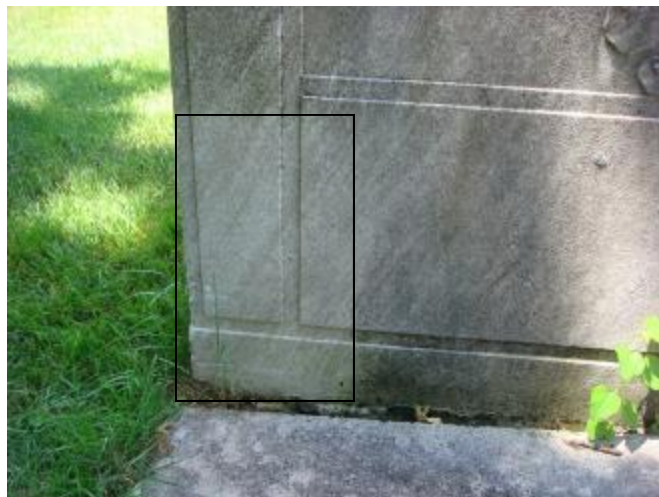
After cleaning
