The Abbey Memorial, Enfield, Connecticut
Condition Assessment and Conservation Recommendations June, 2011

The marble sculpture of Thomas Abbey was carved by the sculptor Sherry Fry, and stands atop an inscribed base. Erected in 1916, the monument is in the center of a patterned limestone and brick paving surrounded by a white marble exedra, approximately 35 feet in diameter with four openings. Within each paving section there are alternate inlaid panels of oval and diamond shaped serpentine marble. The entire ensemble was designed by McKim Mead and White. The sculpture shows minor signs of weathering and biological soiling.

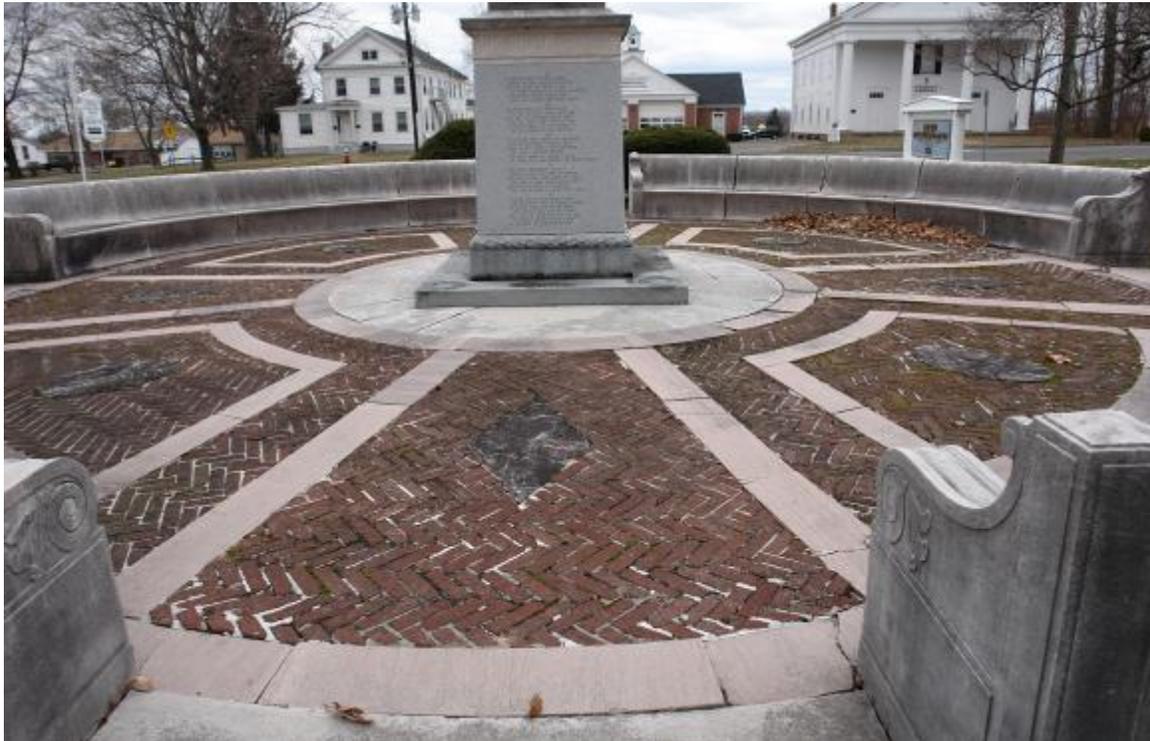
View of pavement from East entrance

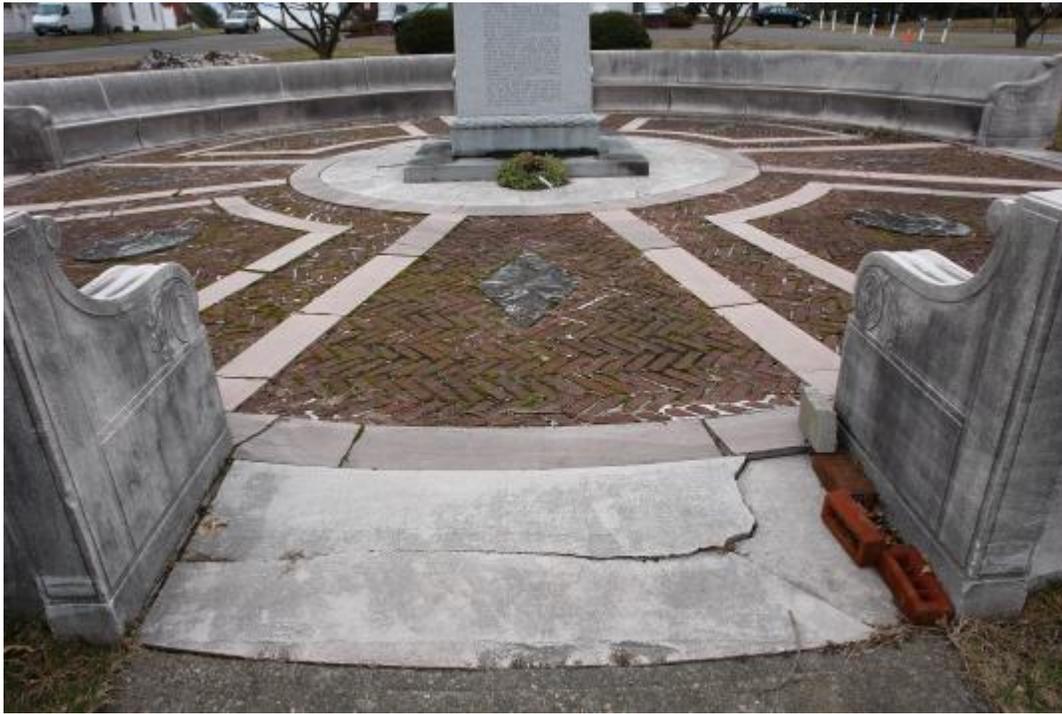
View from West entrance looking towards church

Of major significance is the differential settling of the stone and brick paving. This condition creates a trip hazard and a continued failure of the joints. The lack of evidence of frost shattering to the bricks suggests that they were well chosen high fired pavers. However there has been considerable movement and fracturing of many of the paving elements, primarily on the Northern half. This seems to be associated with cyclical frost heaving, associated with excessive water which may have entered the paved area due to the surrounding topography. See page Appendix 23 for topography map detail of the area.

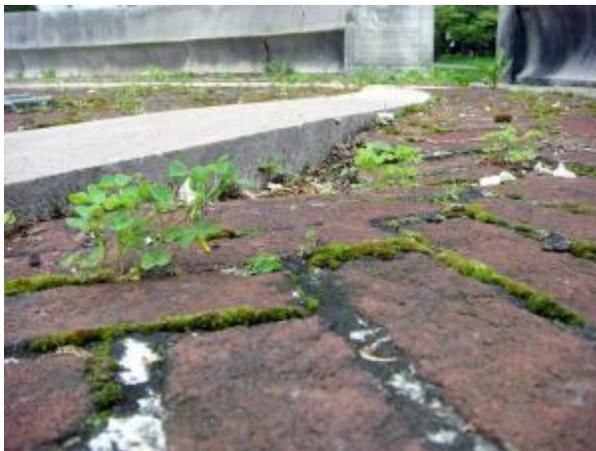
Frost heaving on brick pavers

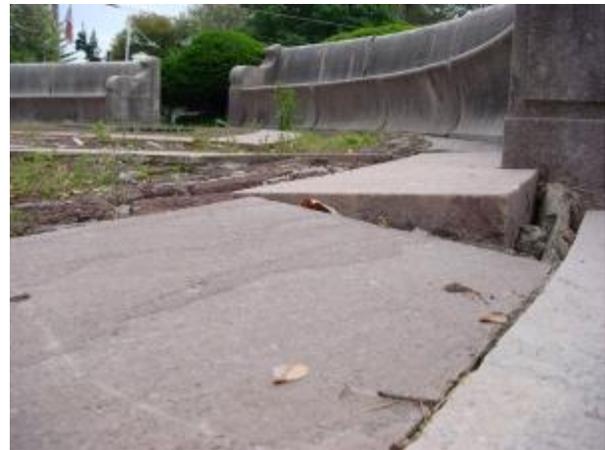
Stone displacement

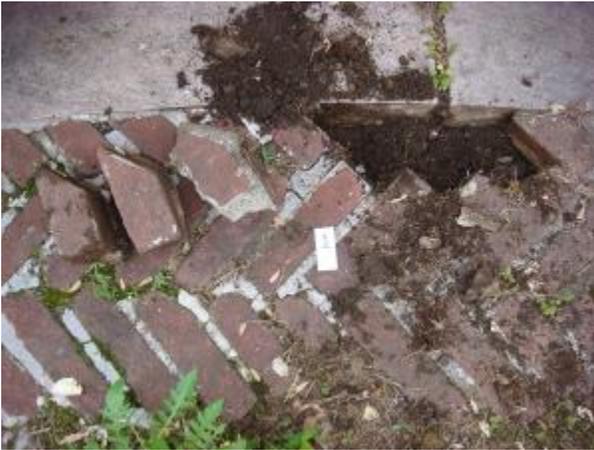
Loose paver bricks

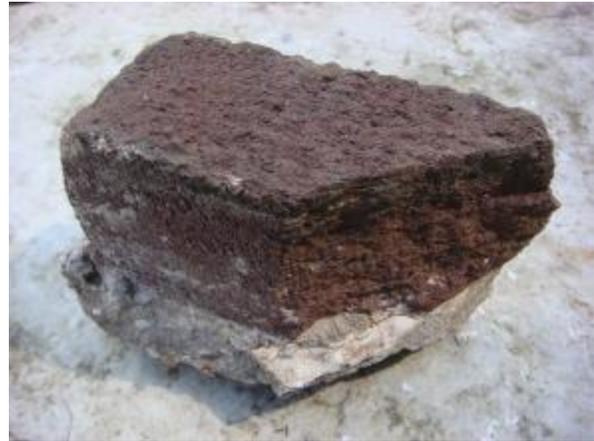
Detail of loose brick. Note setting mortar

A loose brick sample was removed from the North-West perimeter and examined. It was apparent that the paving bricks were originally mortared in two stages. First the bricks were set onto a conventional mortar base laid onto what appeared to be loose pieces of stone, difficult to discern without full excavation, the original base mortar can be seen in the photo above right.

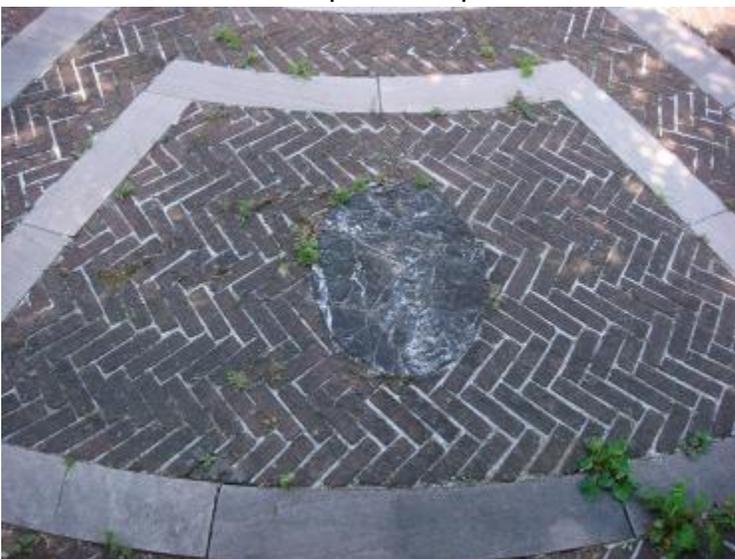
The spacing of the joints and appearance of the mortar in the South-East paving surrounding the oval plaque appears to be original.

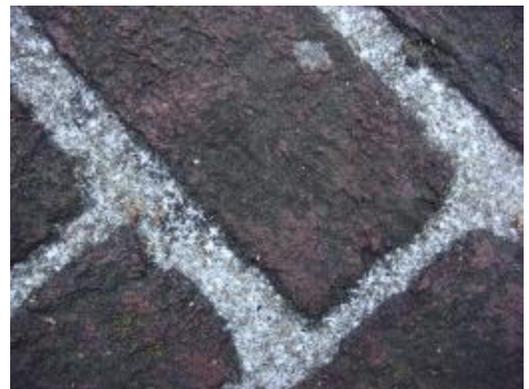
Detail of joints assumed to be original

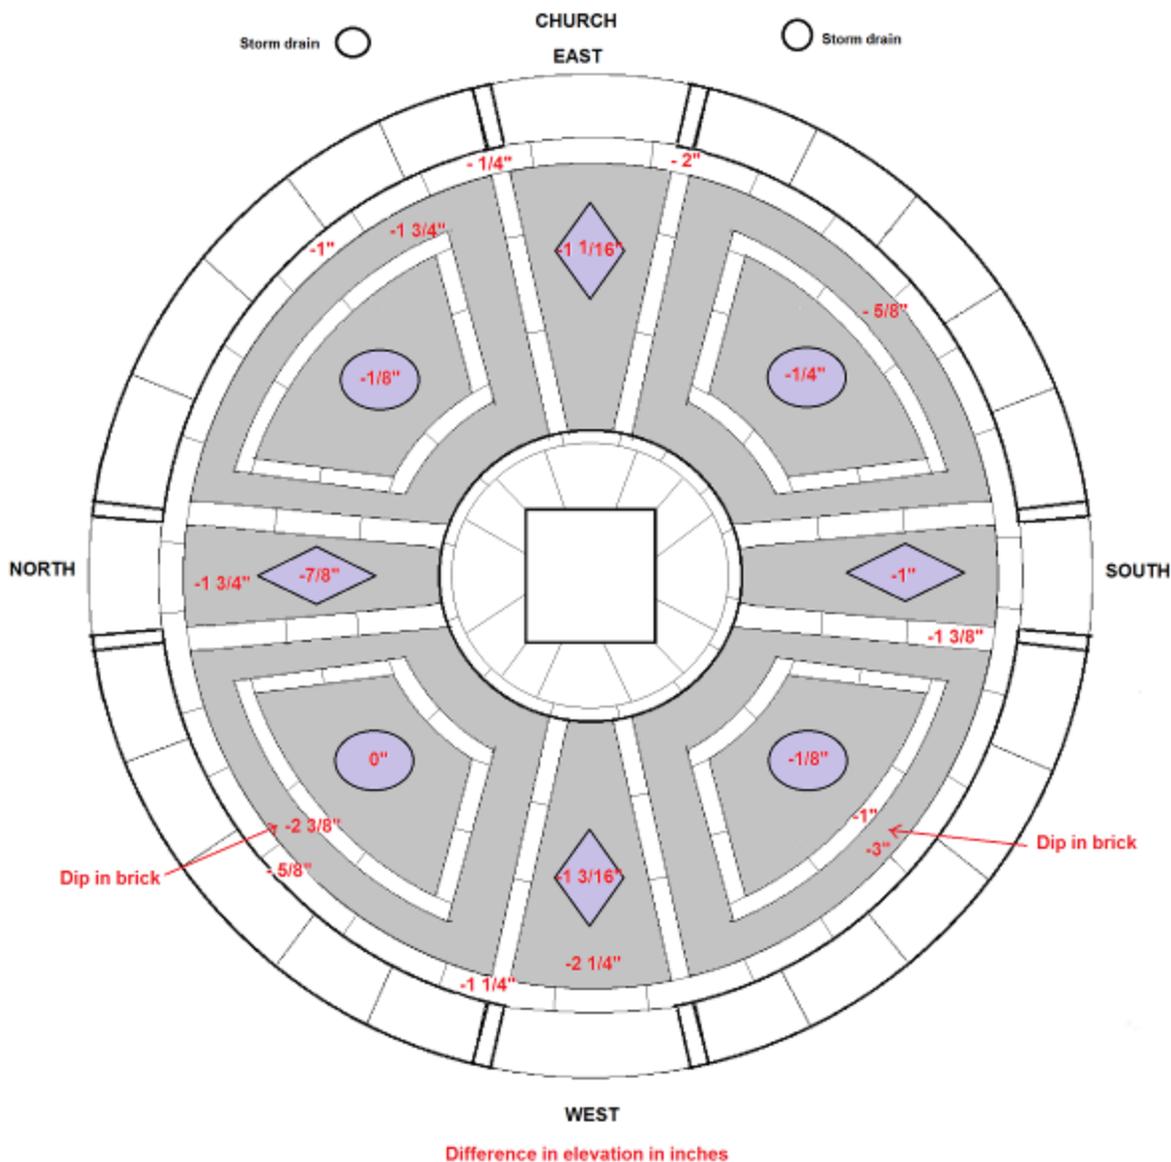
Elevations of the pavement were recorded by laser level and it was found that the oval plaque in the NW quadrant was at the highest elevation of the paving. Differences relative to this oval are noted on the above plan. The difference in elevation of the 4 oval serpentine inserts in the center of each quadrant is only a maximum of 1/4". In an approximate 15 foot distance, this difference is negligible. These ovals are the high points of each quadrant, and were set onto stone slabs which appear to be set onto a concrete foundation. These inserts are most likely still at their original elevation. From this high point, each quadrant slopes down towards the diamond shaped inserts, dropping in elevation approximately 3/4" to just over an 1". The sections of paving with a diamond insert all slope towards the openings in the exedra. All the inset plaques appear to be still at or close to their original elevation. Thus all paving surfaces were initially designed for surface water to run off towards the perimeter exits in the exedra.

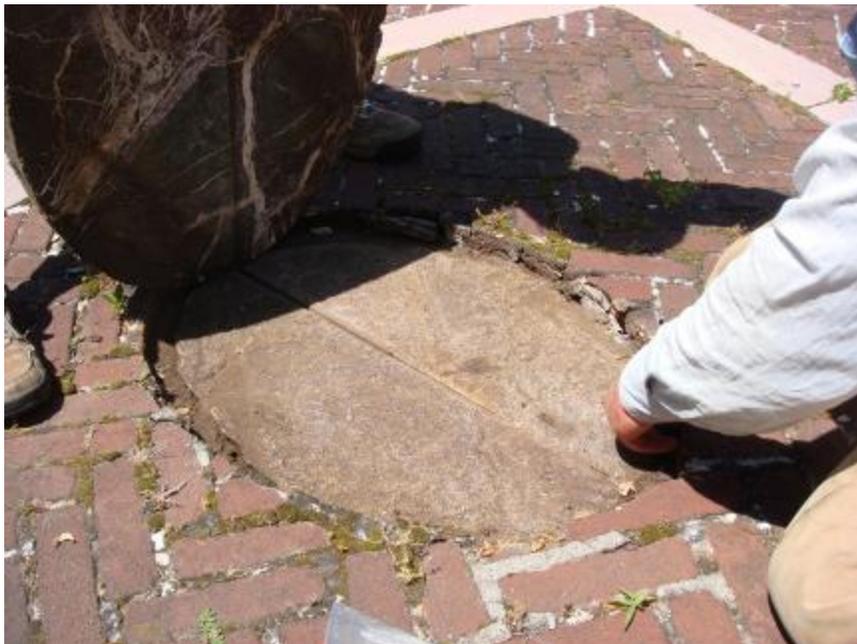
Removal of oval plaque in center of Southwest quadrant to examine setting area. Note stone slab for setting.

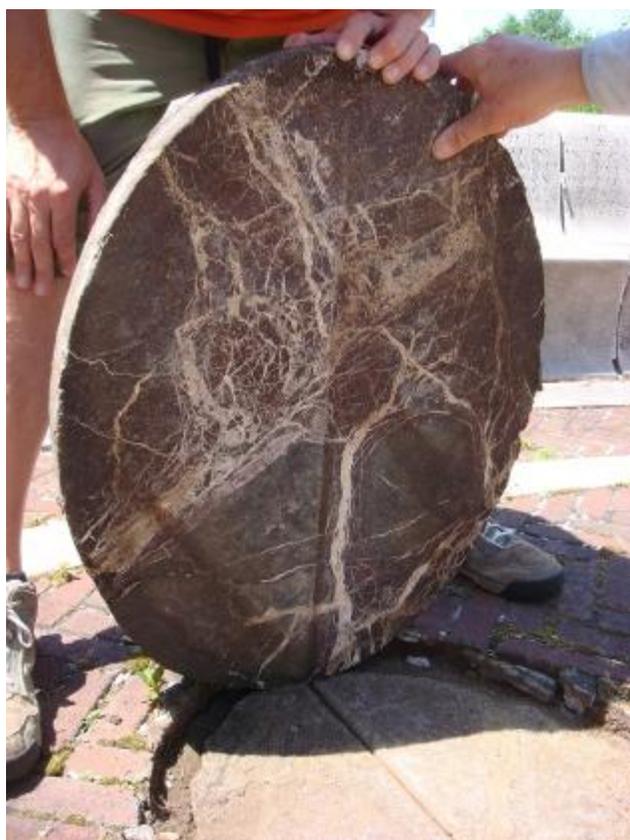
All plaque surfaces, ovals and diamond are extremely weathered. The serpentine plaque in the Southwest quadrant that was removed for inspection is approximately 2" thick. The underside exhibits much less weathering than the exposed surface. While this unexposed surface could be honed and the stone reset with the un-weathered side up, the condition of all the plaques should be inspected to determine if honing all ovals and diamonds is feasible, keeping the final appearance consistent.

Underside of serpentine plaque

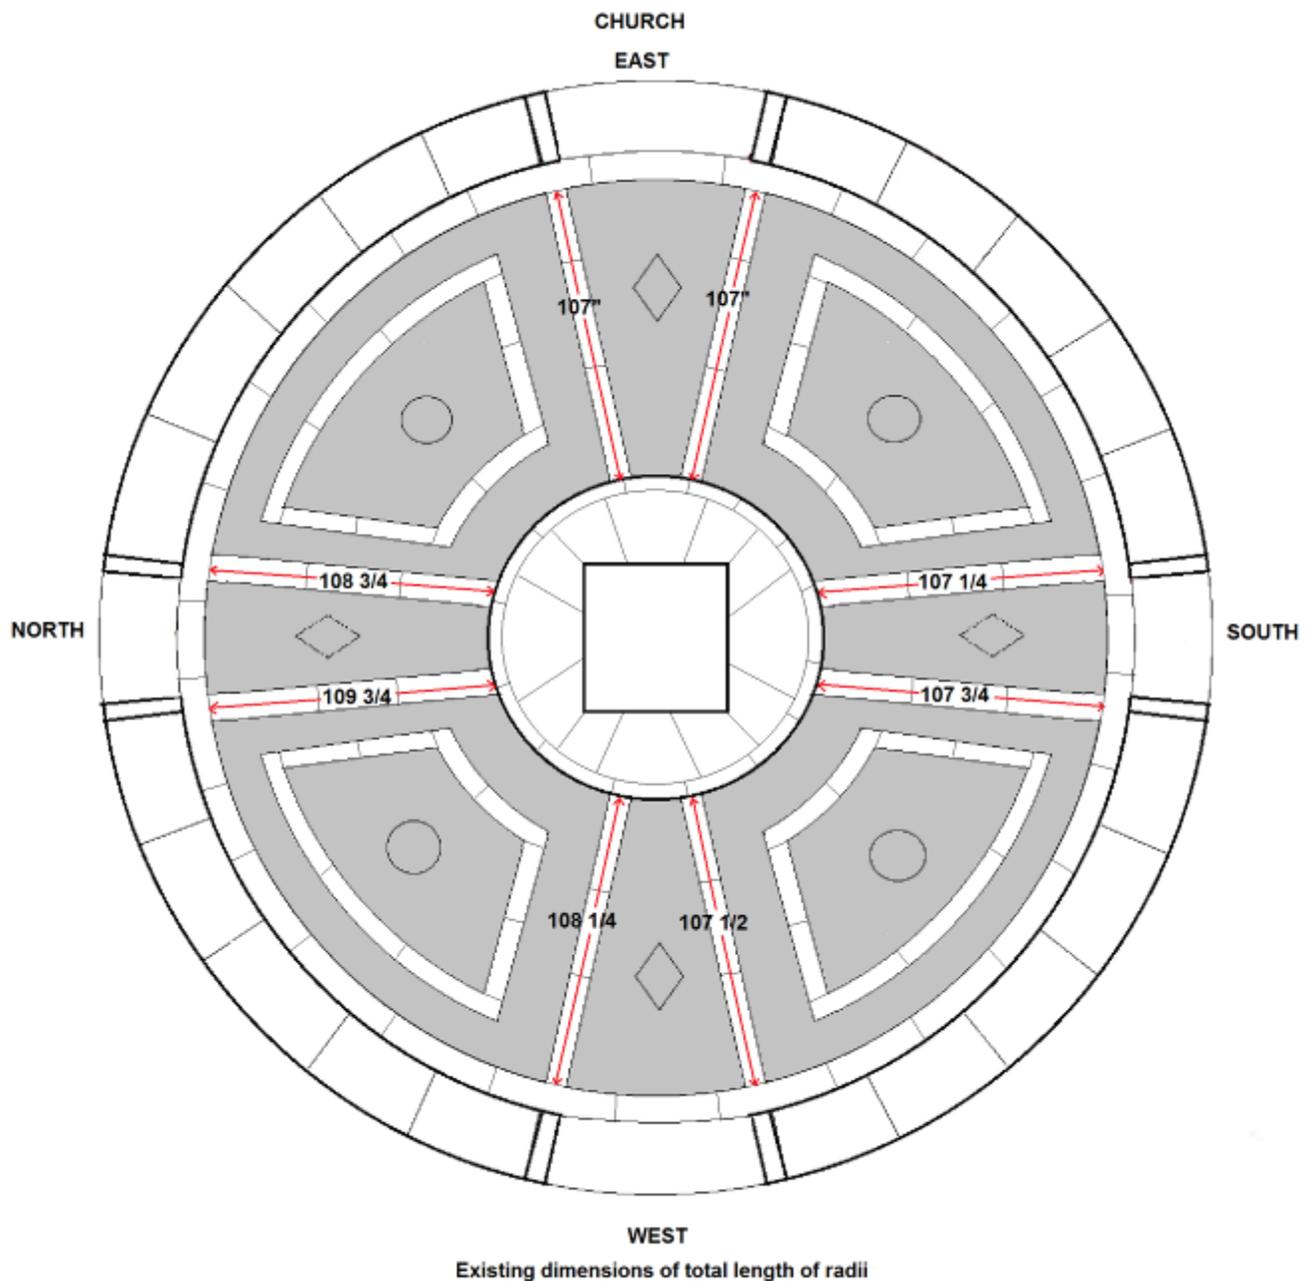
To determine the approximate amount of movement of the pavement and exedra the lengths of the limestone radii were measured and compared. All limestone radii are comprised of 3 separate stones, and the total dimension measured individually, not including joints, only varies approximately $\frac{3}{8}$ " ($105 \frac{7}{8}$ " to $106 \frac{1}{4}$ ").

The above plan notes the total length of the radii including joints. Three of the four radii on the Northern half (including the joints) are $1 \frac{1}{4}$ " to $2 \frac{3}{4}$ " greater than the other radii. This would indicate that the whole Northern side (pavers and exedra) has been displaced approximately this distance.

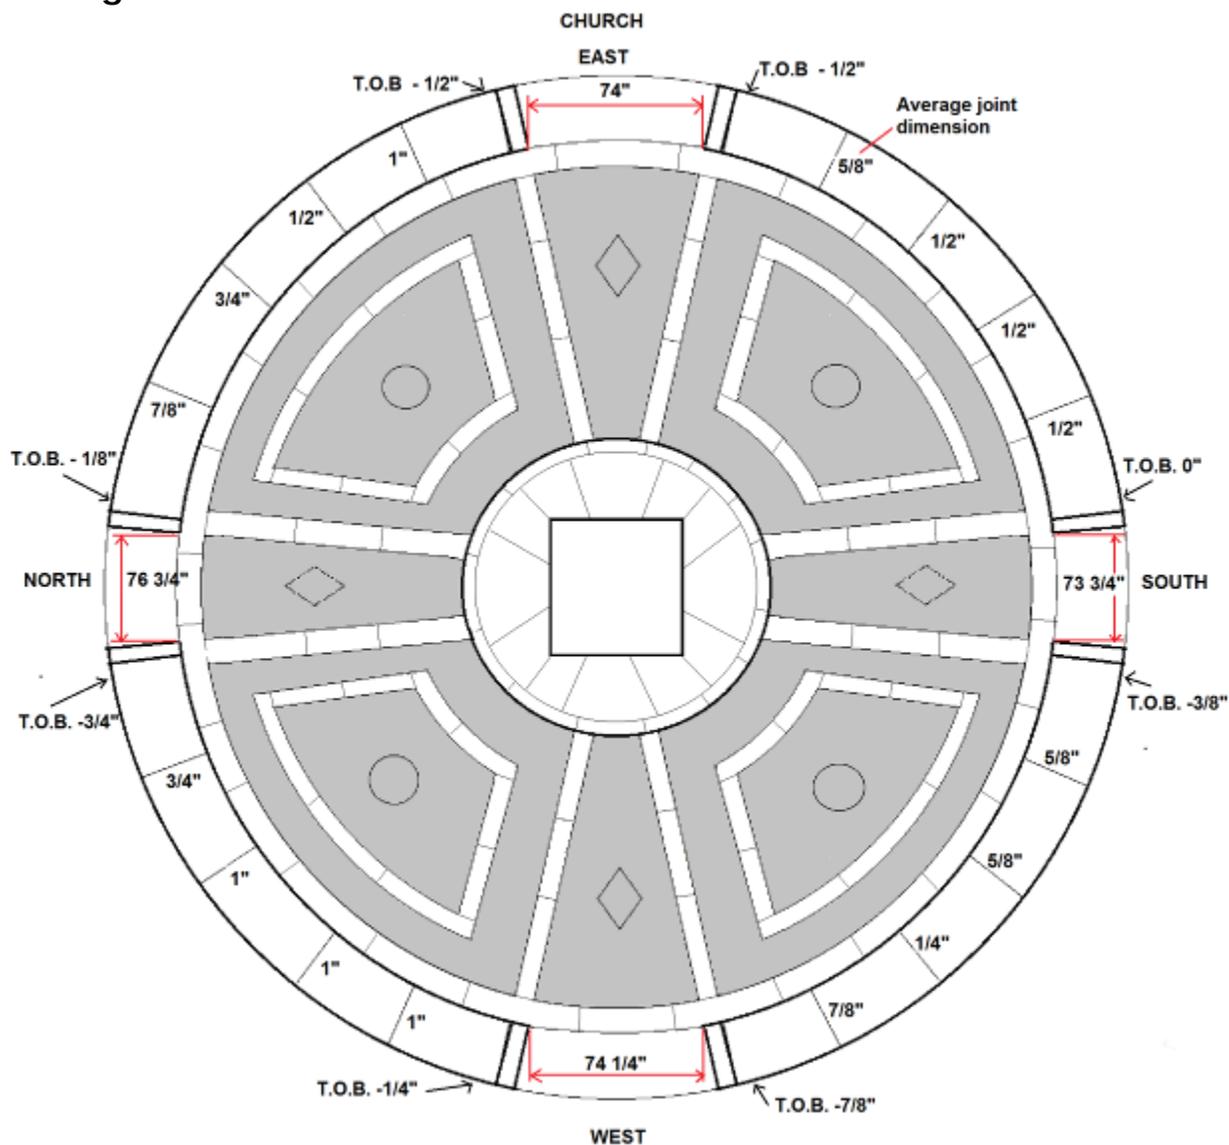
The movement of pavers also caused the exedra units to be displaced. The exedra appears to be set onto a concrete base. The average joint dimensions of the exedra are noted in the above plan. All the units have spread and have wider, open joints than originally planned. The joints on the Northern half are in the 1" range while joints on the Southern side are in the 1/2" range. While all of the exedra units have been displaced outwards, the movement of the Northern half has also caused the North opening of the exedra to be considerably greater than the other 3 openings, approximately 2 3/4" larger than the other openings.

Elevations at the ends of the exedra benches were recorded by laser level and it was found that the Eastern side of the South entrance was the highest point. Differences relative this point, T.O.B. (Top of Bench) varies a maximum of 7/8" with little consistency. Slate shims have been used in the past in an apparent attempt to correct the differences.

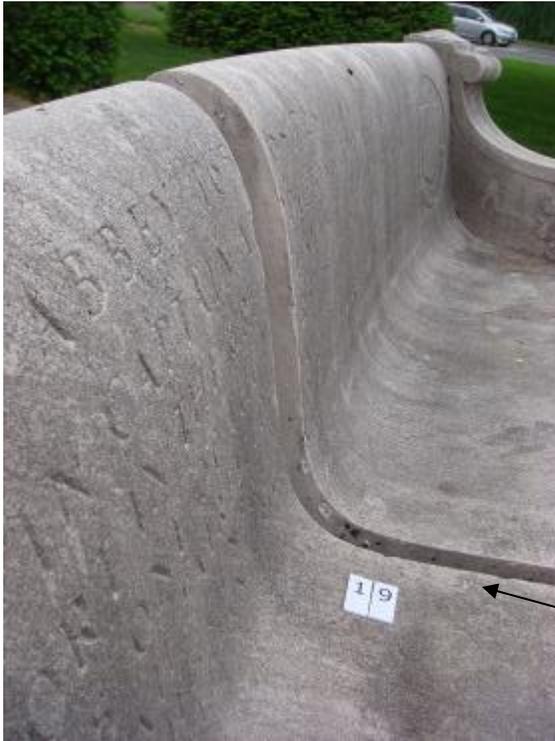
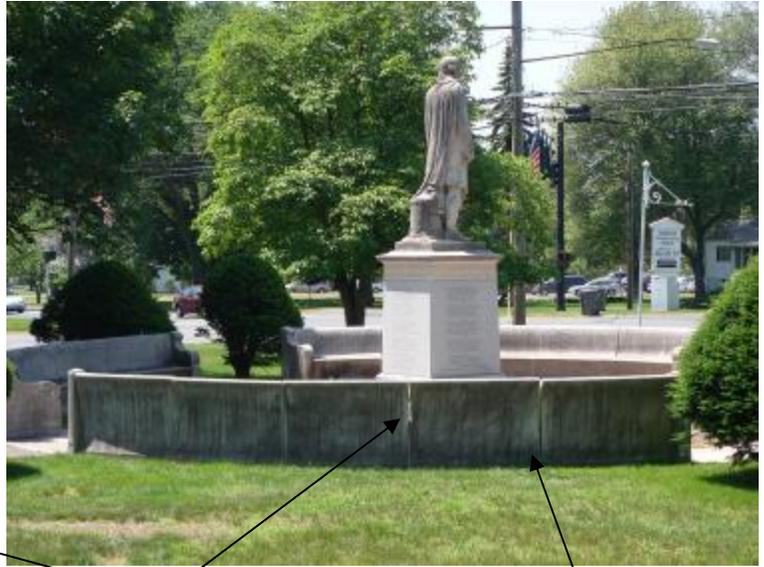
Open joints

The large open joints in the marble exedra and displacement of units is considerable. Each of these units weighs approximately 3000 pounds. There are five units that make up each section of the exedra.

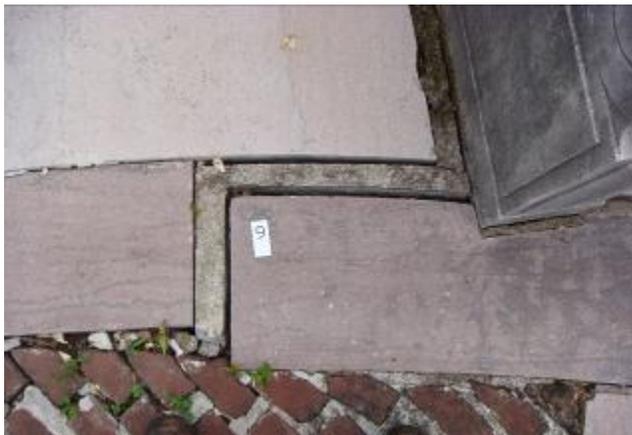
Stone movement and replacement mortar

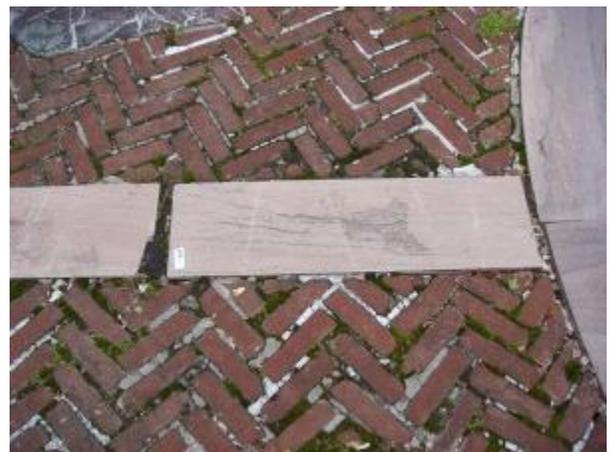
Enlarged joint

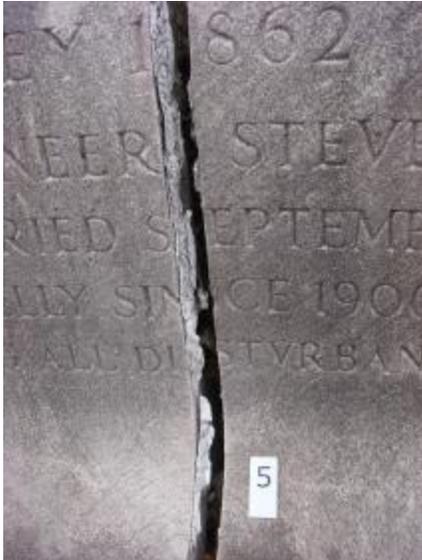
Open joints in exedra with lettering

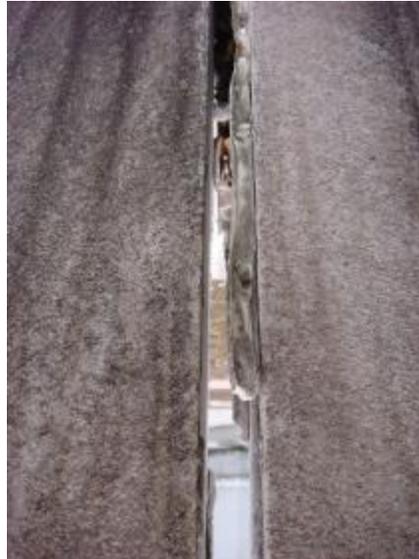
Detail of existing open joints with failed replacement caulking and fibrous backer material.

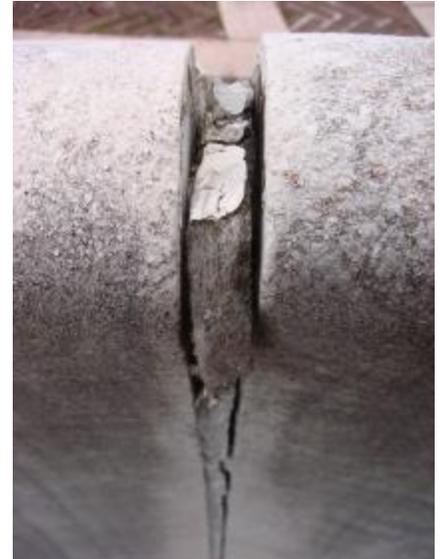
Existing joint opening

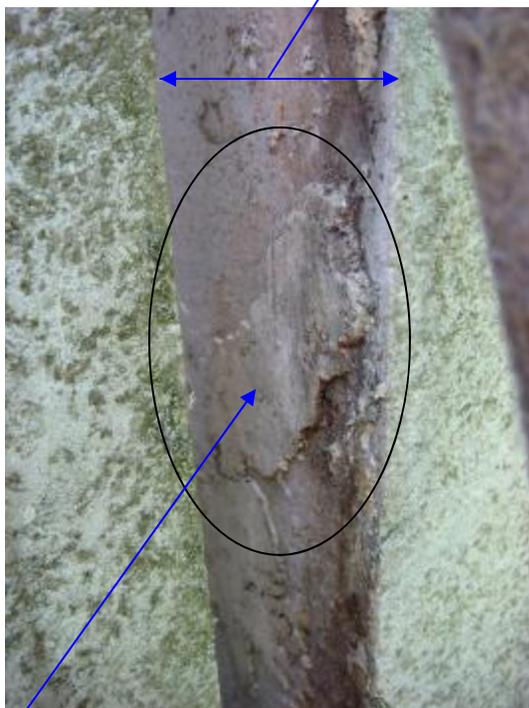
Detail of original thin joint mortar

Examples of original joint mortar from the exedra were scarce; the few pieces found were very thin, ranging from 1/16" to 1/8" in thickness. The spacing of the lettering at the joints would also indicate that the original joints were very thin.

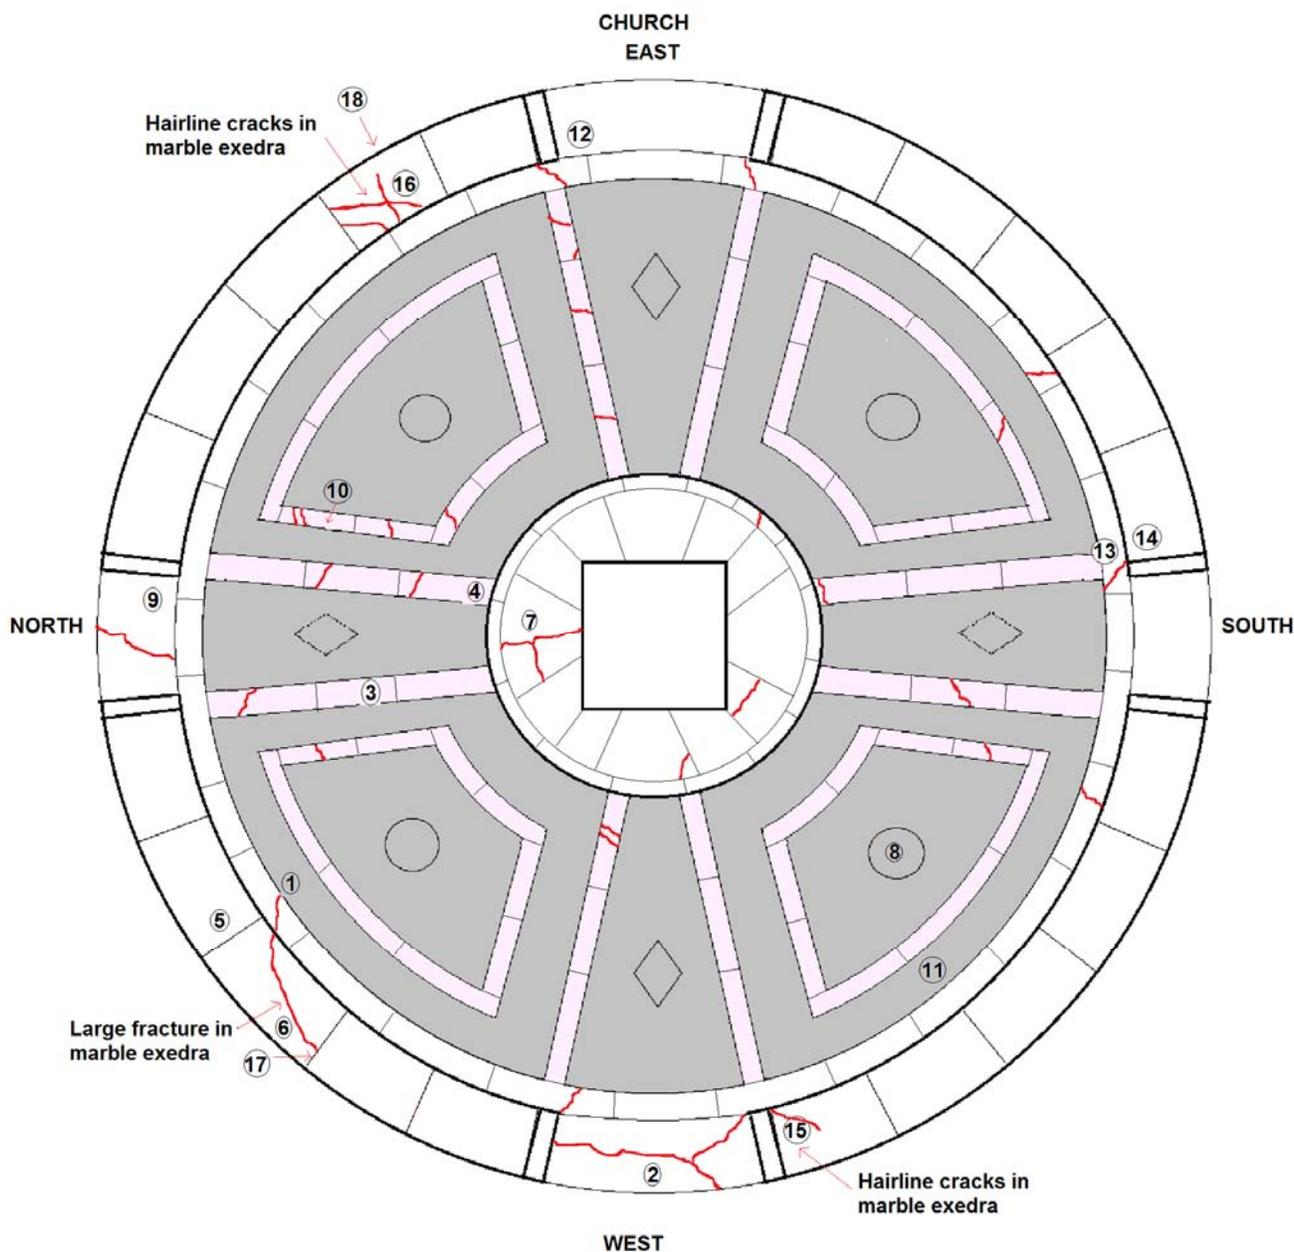
The above plan notes the approximate location of fractures (in red) and photo locations. A sample of the Ross Quarry limestone (pinkish radii and related pattern) at location 13 was removed and found to be 4" thick. It is unlikely that all the fractures were caused by frost heaving.

There are a number of hairline fractures in two of the exedra units and one substantial fracture. The cause of the large fracture to the marble exedra in the North-West quadrant is not known (possible tree or branch damage?)

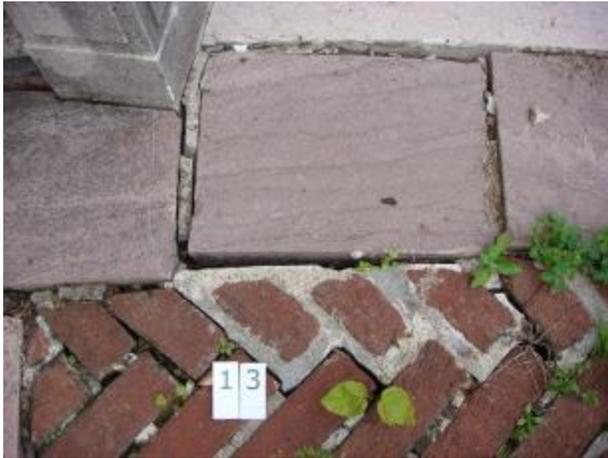
Loose limestone fragment

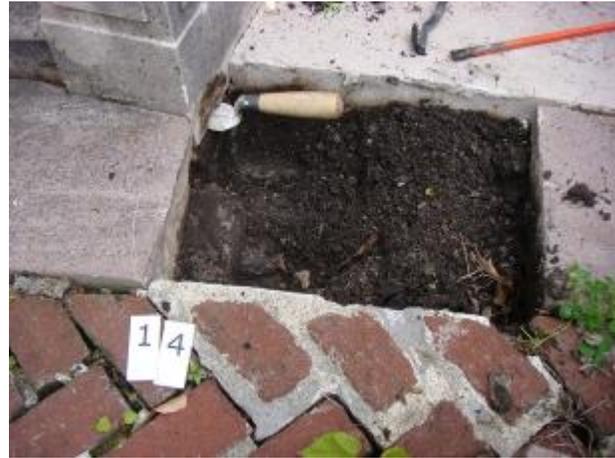
Limestone fragment removed. Note depth of trowel under corner of exedra.

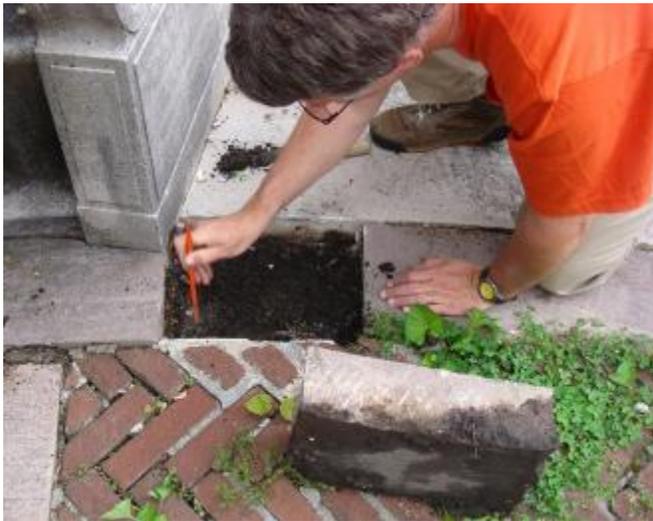
Probing the setting bed

A portion of the Ross Quarry limestone was removed for inspection at the South entrance and was found to be 4" thick. The setting bed was comprised of solid stones with evidence of a decomposed mortar. The loose sample was placed back as found.

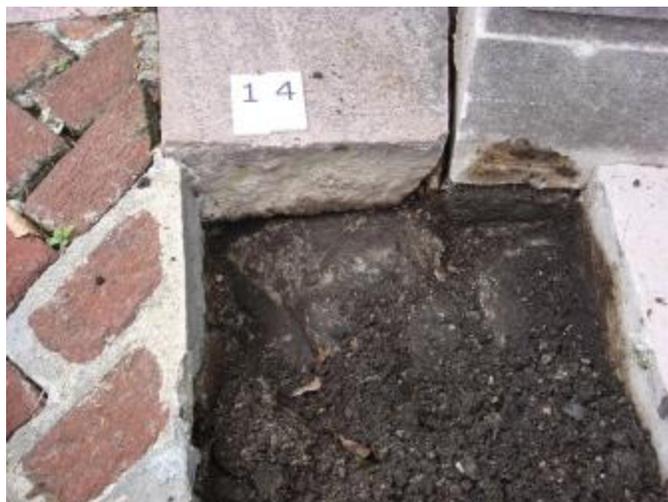
Detail of setting area

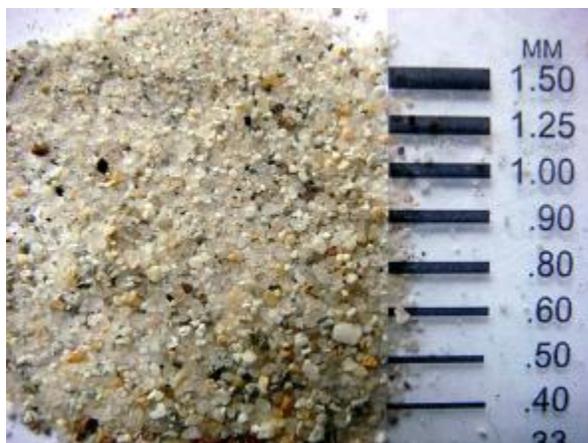
Range of aggregate size of exist pointing mortar in mm. for pavers.

New repointing should be done with a Type O lime rich mortar, 1 white Portland cement 2 high calcium lime, and 7 white quartz sand. Brushed finish to appear weathered.

Aggregate sand to be comprised of the following approximate range in size:

% retained on #16	22%
% Retained on #30	40%
% Retained on # 50	25%
% passing #50	12%

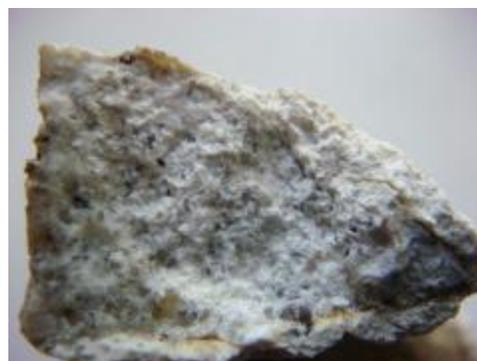
Cross section of existing pointing mortar

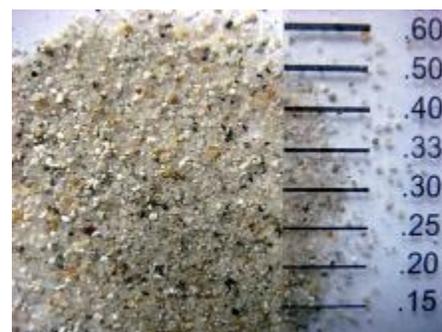
Range of aggregate size of existing pointing mortar in mm. for exedra.

1. All existing pointing material to be removed with hand tools
2. New repointing should be done with a Type O lime rich mortar, 1 w.p.c, 2 high calcium lime, and 7 white quartz sand. Aggregate sand to be comprised of the following approximate range in size:

% Retained on #30	5%
% Retained on #50	65%
% passing #50	30%

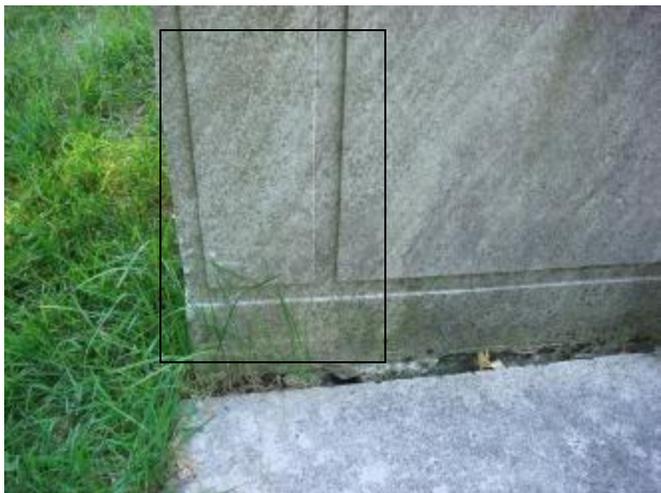
Test area for cleaning.

Cleaning tests were done with D/2 Biological solution (Cathedral Stone, Hanover MD). A contact time of only 1 to 2 minutes will loosen most fungal and algal deposits. It is non-toxic and biodegradable: No special precautions required for handling and storage. Follow manufacturers recommendations for application and disposal.

Area to be cleaned is saturated with D/2 Biological Solution with a pump sprayer. Allow the undiluted D/2 to remain on the surface for 1 or 2 minutes, then apply additional D/2 to maintain a wet surface. Scrub wet surface thoroughly with a non-metallic, short fibered scrub brush. Best results are scrubbing onto wet surfaces, if necessary lightly mist with water and continue scrubbing. Rinse thoroughly with clean water.

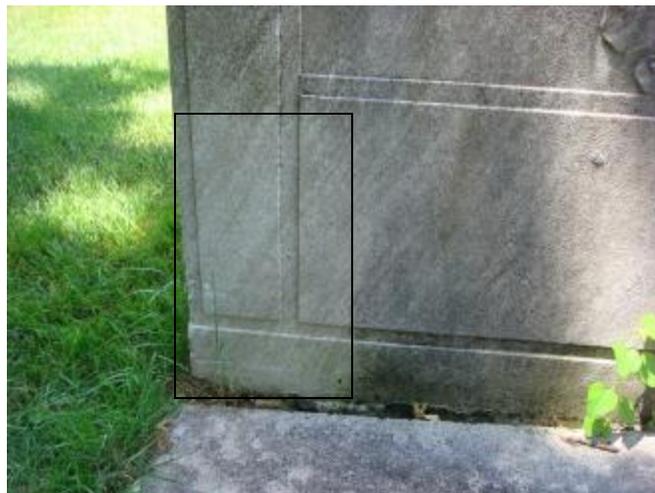
After cleaning

Rinsed areas will appear to be immediately cleaner, and with time, will appear whiter as the dead biogrowth slowly detaches from the stone.
