CONDITION ASSESSMENT OF THE
CARTER TOMBS

Foundation for Historic Christ Church

IRVINGTON, VA

MARCH, 2003

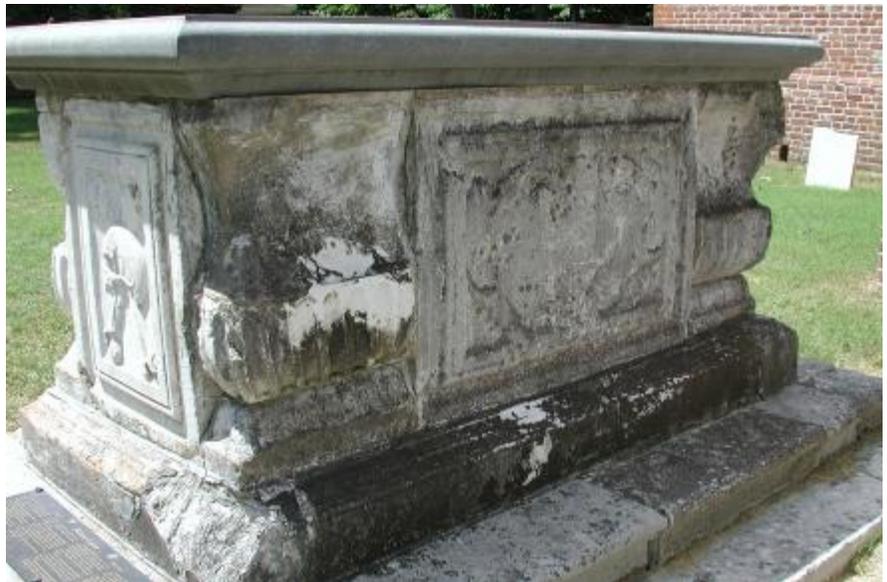
**Robert Carter,
north and east
elevations, August 8,
2002**

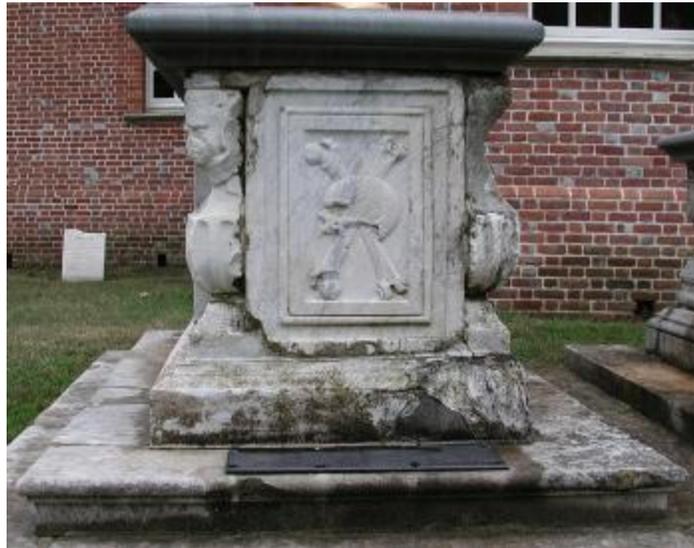
East, Portland limestone. Deterioration, with considerable loss at north end. Most is fill, with some whitewash.

**Robert Carter, east elevation,
November 5, 2002, showing
deterioration of base molding**

The east and west base moldings are in poor condition. They require (either) extensive chemical treatment and filling (especially to re-establish profiles in the area beneath the NE corner), or the installation of replacement elements of new stone.

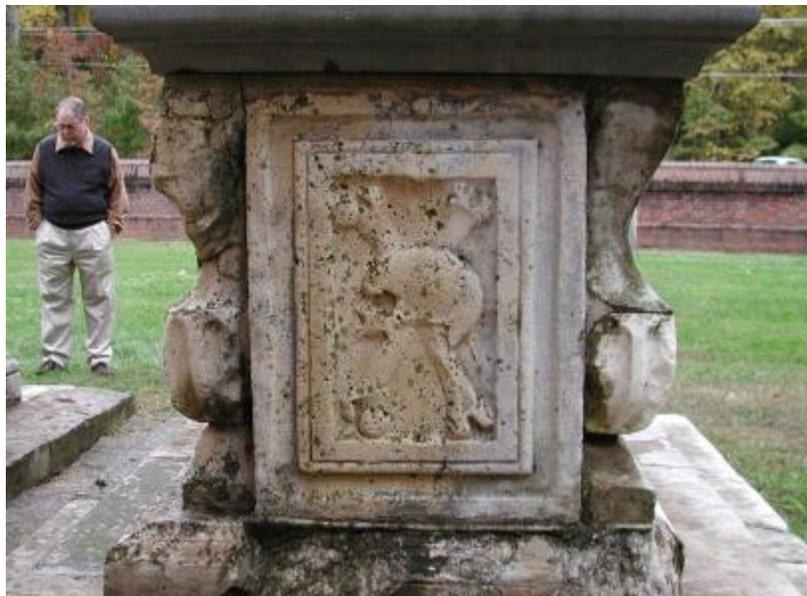
West (short), cast cementitious replica, 1927. Open vertical mortar joints at left and right edges.

Robert Carter, west elevation, November 5, 2002, replica panel

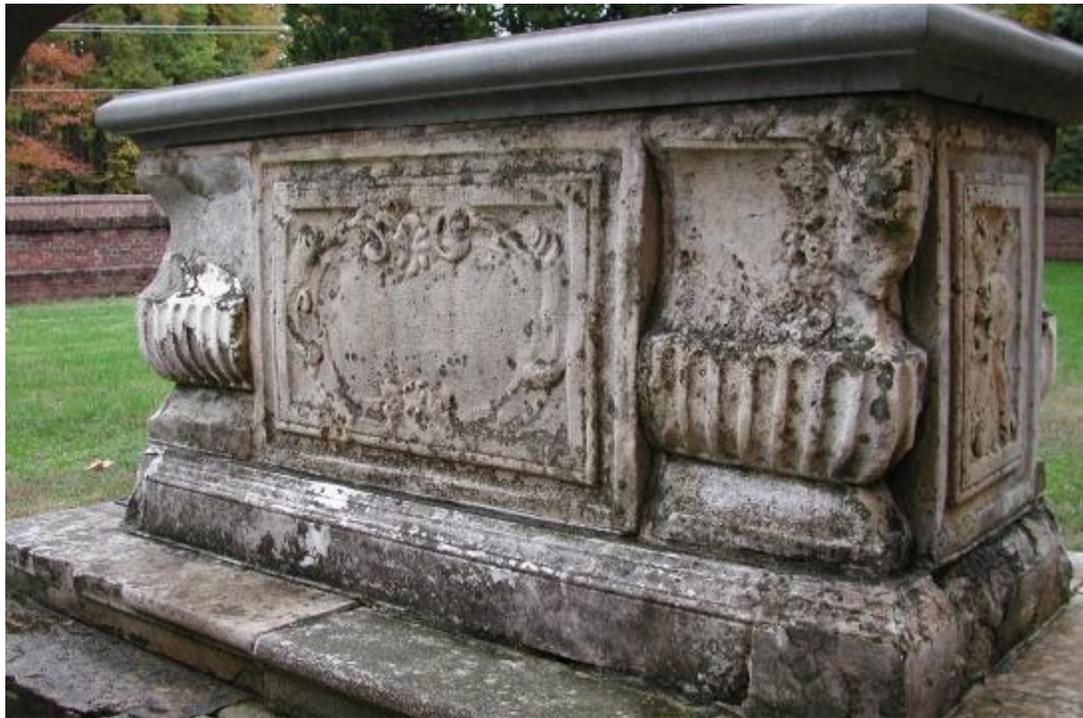
NW, cast cementitious replica of SE corner, 1927 (no head). Of generally poor quality. Open vertical mortar joints on north and west elevations.

Robert Carter, north and west elevations, November 5, 2002, panel and NW corner are replicas

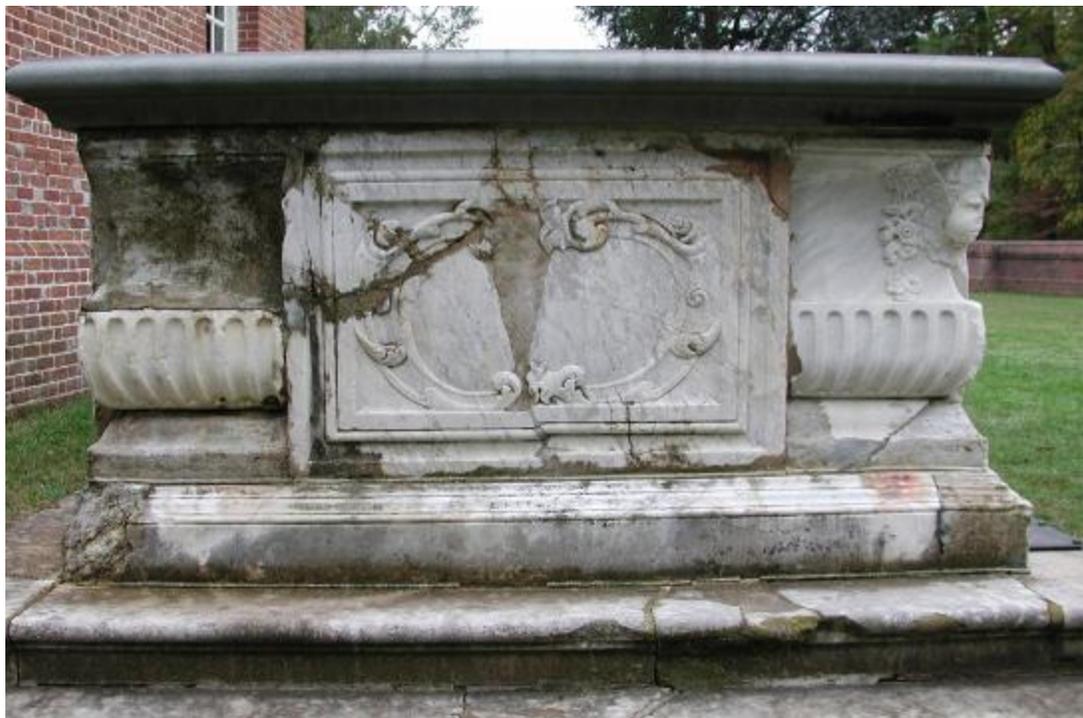
South (long), white marble, pre-1927. Prominent fractures and fills, with fragments poorly fit, as seen in 1927 photograph (#0005). 1927 fills have weathered, discolored and separated; some fractures are open. Two small areas of active surface deterioration. Open vertical mortar joints at left and right edges.

Robert Carter, south elevation, November 5, 2002; note mis-alignment of panel fragments probably assembled in 1927

There are two stone panels (south and east), and two cast replicas. The south panel is in poor condition. It will require the removal and replacement of old fills, crack filling, and localized chemical treatment. Anticipated visual improvement for the south panel, which is particularly prominent, is considerable. Much less work is required for the east panel.

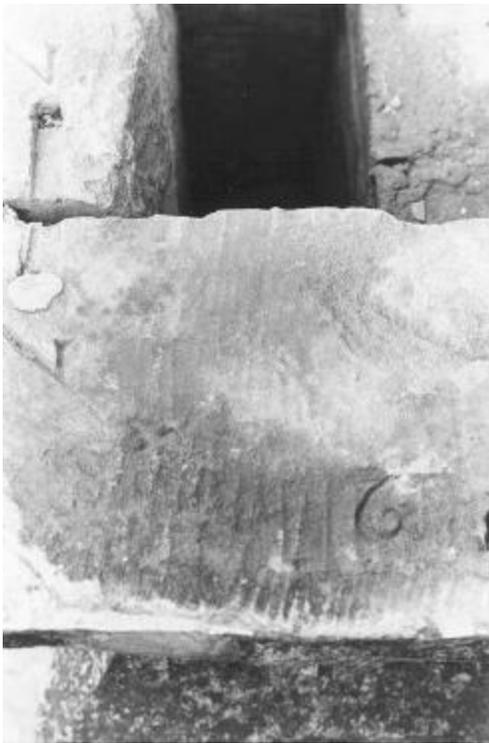
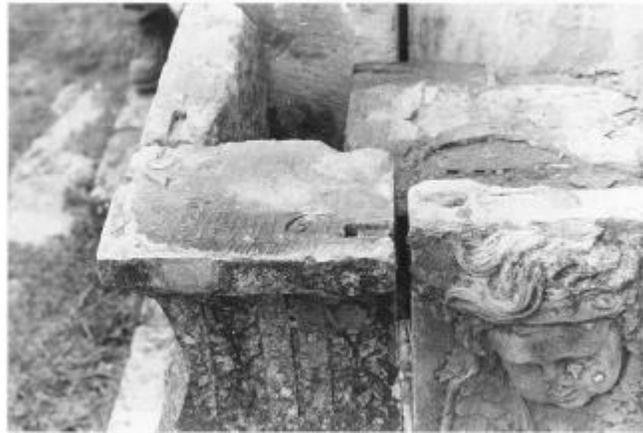
#0077 and #0078, Judith Carter, lid removed, August, 1980

Our second assumption is that the surviving elements were probably re-assembled correctly in 1927. Each tomb has at least one long panel, one short panel and one corner pre-dating 1927, and matching each other (for each tomb) in height. These vertical dimensions are slightly different from tomb to tomb, and there is no obvious evidence of alteration to permit reconstruction. (For Judith, this seems to be confirmed by the presence of original mason’s numerals on the upper surfaces of the NE corner and east panel, as seen in photographs #0077 and 0078, taken in 1980).

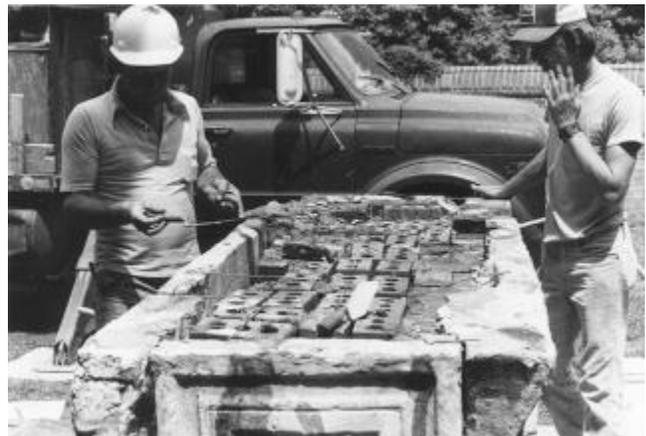
#0065, Betty Carter, lid removed, August, 1980

Finally, there is the question of whether to accomplish the work in place, or to disassemble the tombs, conserve and re-build. The photographic documentation of the work done in 1980 in conjunction with the replacement of the lids (e.g., #0065) shows the extent to which the individual elements have been attached to back-up brickwork and to each other. This argues strongly against disassembly, which could cause serious damage to weakened, historic stone.

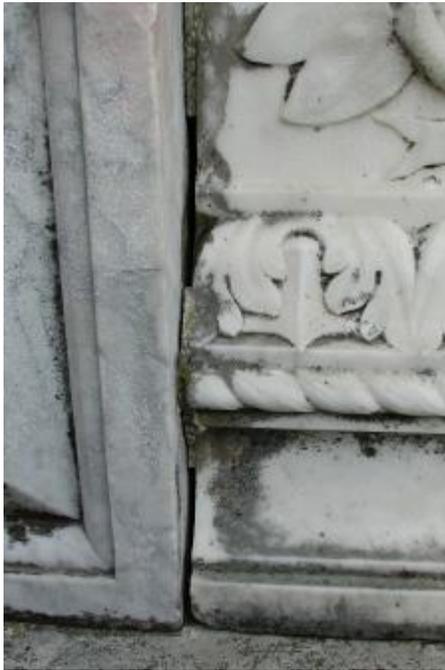
**Open mortar joint (typical),
November 5, 2002**

4.2 All three tombs require additional cleaning and the re-pointing of all mortar joints. The platforms, on which the tombs rest, will require some minor repairs, and the re-pointing of the bed joint beneath the base moldings. (The Robert Carter tomb has an additional bed joint between the two levels of the platform.) Platform head joints should probably be left open to permit drainage of surface water directly into the soil.

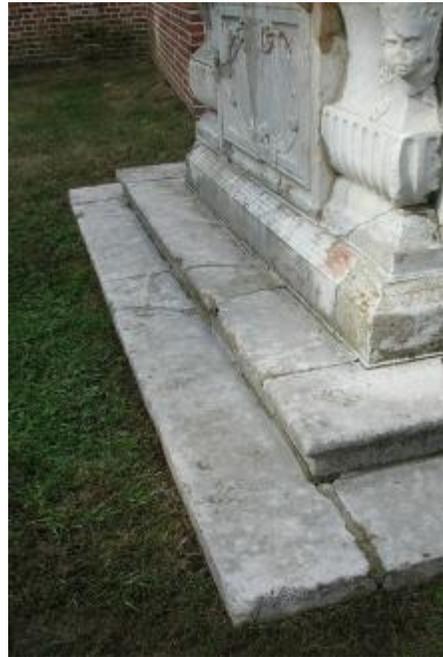
**Platform, Robert Carter, south
elevation, November 5, 2002**
