Beth Haim preservation-project

Report on the second test with cleaning-products

Bureau Funeraire Adviezen, Amsterdam
Monument Conservation Collaborative, Massachusetts (USA)

December 2009

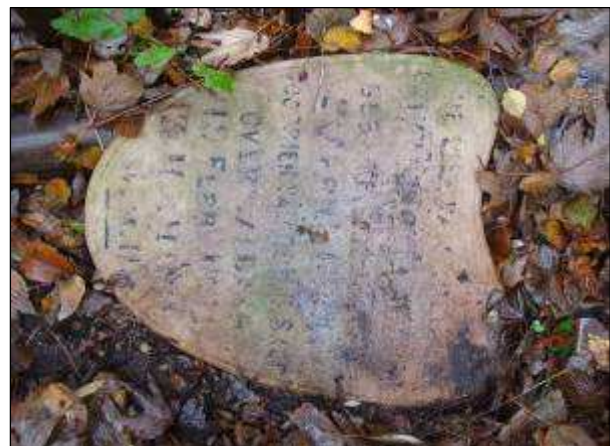
* The piece of marble was left under a hedge and was eventually covered up with leaves. This condition may contributed to more biogrowth and staining. Even so, it appeared that the area that was treated with Biowash looked better than the area treated with BFA.

The marble after being covered up with leaves. Even under these conditions the ends appear cleaner than the middle that was not treated.

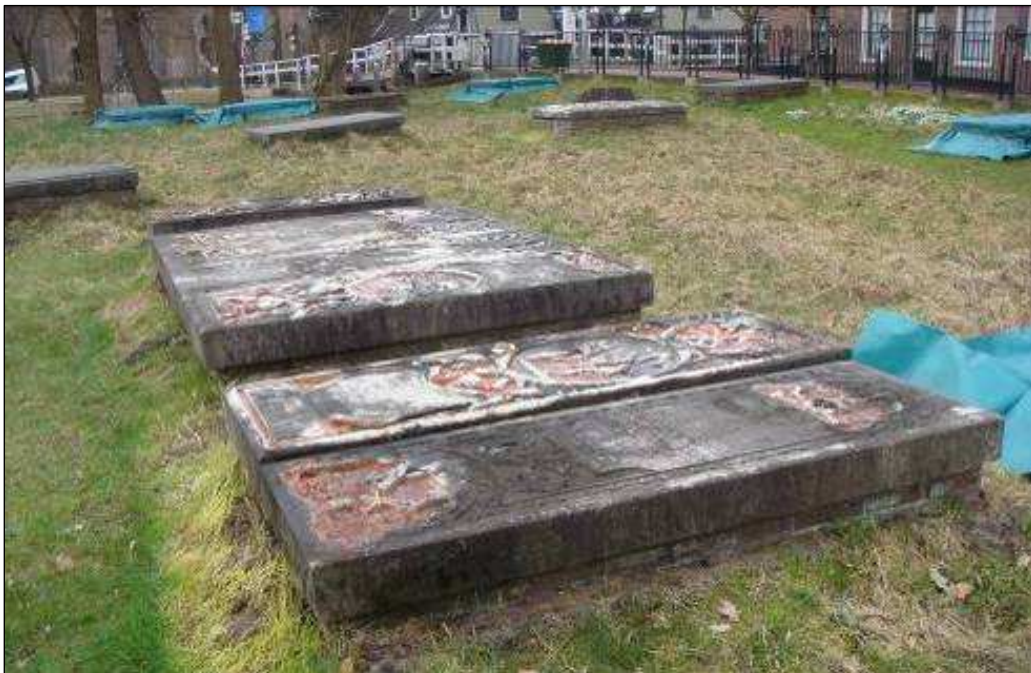
First test group as it appeared in 2008

The biological growth on the six stones above is quite similar, with significant existence of the red alga called trentepohlia. This alga thrives in slightly salty air, especially on wet surfaces.

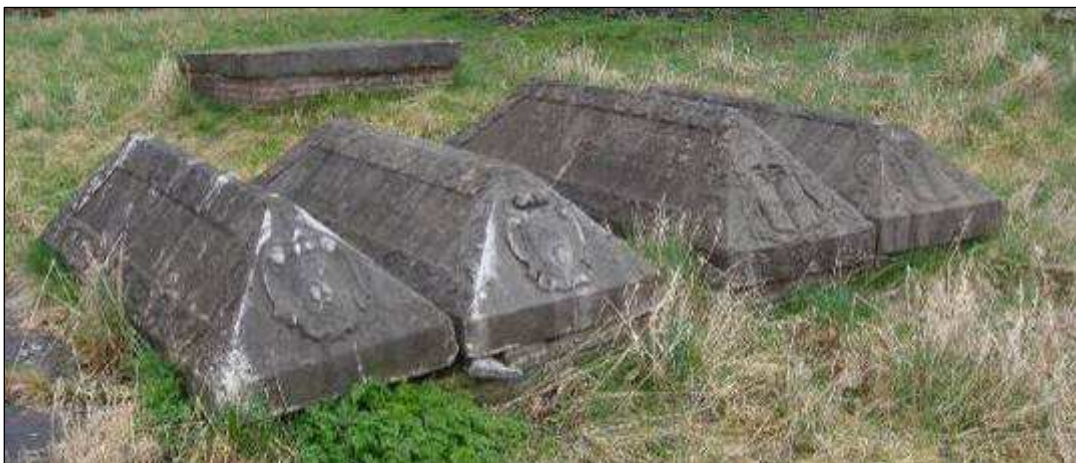
Second test group as appeared in 2008. Notice the different type of soiling.

These sarcophagus-shaped monuments readily shed water and no red alga could be detected. The surfaces were totally blackened by biological growth. This group of stones was last cleaned in 2004, probably by high-pressure cleaning.

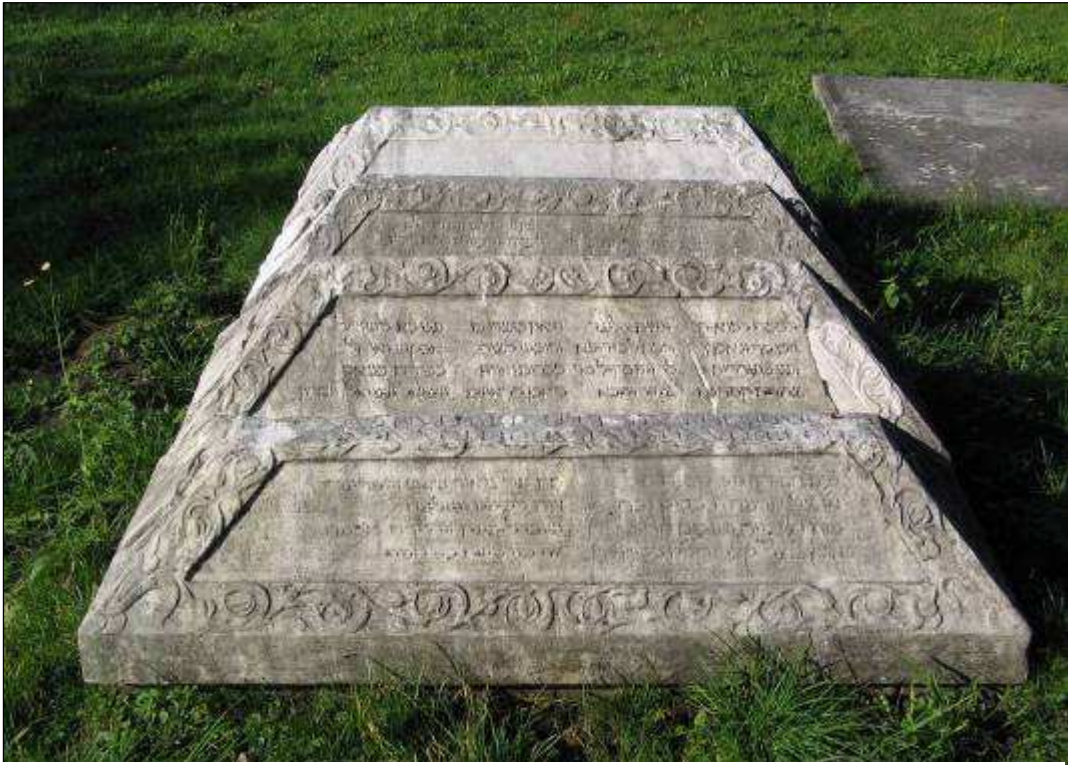
The second testgroup at October 19th 2004, not long after they were pressure-washed.

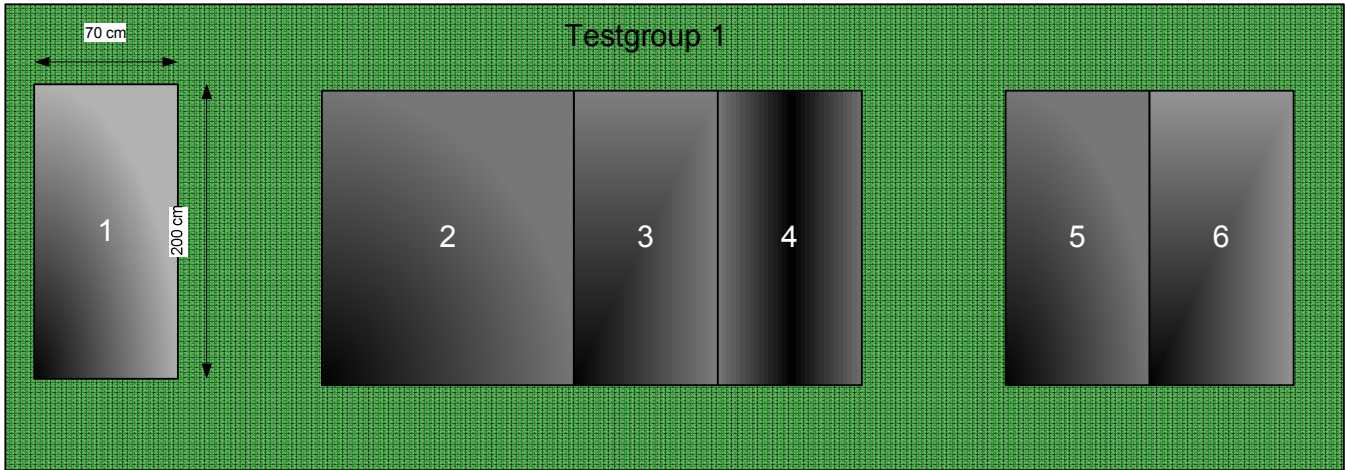
In the first group there was an outline of six stones. They were numbered according to the situation in the field from left to right. According to the proposal the stones were treated as follows:

- 1. Treatment with Biowash
- 2. No treatment
- 3. Cleaning with tapwater and brushed
- 4. Treatment with BFA
- 5. No treatment
- 6. Only sprayed with BFA

Because of the wet weather the monuments were saturated before the start of the treatments. There was a drizzle when the work started but the weather soon cleared, with occasional sun. The wind was mild. Temperatures rose to about 13° Celsius.

The surface water was cleared with sponges before testing began.

On stones 1 and 4 the products were sprayed on with a dwell time of a few minutes. Additional product was applied and the surface was then brushed with a soft natural bristle brush. The stone treated with Biowash had considerably more foam which was colored with the removal of soiling. That showed that alga was broken down by the product instantly.

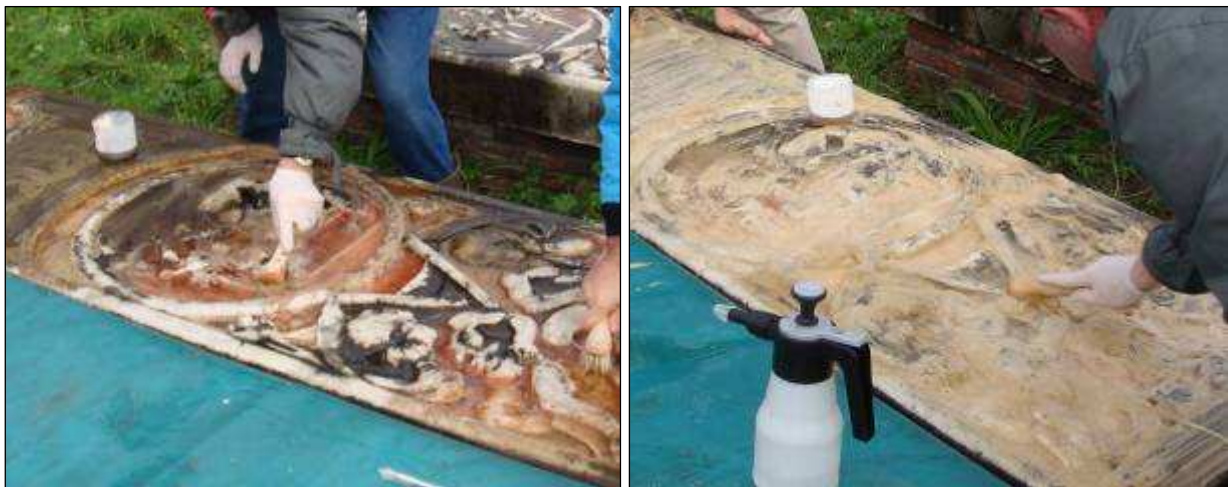
At the first cleaning round (left) the BFA did not foam as much as with the second round (right).

After all over brushing both stones were hosed down in each group with tap water. After drying them again with sponges and short air drying, treatments were repeated as above with the same result. This time the foam produced from the BFA product was more significant.

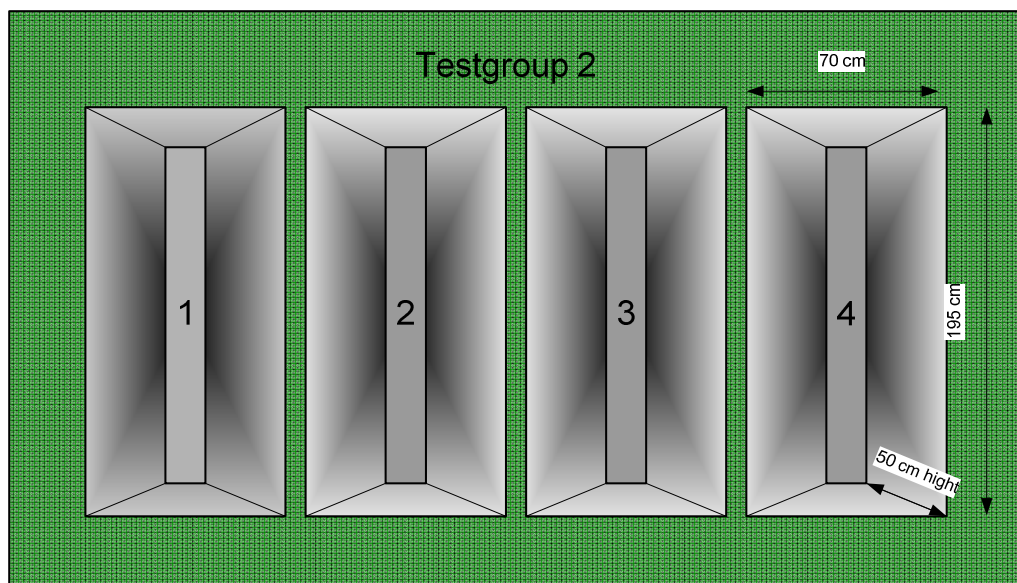
This second group consisted of four stones in a row. Here the testing was carried out in a slightly different way. Again the stones were numbered, according to what had to be done. From left to right;

1. Treatment with Biowash, and mildly pressure washed
2. No treatment
3. Cleaning with mild powerwash only
4. Treatment with BFA, and mildly pressure washed

Stones 1 and 4 were sprayed with the products with a longer dwell time (45-60 minutes). Before brushing, the stones were sprayed with additional treatment and brushed with wet bristle brushes. The stone treated with BFA appeared to have better results removing the black coloration than the Biowash.

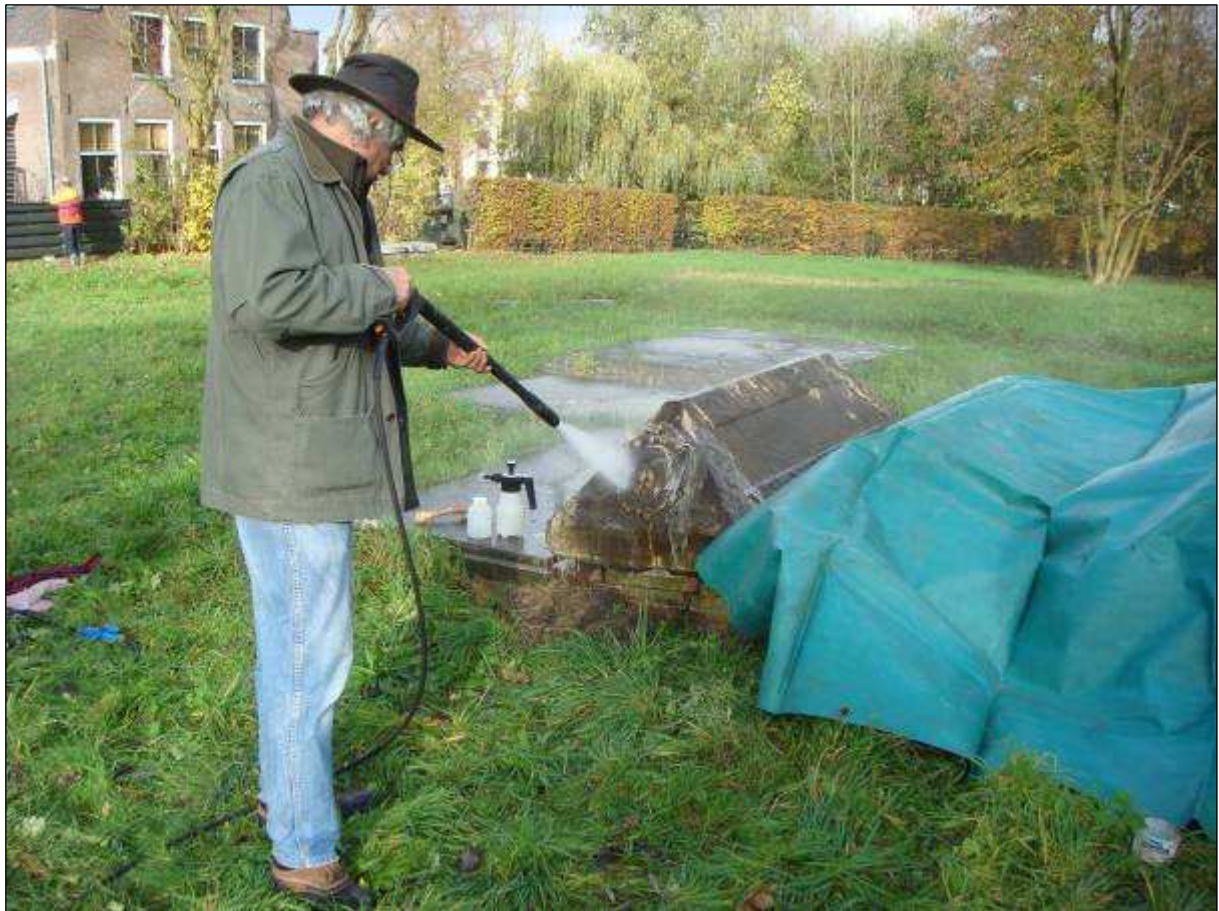
Pressure washing in progress at the nr. 1 stone that has been cleaned with Biowash.

The treatment was repeated with additional brushing and at the end the final rinsing was done with a mild pressure wash. For that purpose we used a Stihl RE 142 K pressure washer (see appendix B). A fan shaped tip was used and the distance of the nossle from the stone was kept well back to limit the pressure.

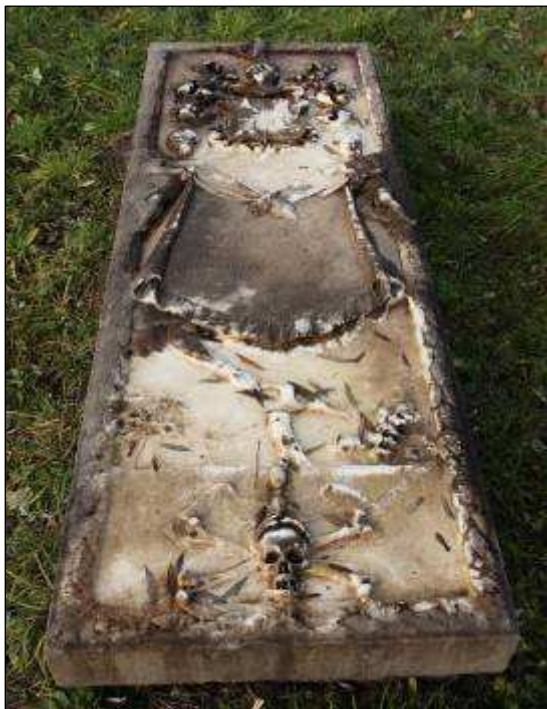
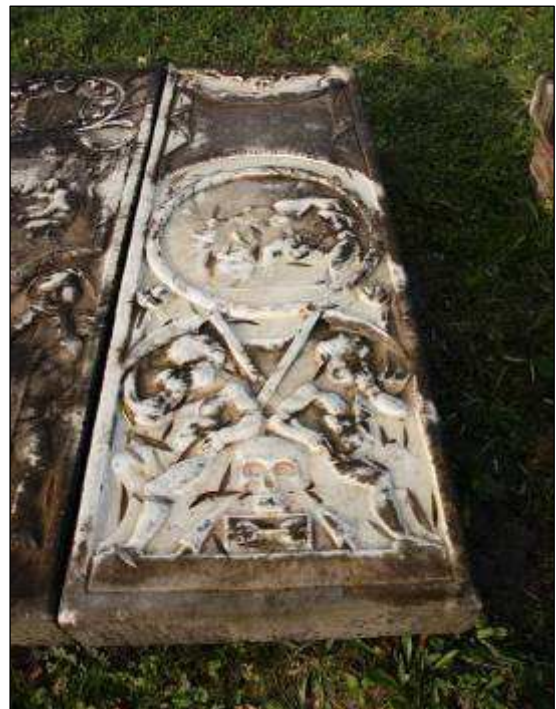
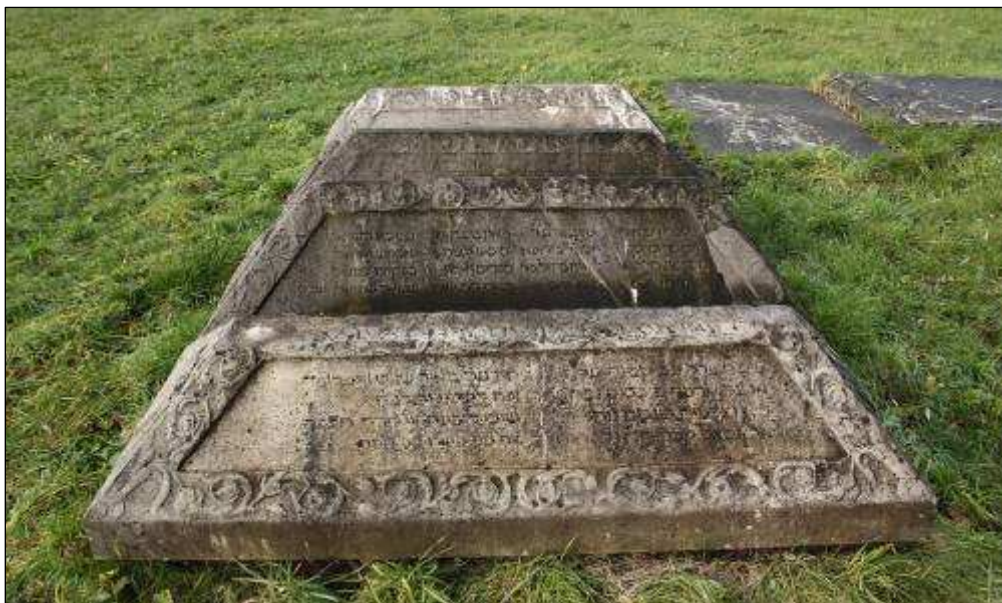
Result at November 20th, one week after the test, for both testgroups

After the testing was ready the first group was assessed for result (see photo caption in appendix A). It seemed at this point that the BFA left the surface of the marble more white than the Biowash. At the stone number 1 (Biowash) the surface seemed to be more brown-red. It was also noted that the stones were drying up very rapidly. Large portions had already dried.

The second group dried as well, after the work, but the surface showed limited cleaning.

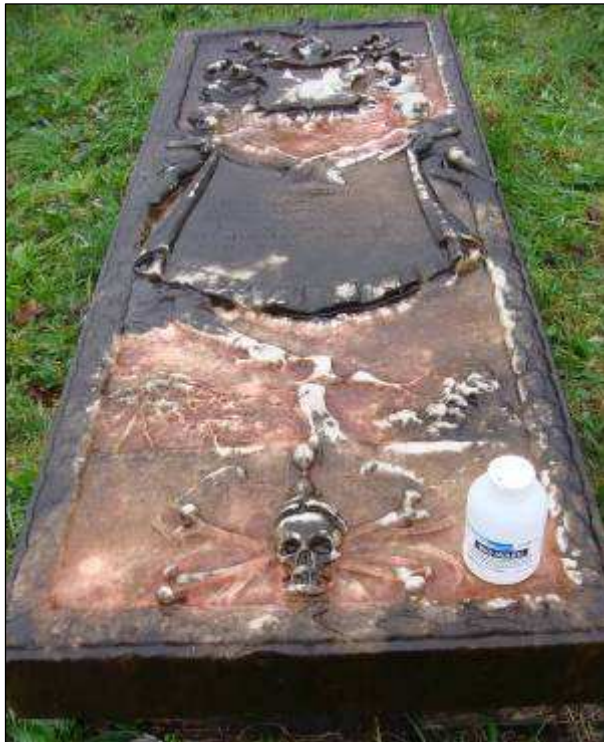
Nr. 1 stone before treatment

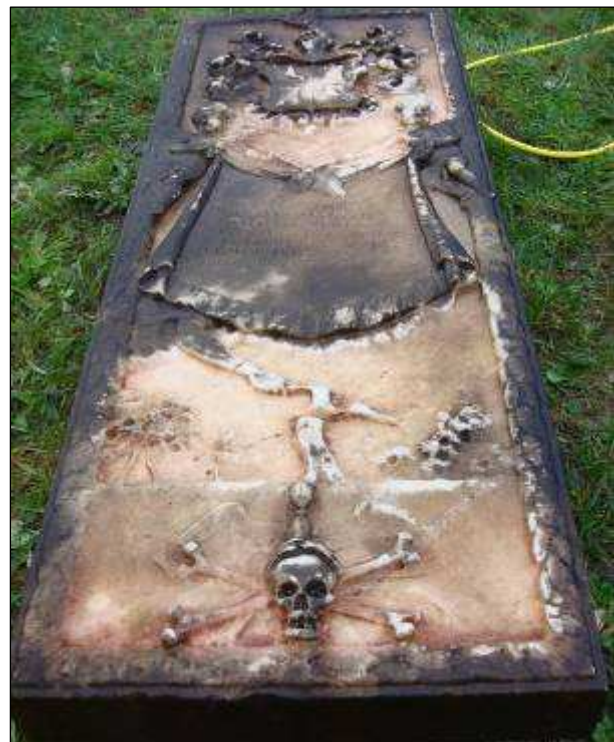
Nr. 1 stone after first treatment with Biowash

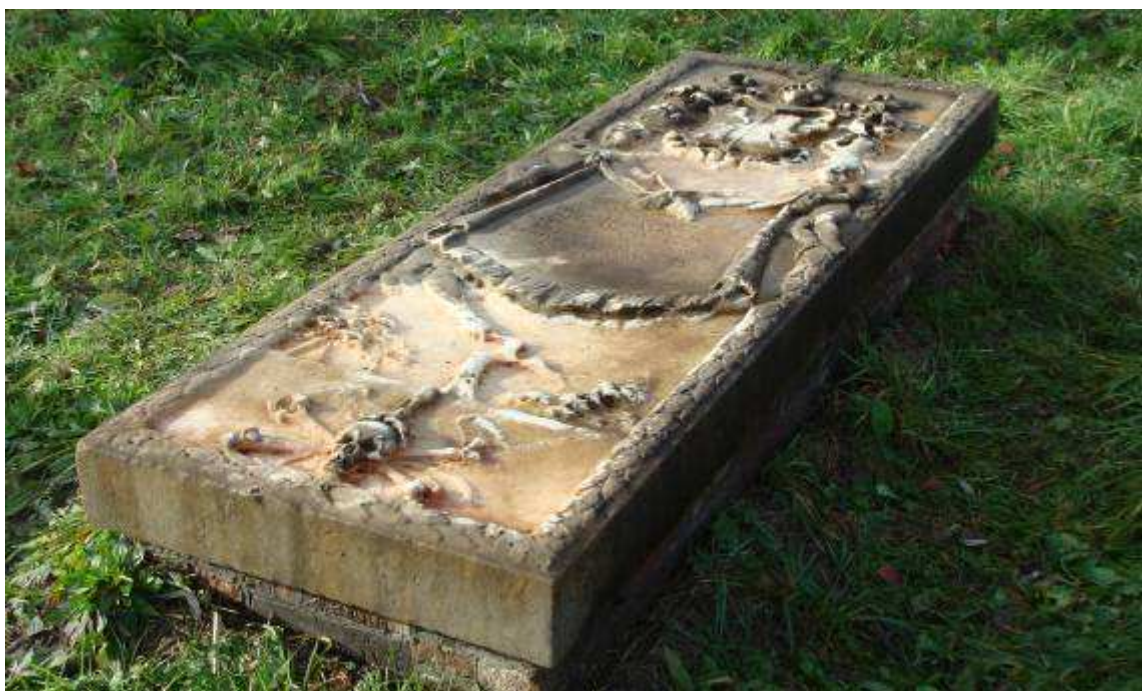
Result after finishing testing on nr. 1 stone.

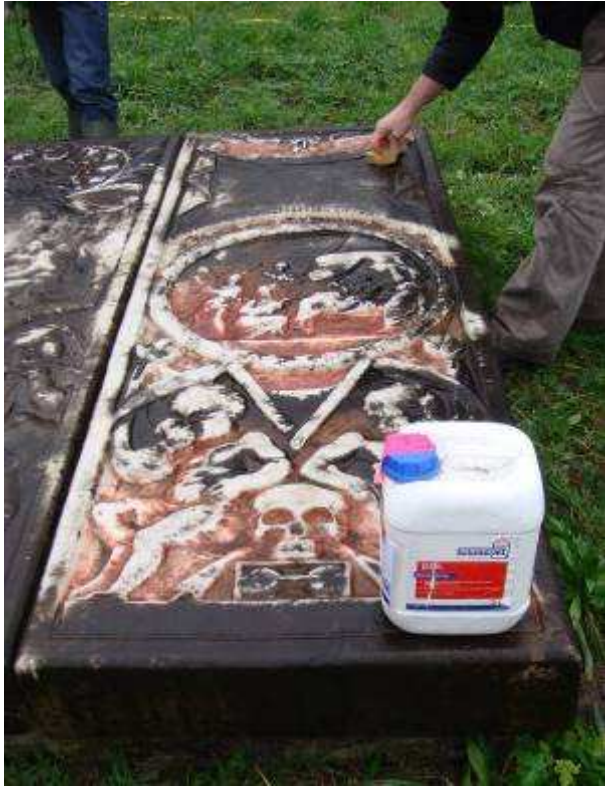
Nr. 4 stone before treatment.

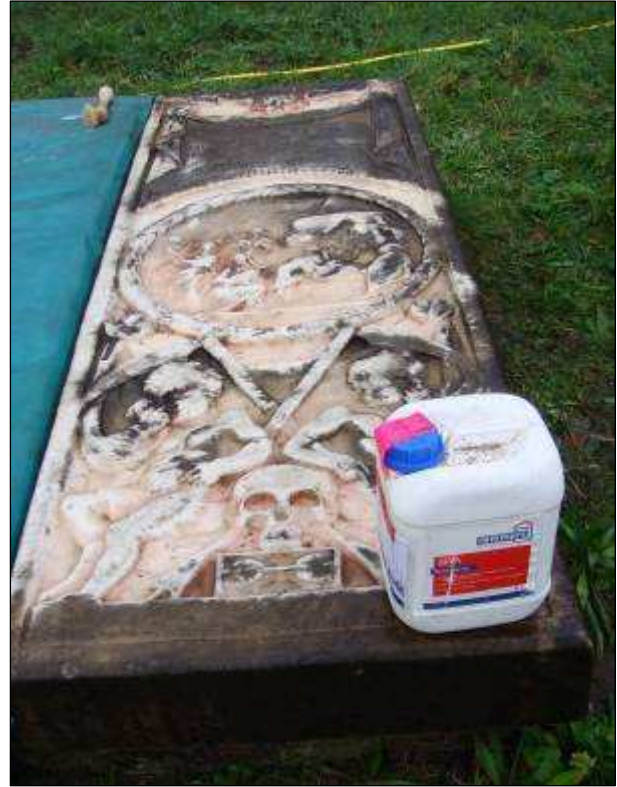
Nr. 4 stone after first treatment with BFA.

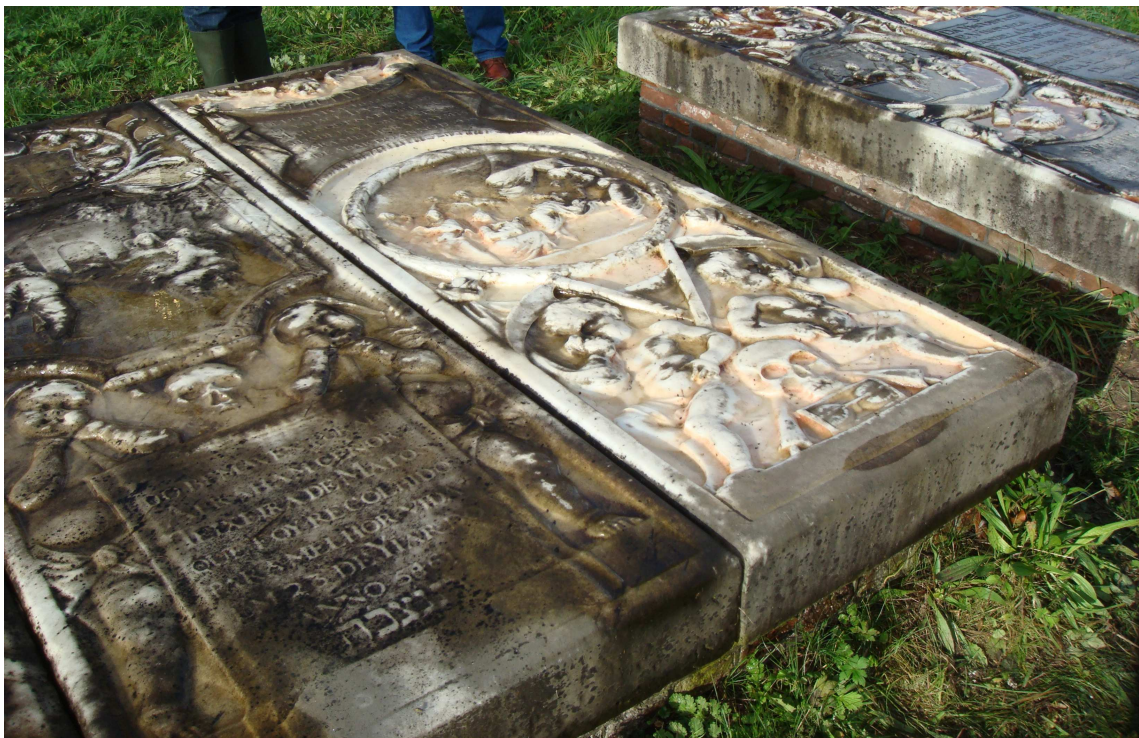
Stones nr. 3, 4 and 5 after finishing the test.

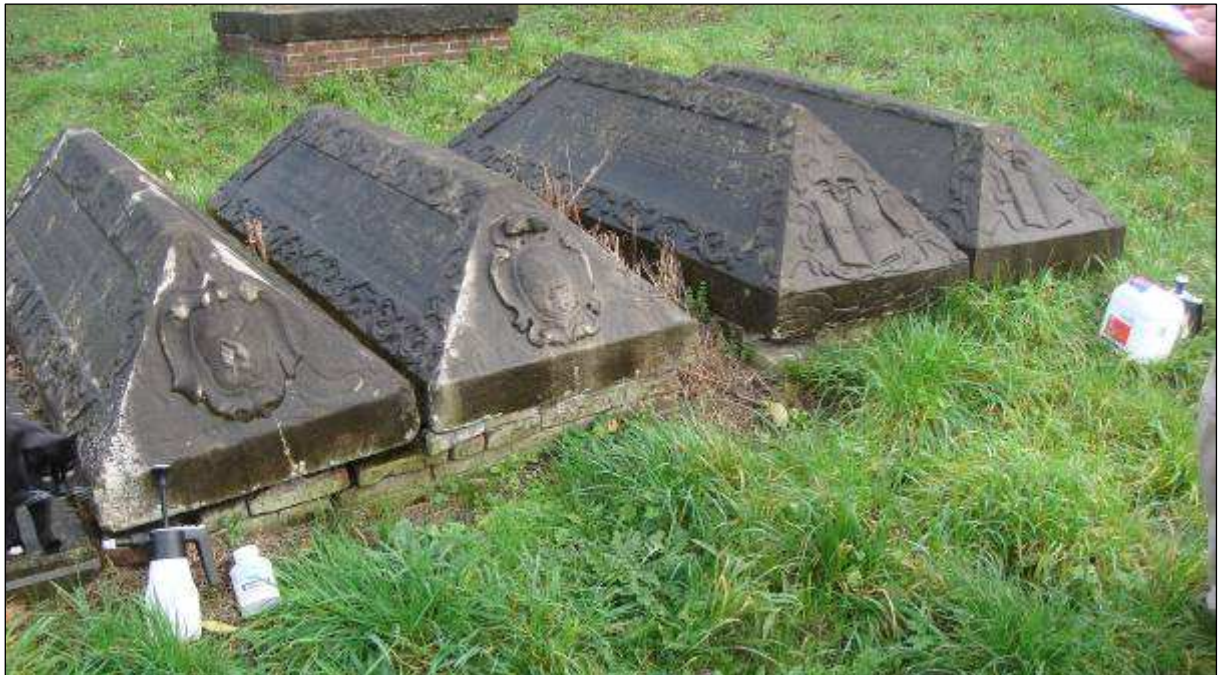
Second group before testing, nr. 1 on the left, nr. 4 on the right.

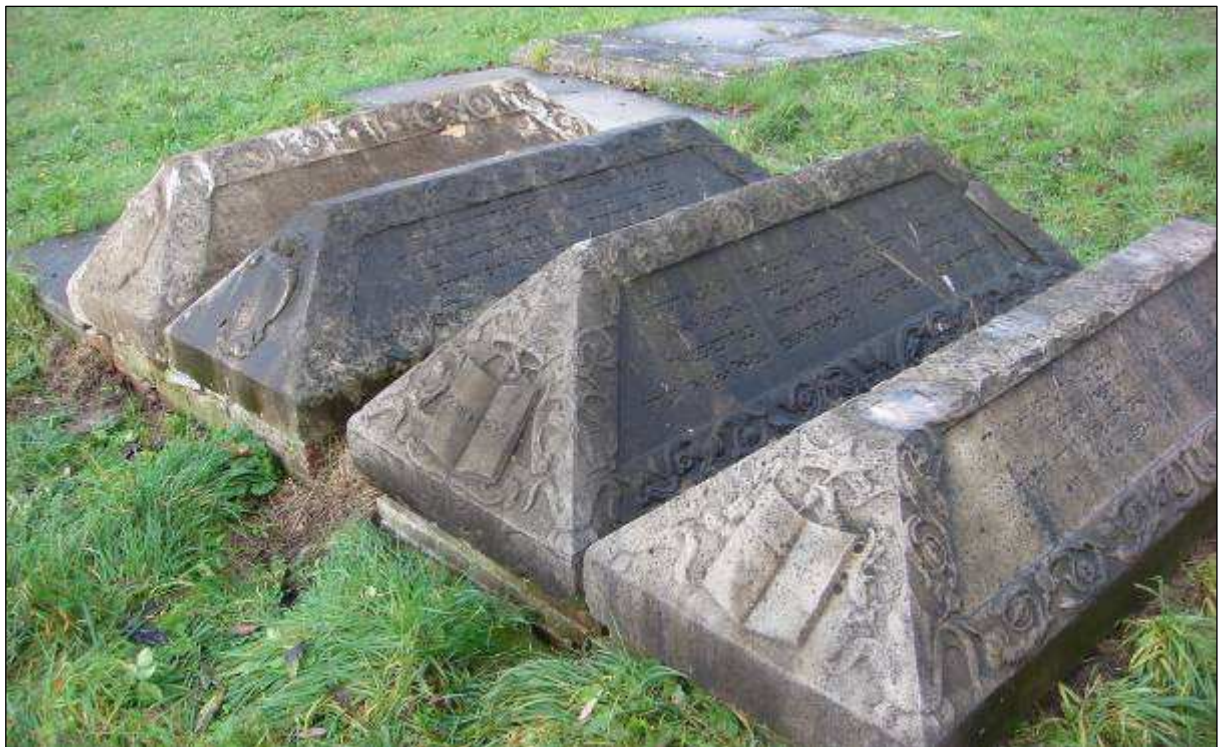
After finishing the testing, stone nr. 1 and 4 looked better than 2 and 3 but the result differed from the first testgroup.

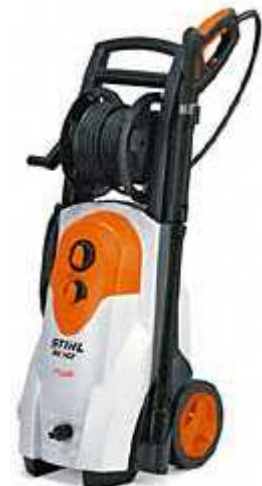
Stihl Re142K Plus High Pressure Washer

Description of the pressure washer, from <http://www.stihl.co.uk/>
Practical Cold water high pressure for demanding cleaning tasks in workshops garages or around the home. Compact nozzle system with bayonet coupling. Hose drum for tidy storage. Fan jet nozzle with pressure adjustment. 12m Steel reinforced high pressure hose. Adjustable pressure gauge and pressure flow control. Integrated cleaning agent tank. Ceramic coated piston and brass pump head.

The nossle used was the Fan-jet nozzle, variable pressure: with the variable pressure fan jet nozzle, larger areas are cleaned quickly and effectively, with control over the pressure to suit different tasks.

Working pressure	10-140 bar
Max. water throughput	610 l/h
Power output	2.9 kW
High-pressure hose length	12.0 m
Weight	23.5 kg
Mains voltage	230 V
Max. water feed temperature	60 °C
