Beth Haim preservation-project

Report on the second test with cleaning-products

Bureau Funeraire Adviezen, Amsterdam
Monument Conservation Collaborative, Massachusetts (USA)

December 2009

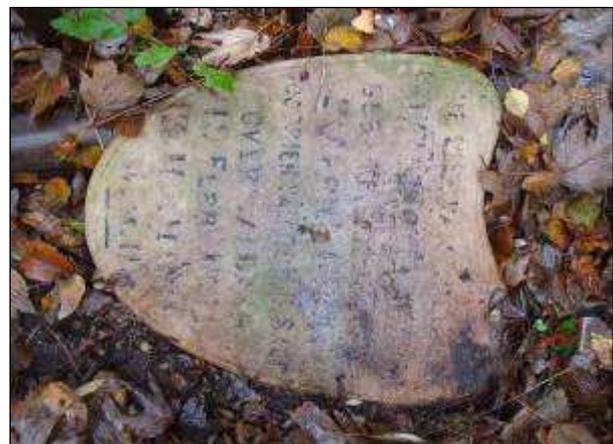
The marble after being covered up with leaves. Even under these conditions the ends appear cleaner than the middle that was not treated.

* The piece of marble was left under a hedge and was eventually covered up with leaves. This condition may contributed to more biogrowth and staining. Even so, it appeared that the area that was treated with Biowash looked better than the area treated with BFA.

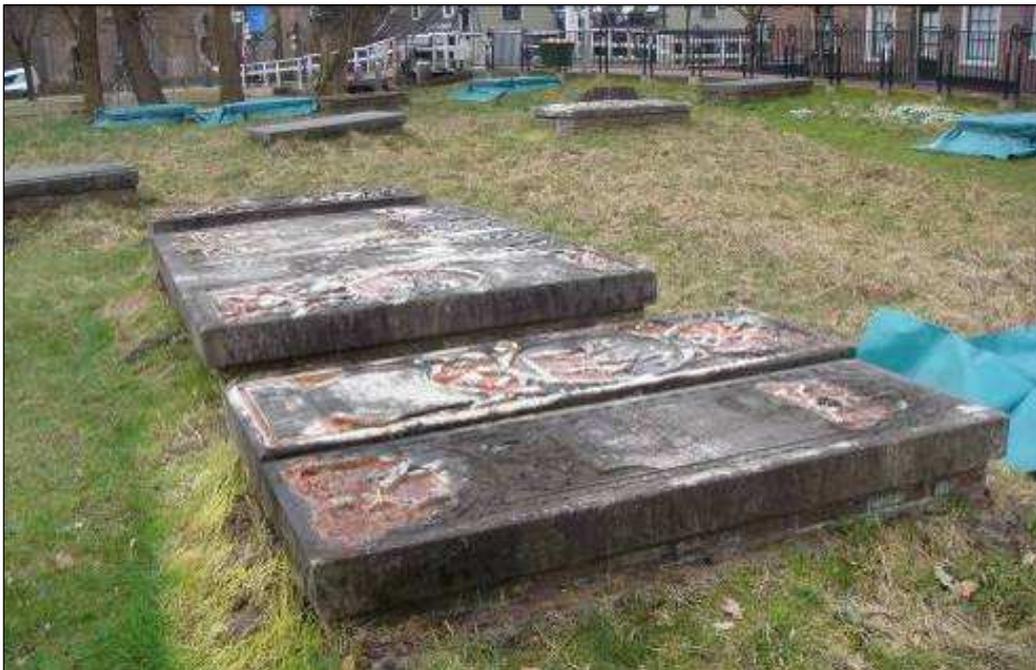
First test group as it appeared in 2008

The biological growth on the six stones above is quite similar, with significant existence of the red alga called trentepolzia. This alga thrives in slightly salty air, especially on wet surfaces.

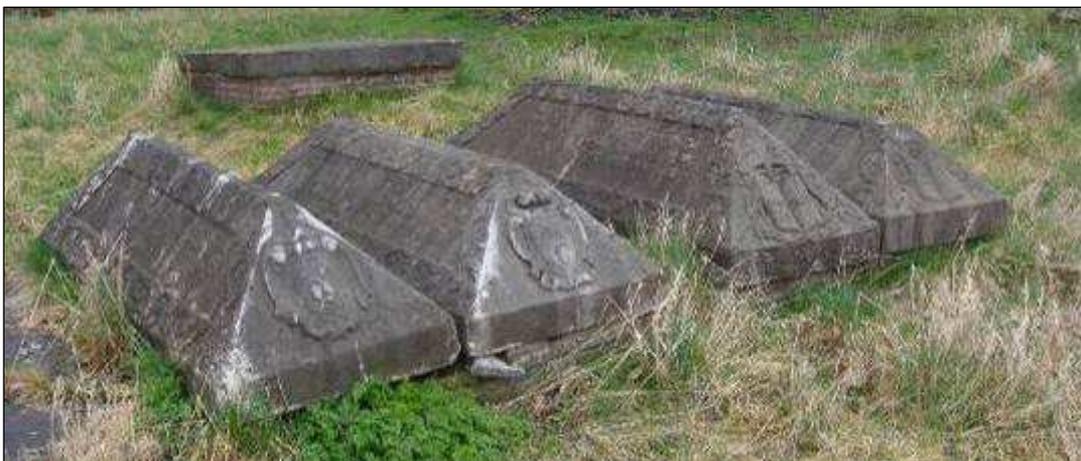
Second test group as appeared in 2008. Notice the different type of soiling.

These sarcophagus-shaped monuments readily shed water and no red alga could be detected. The surfaces were totally blackened by biological growth. This group of stones was last cleaned in 2004, probably by high-pressure cleaning.

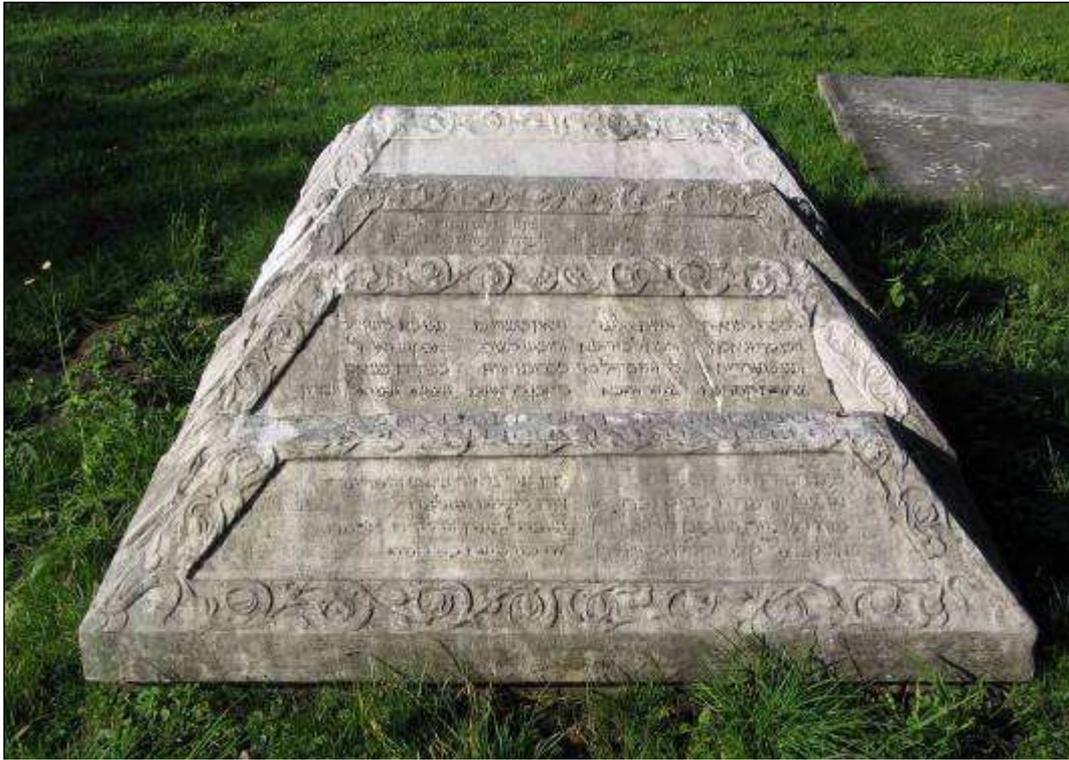
The second testgroup at October 19th 2004, not long after they were pressure-washed.

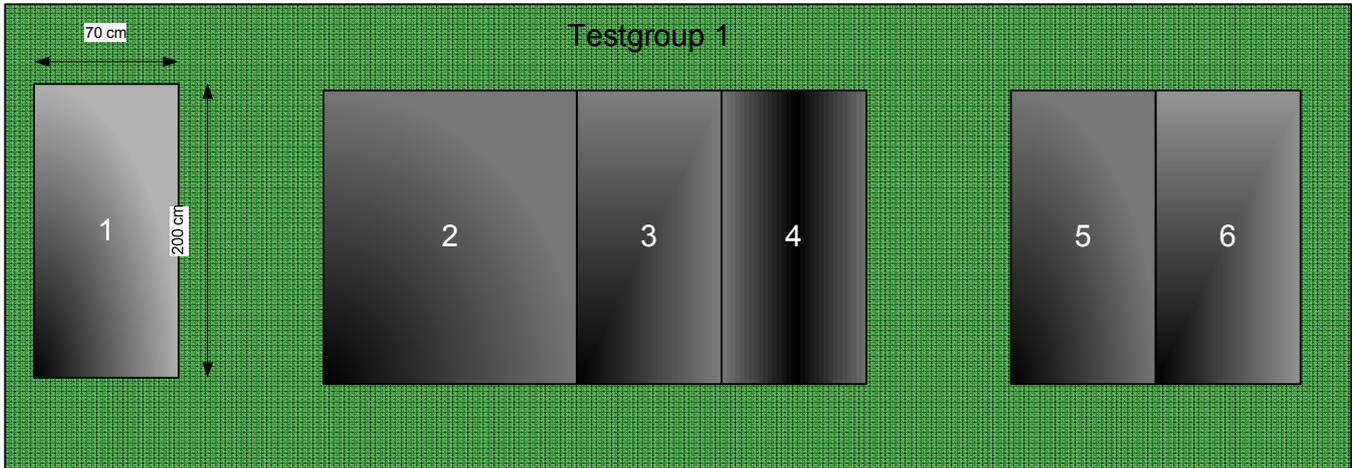
In the first group there was an outline of six stones. They were numbered according to the situation in the field from left to right. According to the proposal the stones were treated as follows:

1. Treatment with Biowash
2. No treatment
3. Cleaning with tapwater and brushed
4. Treatment with BFA
5. No treatment
6. Only sprayed with BFA

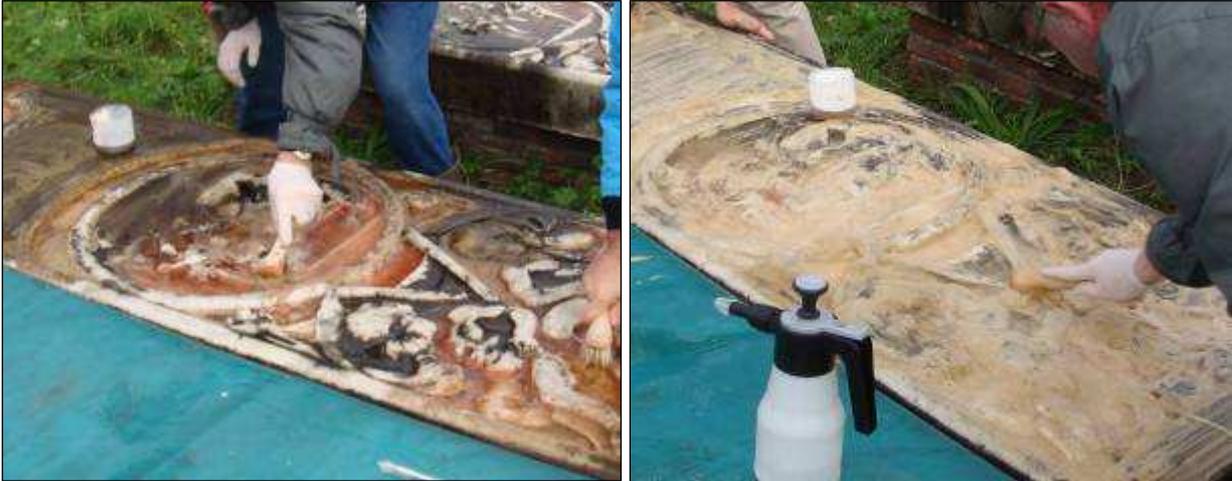
At the first cleaning round (left) the BFA did not foam as much as with the second round (right).

After all over brushing both stones were hosed down in each group with tap water. After drying them again with sponges and short air drying, treatments were repeated as above with the same result. This time the foam produced from the BFA product was more significant.

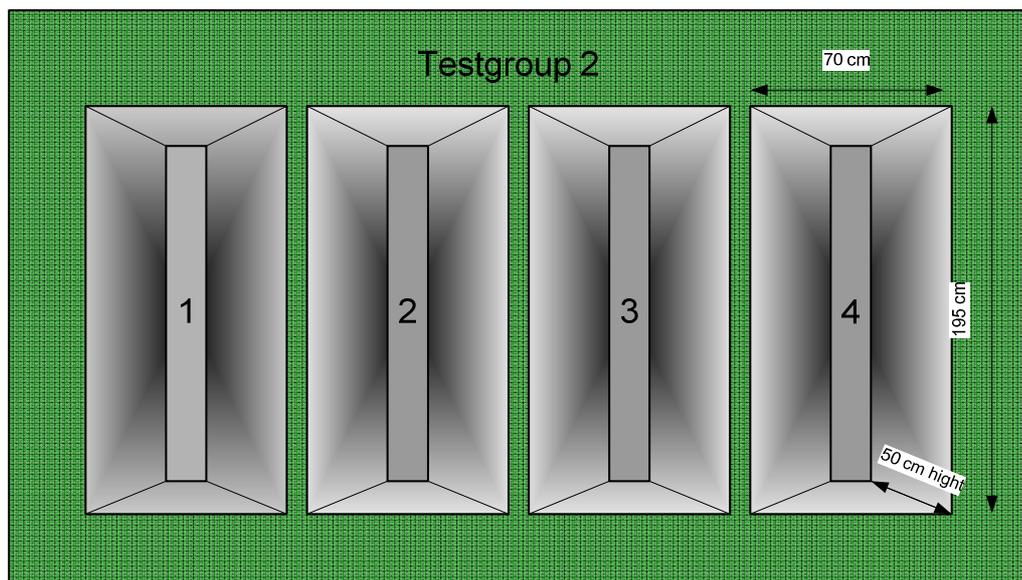
This second group consisted of four stones in a row. Here the testing was carried out in a slightly different way. Again the stones were numbered, according to what had to be done. From left to right;

1. Treatment with Biowash, and mildly pressure washed
2. No treatment
3. Cleaning with mild powerwash only
4. Treatment with BFA, and mildly pressure washed

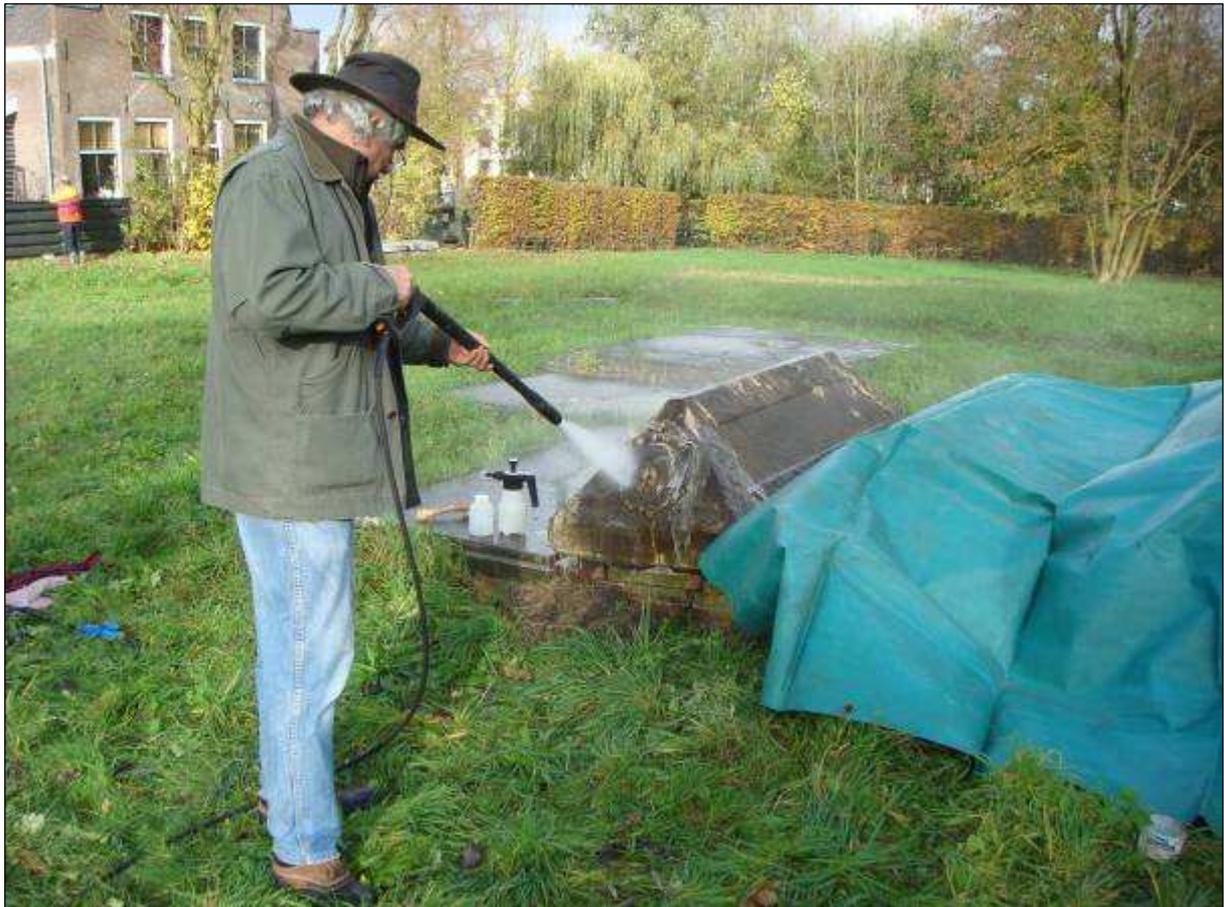
Pressure washing in progress at the nr. 1 stone that has been cleaned with Biowash.

The treatment was repeated with additional brushing and at the end the final rinsing was done with a mild pressure wash. For that purpose we used a Stihl RE 142 K pressure washer (see appendix B). A fan shaped tip was used and the distance of the nossle from the stone was kept well back to limit the pressure.

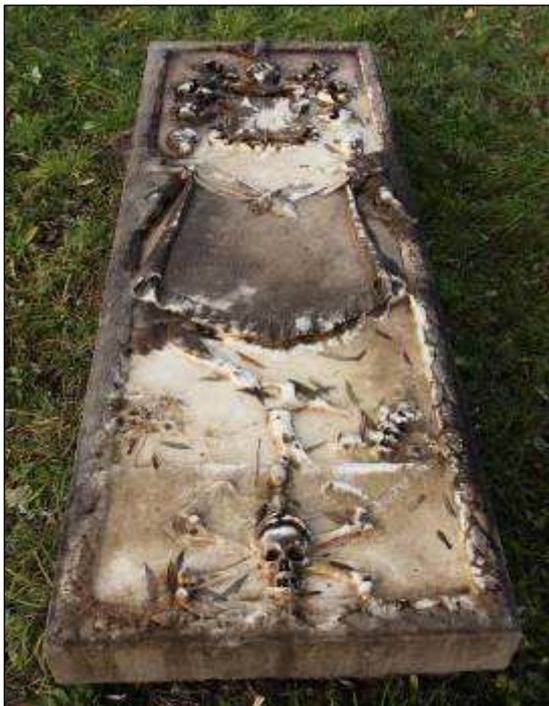
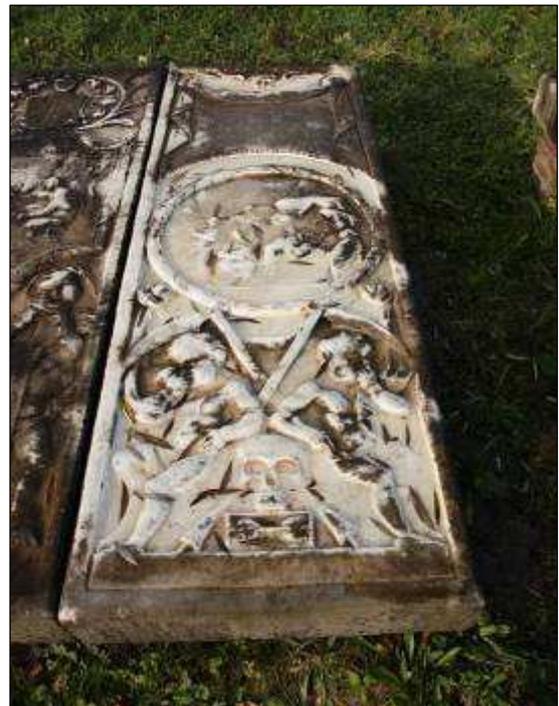
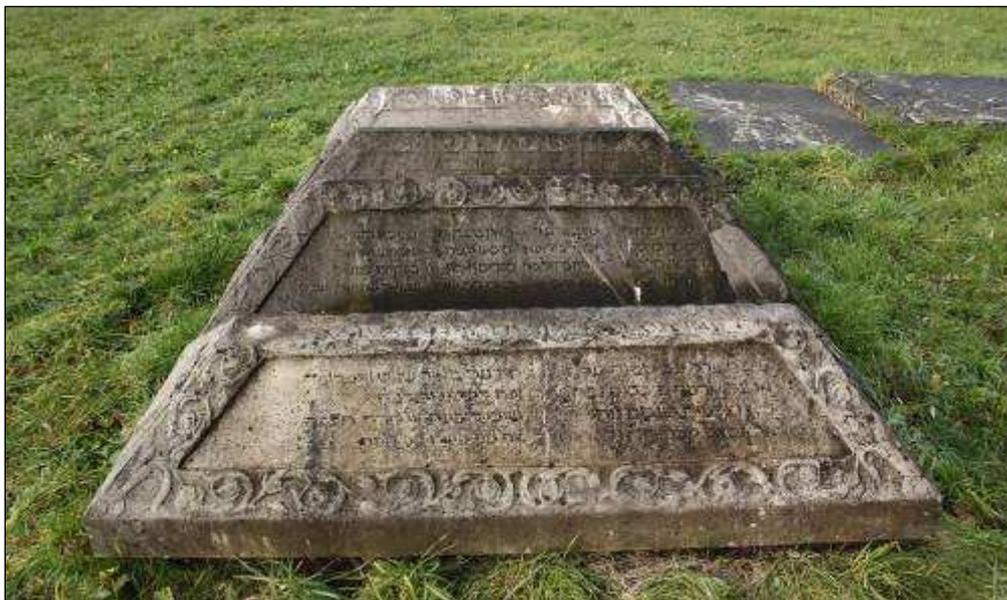
Result at November 20th, one week after the test, for both testgroups

After the testing was ready the first group was assessed for result (see photo caption in appendix A). It seemed at this point that the BFA left the surface of the marble more white than the Biowash. At the stone number 1 (Biowash) the surface seemed to be more brown-red. It was also noted that the stones were drying up very rapidly. Large portions had already dried.

The second group dried as well, after the work, but the surface showed limited cleaning.

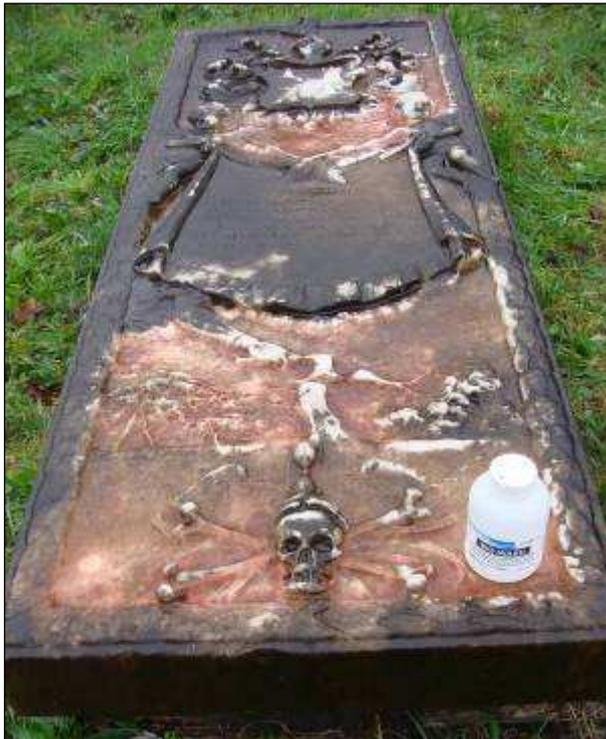
Nr. 1 stone before treatment

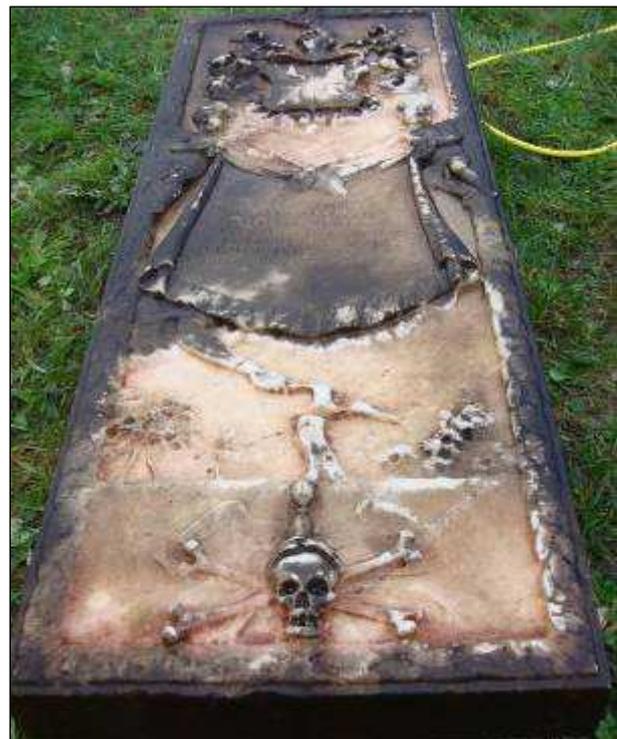
Nr. 1 stone after first treatment with Biowash

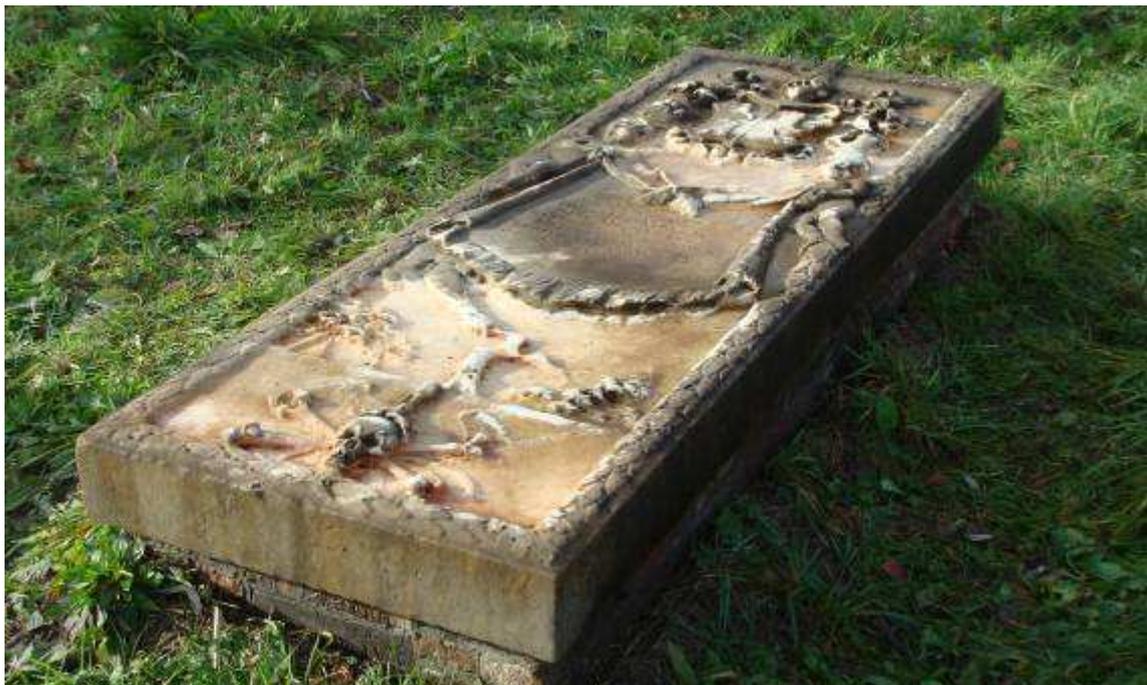
Result after finishing testing on nr. 1 stone.

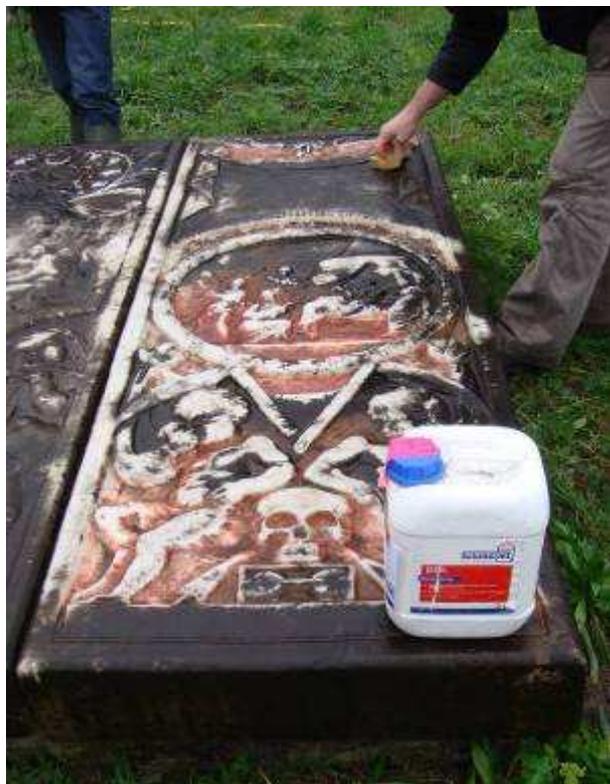
Nr. 4 stone before treatment.

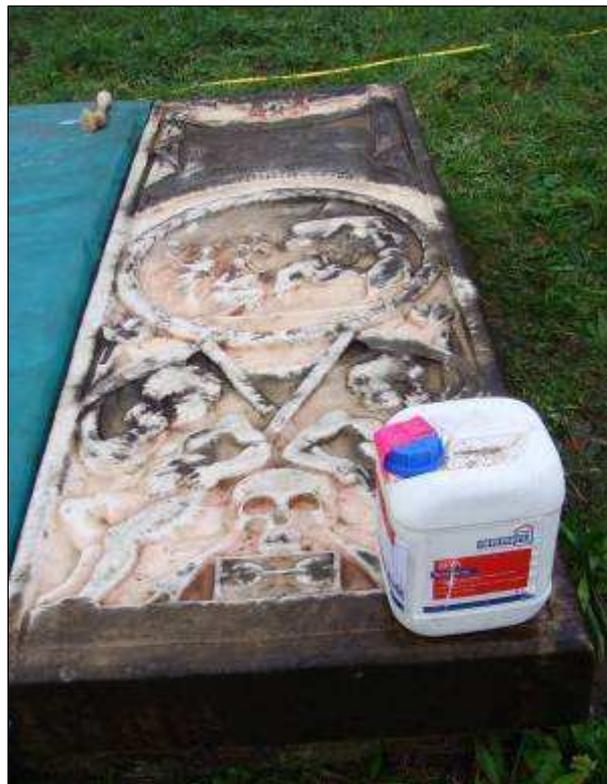
Nr. 4 stone after first treatment with BFA.

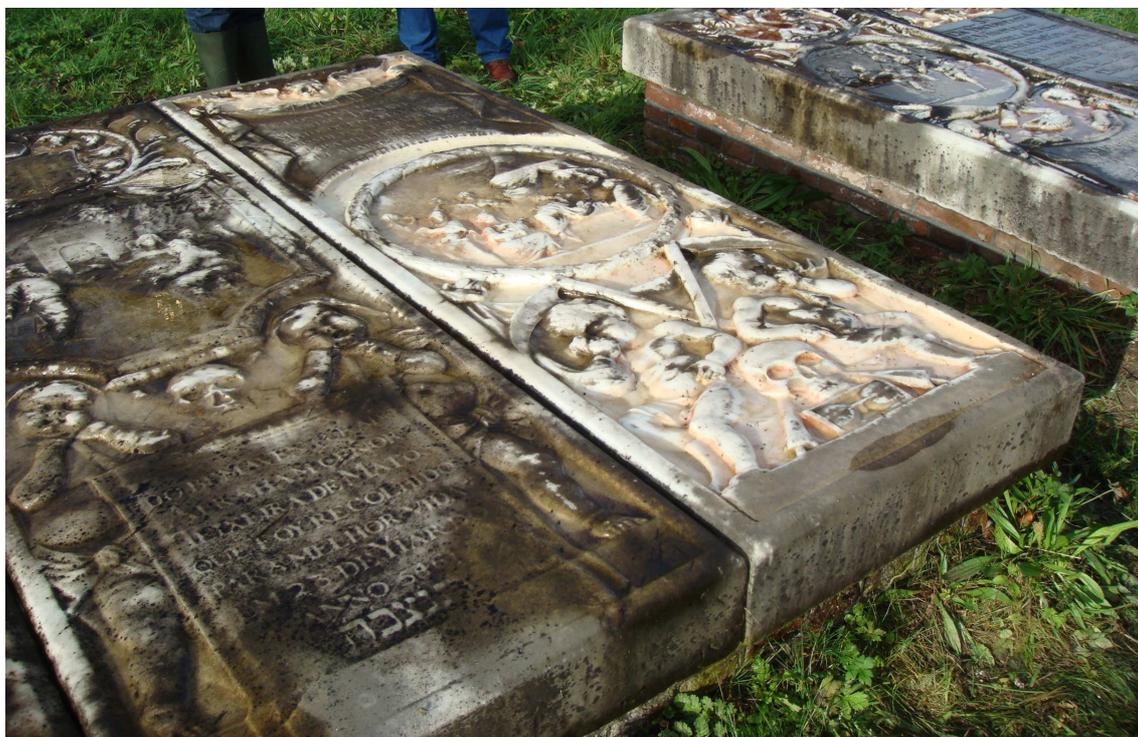
Stones nr. 3, 4 and 5 after finishing the test.

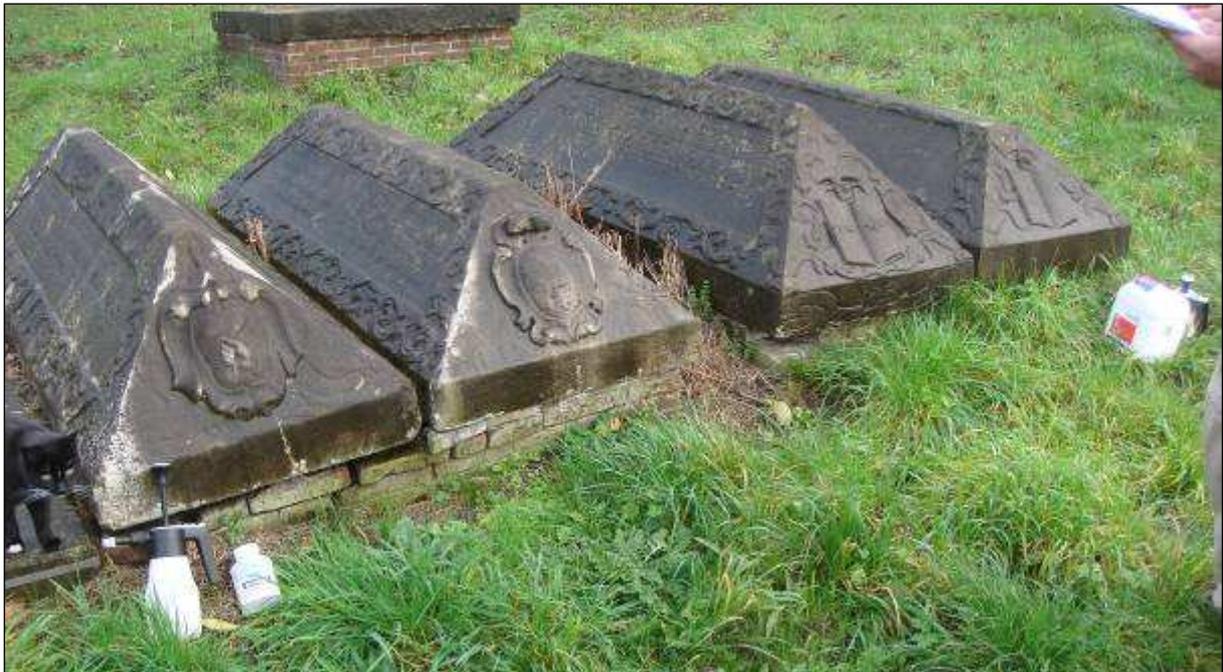
Second group before testing, nr. 1 on the left, nr. 4 on the right.

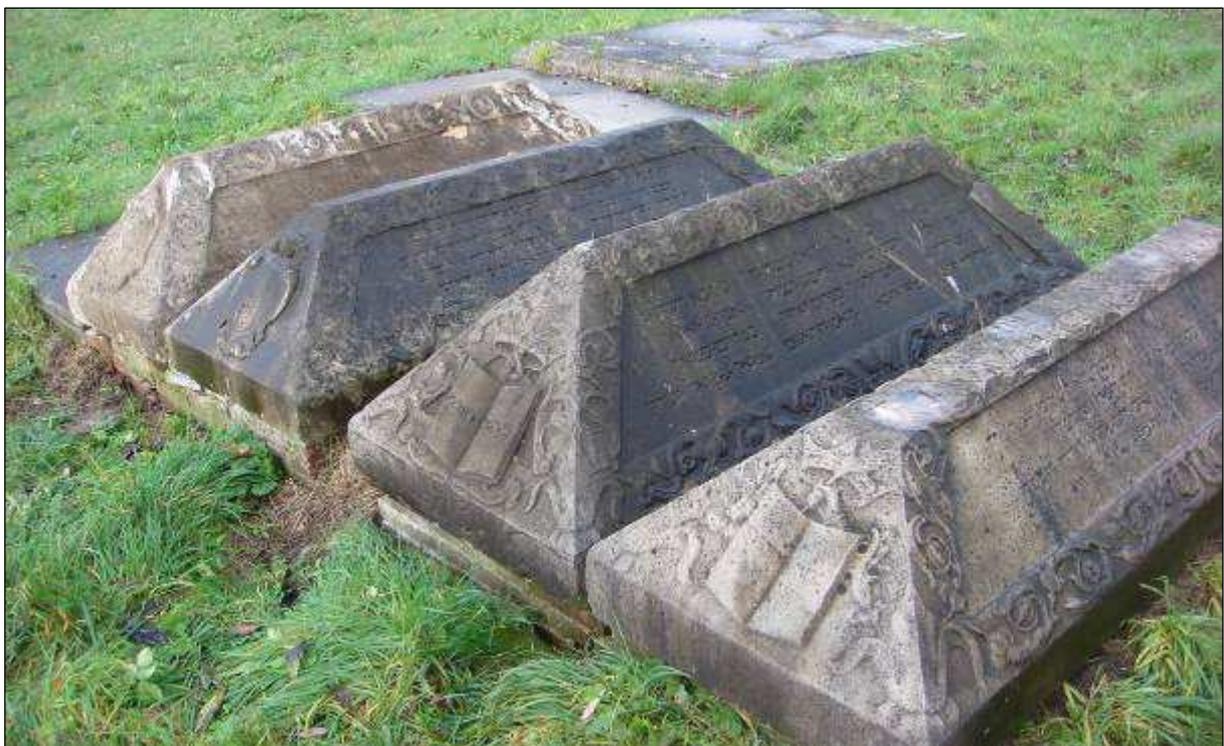
After finishing the testing, stone nr. 1 and 4 looked better than 2 and 3 but the result differed from the first testgroup.

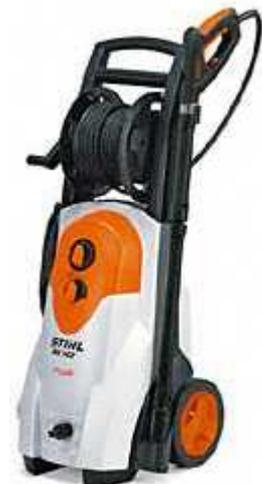
Stihl Re142K Plus High Pressure Washer

Description of the pressure washer, from <http://www.stihl.co.uk/>
Practical Cold water high pressure for demanding cleaning tasks in workshops garages or around the home. Compact nozzle system with bayonet coupling. Hose drum for tidy storage. Fan jet nozzle with pressure adjustment. 12m Steel reinforced high pressure hose. Adjustable pressure gauge and pressure flow control. Integrated cleaning agent tank. Ceramic coated piston and brass pump head.

The nossle used was the Fan-jet nozzle, variable pressure: with the variable pressure fan jet nozzle, larger areas are cleaned quickly and effectively, with control over the pressure to suit different tasks.

Working pressure	10-140 bar
Max. water throughput	610 l/h
Power output	2.9 kW
High-pressure hose length	12.0 m
Weight	23.5 kg
Mains voltage	230 V
Max. water feed temperature	60 °C
