Satala Cemetery restoration underway

SATALA CEMETERY RESTORATION TREATMENT REPORT June/July 2010
Monument Conservation Collaborative LLC, Norfolk, CT 06058

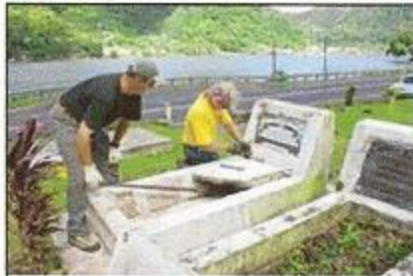
Martin Johnson (left) and Karl Munsum (right) of Monument Conservation Collaborative, a restoration company from Connecticut, seen here working to restore one of 60 grave monuments damaged by the September 29, 2009 tsunami. (Courtesy Photo)

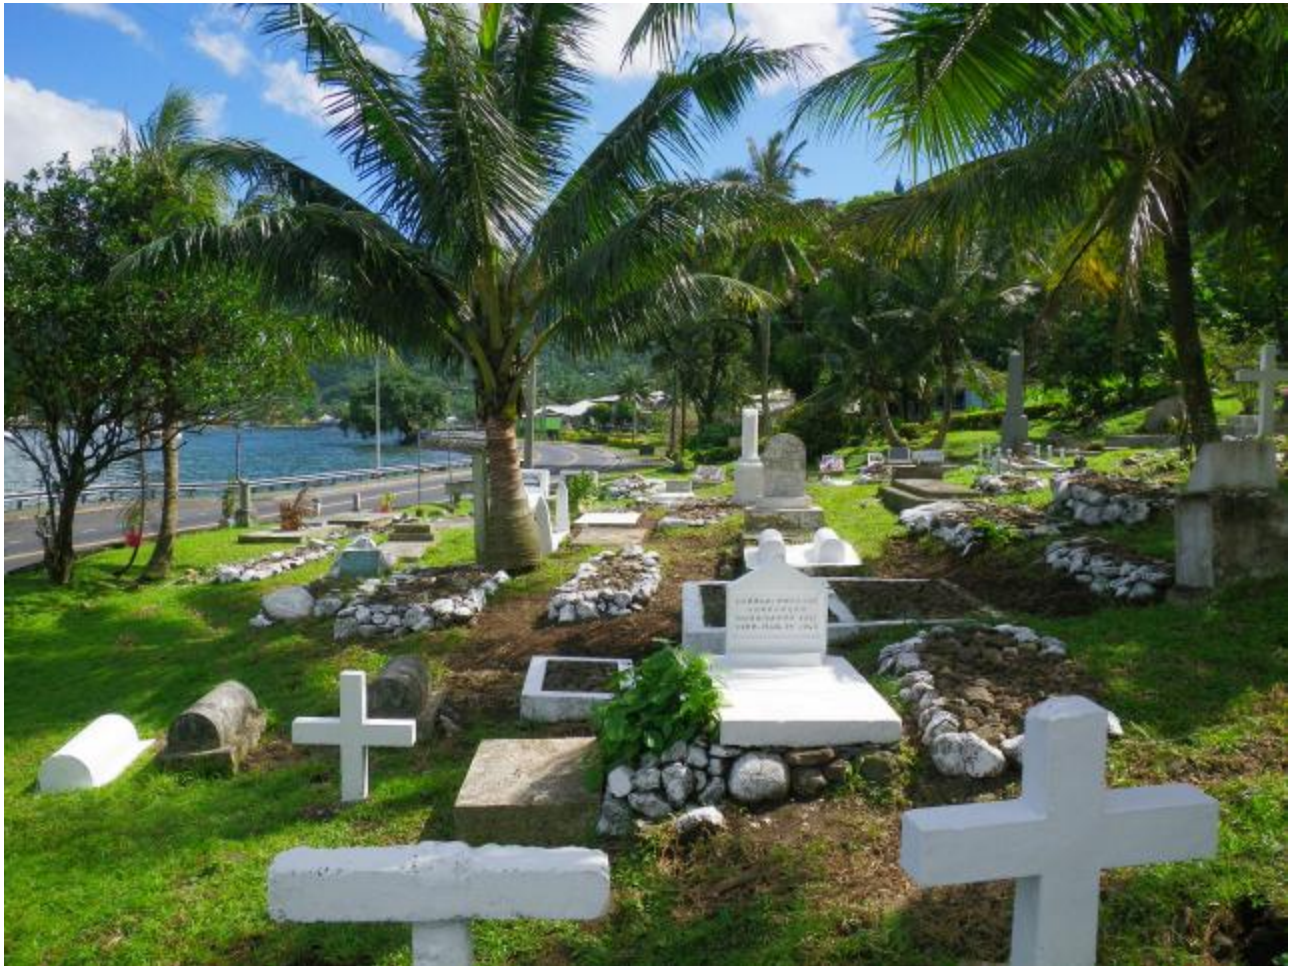
Restored July 2010

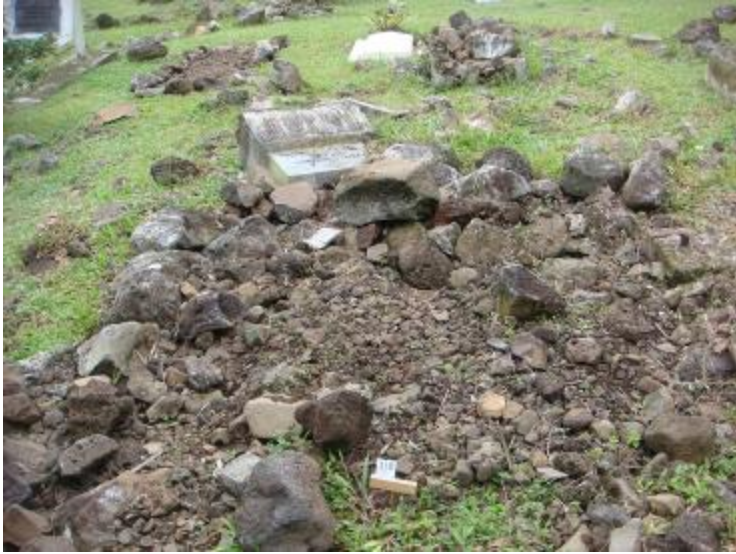
#18 As found

Typical rebuilding details of some of the loose dry laid stone foundations that were dislocated. We found that a great number of stones were required for proper resetting, usually much more than what the contract descriptions indicated. These extra stones were required for necessary foundations and footings for the exposed stones.

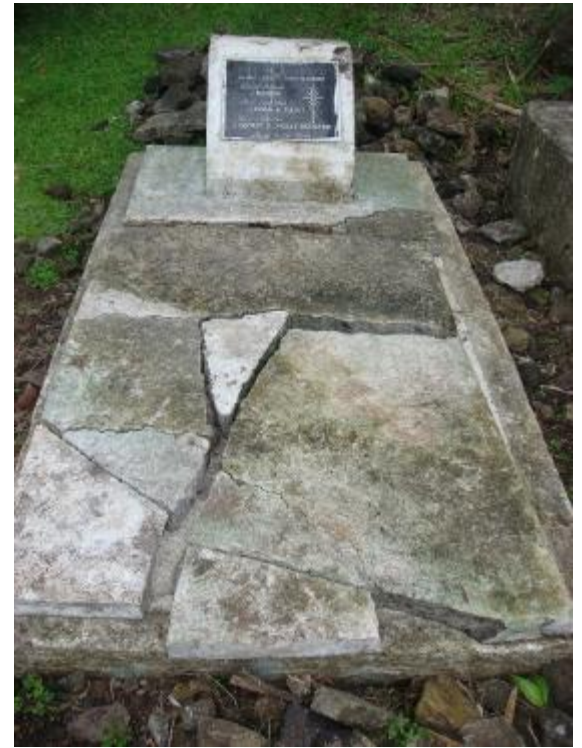
#135 with loose fragments
