MARBLE CONSOLIDATION TESTING

THE GRANT MEMORIAL

MCC MATERIALS, INC.

THE GRANT MEMORIAL MARBLE CONSOLIDATION TESTING

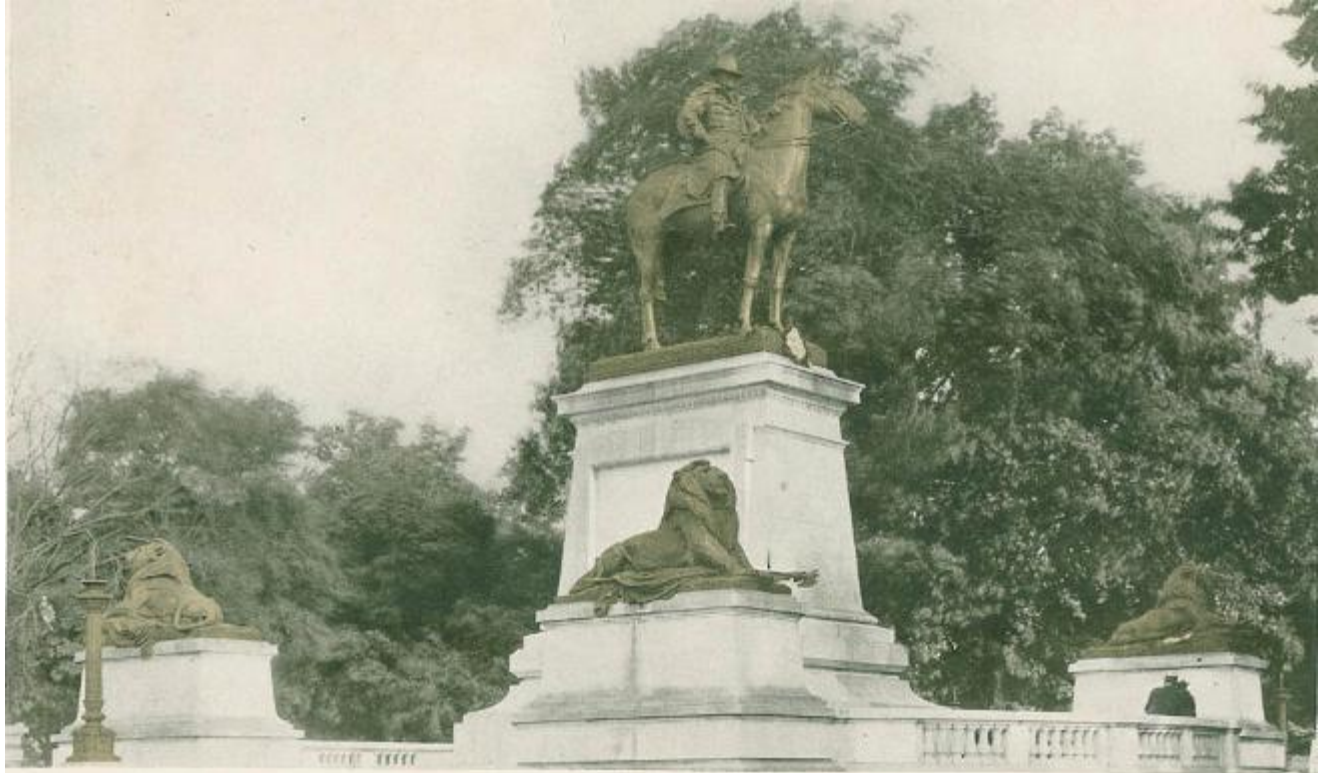
THE CENTRAL PEDESTAL OF THE GRANT MEMORIAL

Towering 44 feet above the ground, this statue of General Grant, two and one-half times life size, is the largest equestrian statue in the world. Mounted on the central pedestal and guarded at each of the four corners by a bronze lion, it forms the central portion and main theme of the Memorial

Casey mentions no particular marble name or quarry location; this issue will be discussed further below. Of note in the 1924 book are the full page photographic illustrations, showing the Memorial as it looked immediately following the dedication. Several of these photographs show distinct patterns of staining, presumably the early stages of the situation that is seen today. This is most especially true for the bases of the four lions, which were the first bronzes installed, in late January of 1909.⁵

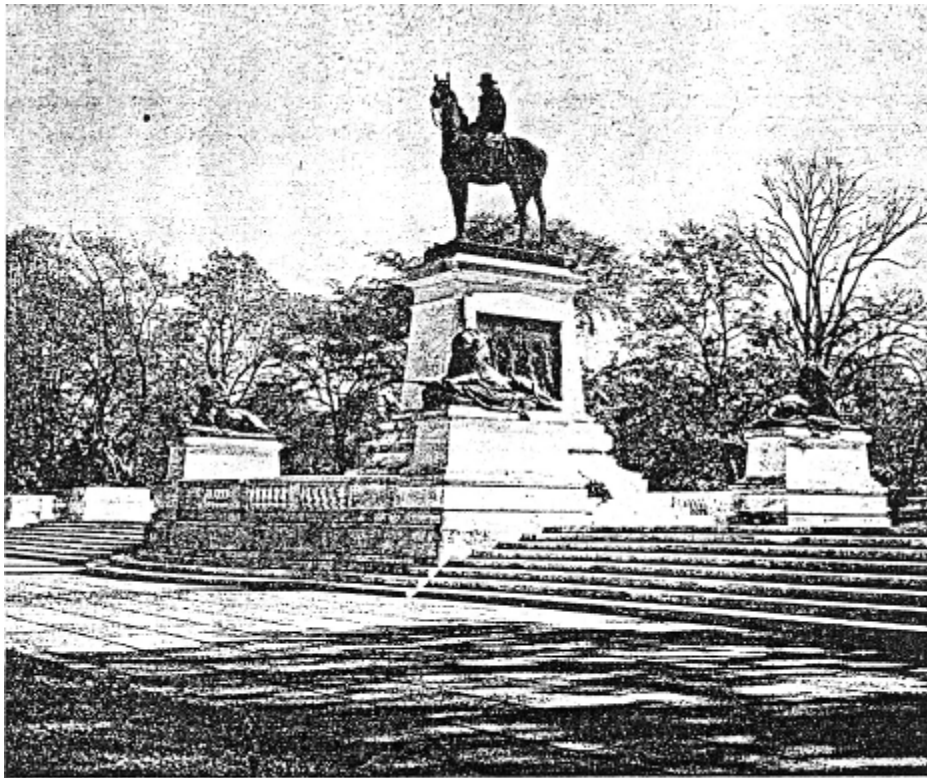
FIGURE 1. Grant Monument, Washington, D. C., from the southwest showing all but one of the bronze groups and the supporting marble.

"Several blocks have prominent brown stains, accompanied by cracking of the marble. The worst condition is shown in figure 3, but many blocks appear to be in good condition. The corner block under the south group is projecting considerably over the edge of the block below. This is believed to indicate that the injured block has undergone a swelling action.

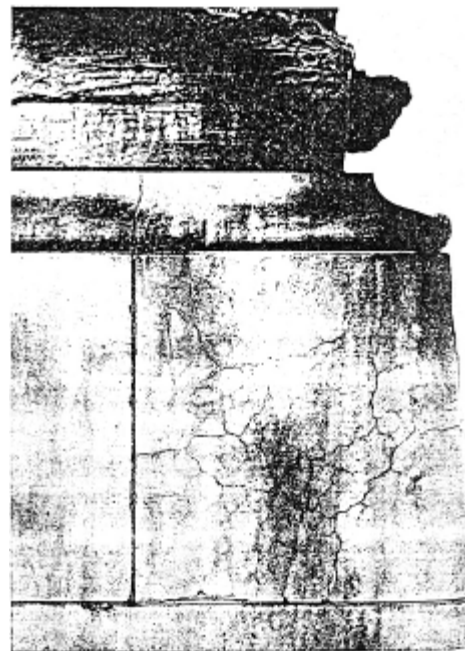
FIGURE 3. Block of badly cracked marble under the north statuary group of the Grant Monument showing the worst condition in this structure.

This same marble was used in the American Red Cross Building on Seventeenth Street. Two bronze lampposts are attached to the marble cheek walls at the main entrance. One block in the north cheek wall is showing a condition of incipient cracking similar to the more advanced stage shown in figure 3."⁷

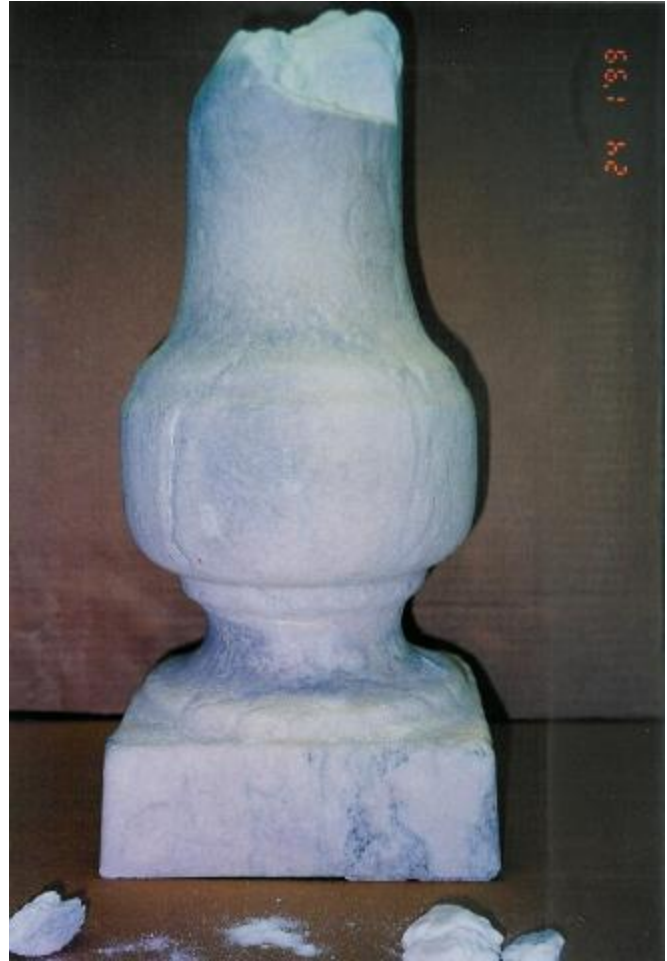
**The baluster fragment as received
in MCCM Laboratory**

A stone sample for analysis and testing was taken from the Memorial late last year, and shipped to MCC Materials' Connecticut laboratory. It was received on November 24, 1998. It is a large fragment of a baluster (lacking the uppermost portion), measuring 16½" in height. The 7¼" square base is 2½" high. The thickest part of the turned portion of the baluster is (similarly) 7¼" in diameter.

The entire fragment is heavily weathered and discolored. The upper one-third was fragile, with the topmost portion exhibiting extreme “sugaring” and losses. A considerable amount--550 grams--of loose debris was able to be collected. This material was run through a set of U.S. Standard Series sieves using a Tyler Ro-Tap shaker (Model B, Tyler Industrial Products, Mentor, OH). Separated into individual size fractions, the rock particles were examined under a Nikon SMZ-1 stereobinocular microscope at 7 to 30X magnification.

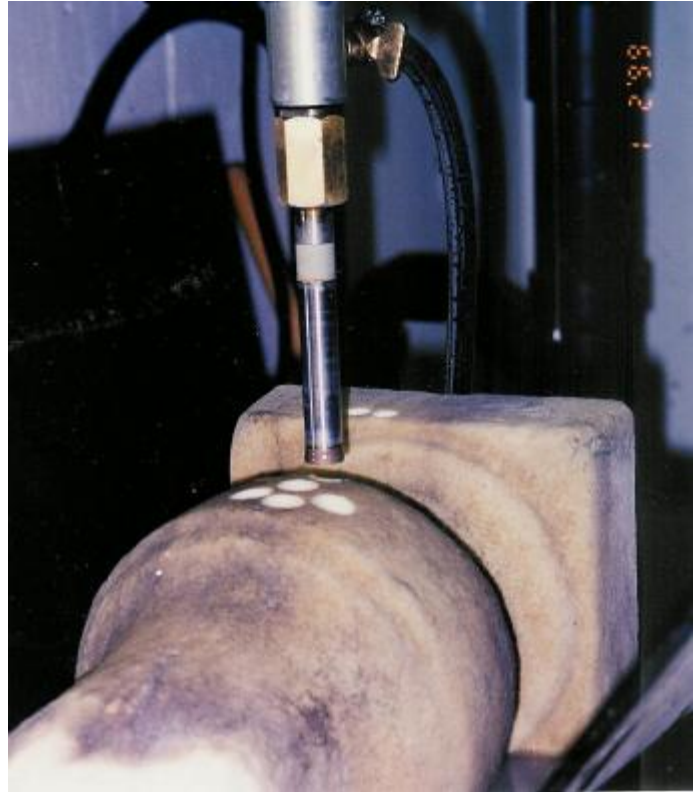
Drilling of cores from the center of the baluster

Coring of the base and the lower turned portion ("center") of the baluster was done with a standard 14" Delta bench-top drill press operating at 460 rpm (Delta Industrial Machinery Corp., Pittsburgh, PA). Our press is fitted with a 4" long by 14 mm. ID impregnated core drill by Lunzer Diamond Associates (Saddle Brook, NJ), attached via a water swivel chuck that permits bit cooling and flushing of cutting debris. Coring by this method yielded approximately 70 "mini-cores," each 13.7 mm. in diameter, typically 20 to 65 mm. in length.

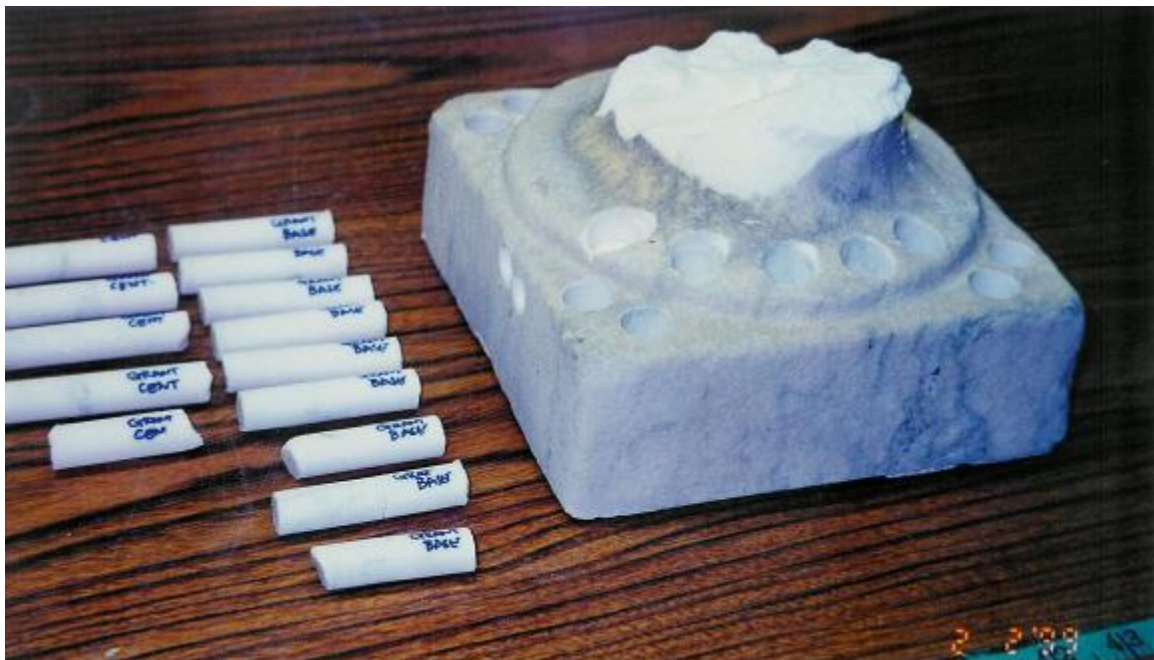
Cores taken from the base of the baluster

Three cores from the baluster base were utilized to determine specific gravity and % absorption, as per ASTM C 97. The cores were dried under an infrared heat lamp for 24 hours, then air dried for several weeks, and weighed on an A&D HR-120 electronic balance (A&D Engineering, Inc., Milpitas, CA) to the nearest 0.1 mg. Apparent volume was computed for each core from measurements taken with a digital micrometer (Mitutoyo SC-6”), and the specific gravity computed. The mean value for the three cores is 2.642 g/cm³. This is in compliance with the physical requirements for exterior marble as stated in ASTM C 503-67, that is, a minimum specific gravity of 2.60 for calcite marble.¹⁵

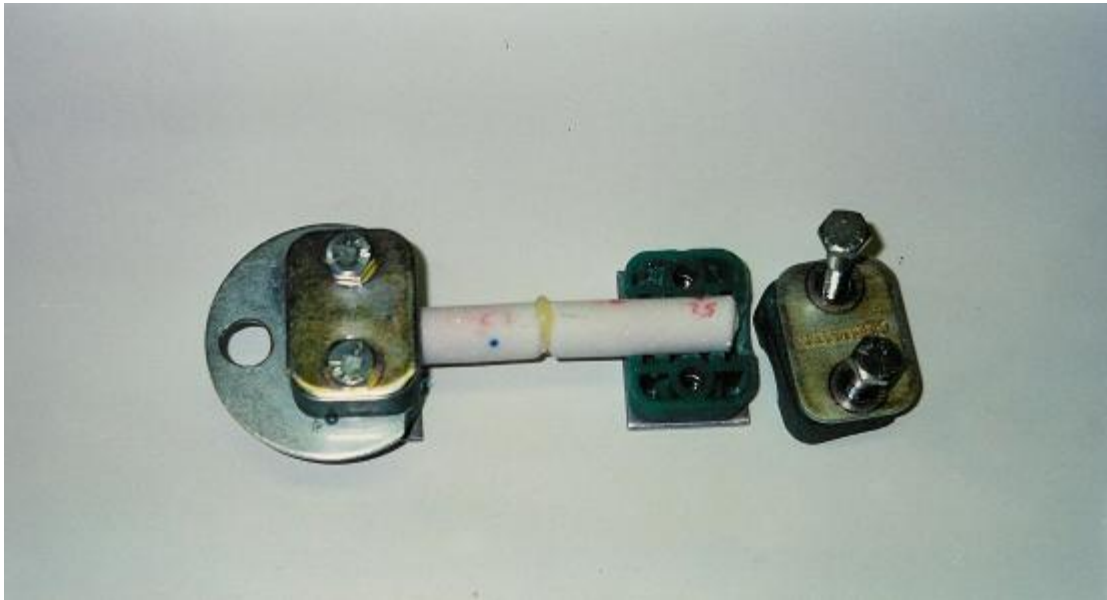
Surface-coupled cores secured with pipe clamps

Cores from the base and center of the baluster were then examined visually. If the weathered surfaces were largely intact (that is, they survived the coring process), pairs of cores were precisely aligned and adhered--surface to surface--with Abocast 8101-5, a two-part thixotropic epoxy adhesive (Abatron, Inc., Kenosha, WI). Each surface-coupled pair was then tested in tension to assess surface soundness. "Breaks" within 3 mm. of the glue line were considered to provide useful data. The average tensile force to cause failure in the base specimens was 7.7 ± 1.2 lbs. The more fragile center specimens failed at 4.4 ± 0.8 lbs.

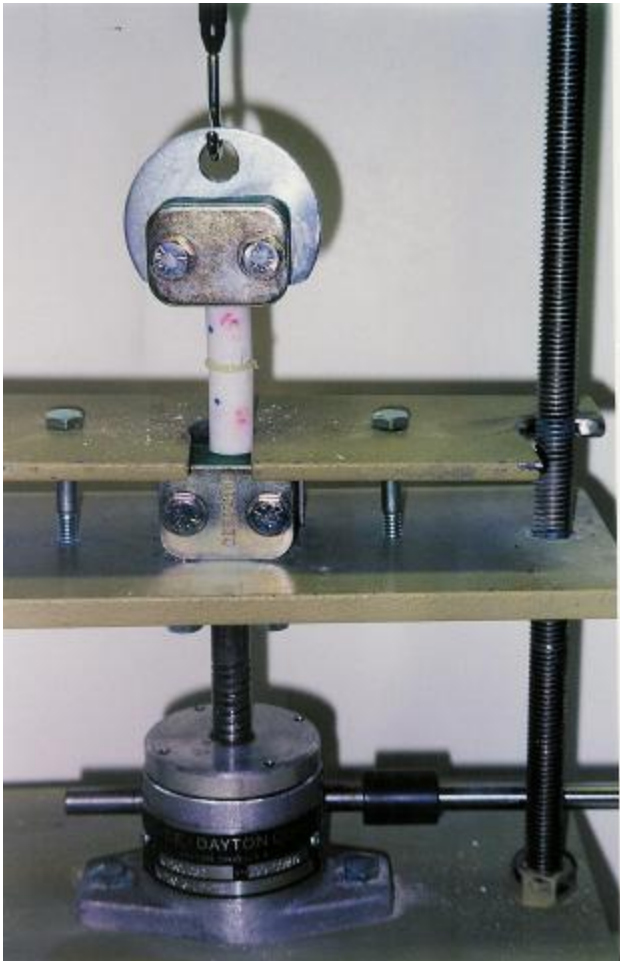
Coupled cores mounted on test stand

The majority of the longer cores were utilized in the design of a novel experiment to determine the cohesive strength of the weathered surface. For control (unweathered) data, five cores from the baluster base were tested in direct tension, using a modification of ASTM D 2936-95, eliminating the gluing of end caps, and instead securing the specimen with plastic pipe clamps.¹⁷ These cores ranged from 62 to 73 mm. in length. Measurement of the applied tensile load was with an Imada PS 100 Mechanical Force Gauge (0.5 lb. resolution, Imada, Inc., Northbrook, IL), on a custom-built test stand. The five specimens averaged 21.0 ± 3.7 lbs. of load at failure.

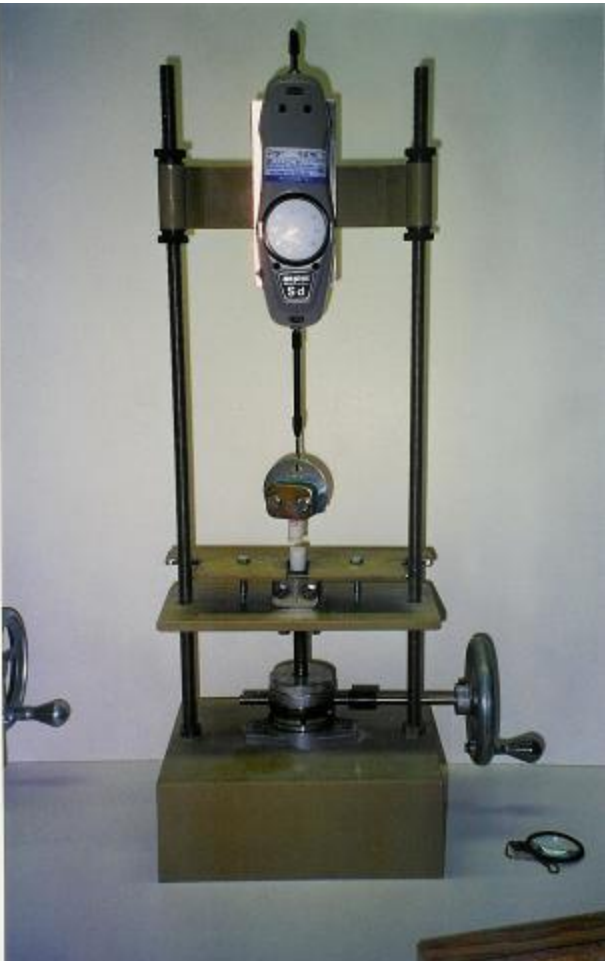
Testing surface-coupled cores in tensile failure

The mean value for base cores after capillary treatment was 17.2 ± 2.1 lbs. This represents a strength increase of more than 120% from the untreated value. A more reasonable way to regard the data may be to calculate both treated and untreated values in

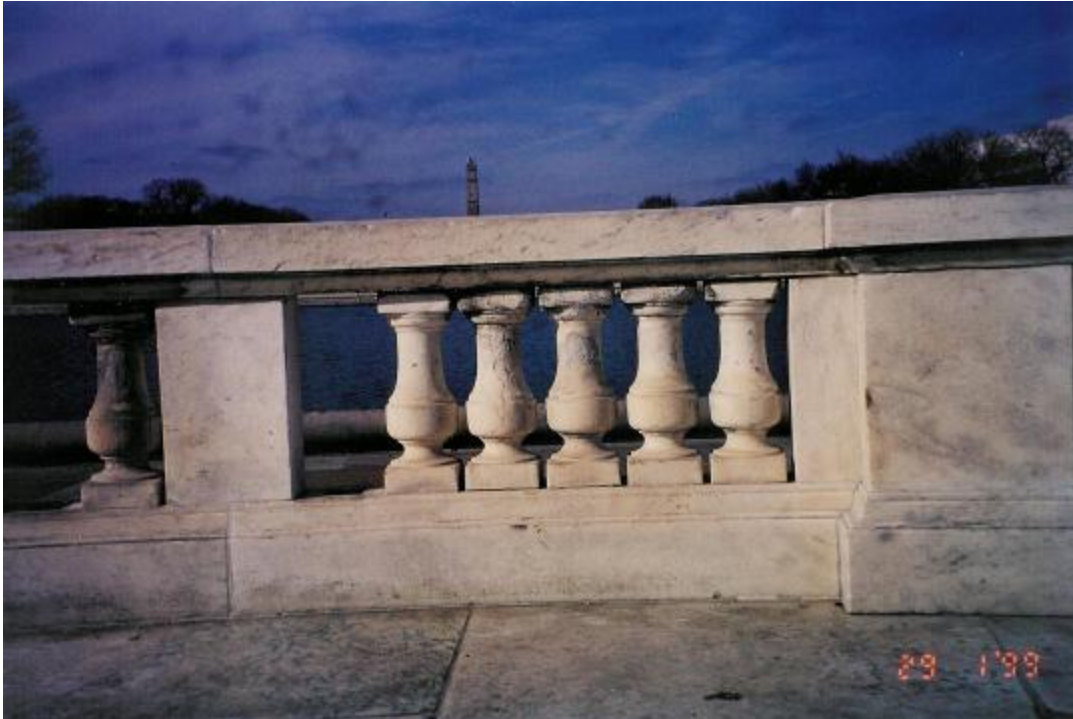
Sample area examined during our January 1999 site visit

We visited the site on January 29, 1999.²³ In the light of the encouraging laboratory research results of the past few months, we believe that we can now recommend that a well-documented prototype field treatment be undertaken. This should be done in one or more limited areas with the newer formulation. Details of the exact size and location of the installation would be worked out with National Capital Parks professional staff. Monitoring of quantities used during the field treatment will permit realistic evaluation of coverage; it was not possible to make such measurements with the mini-cores.
