MARBLE CONSOLIDATION TESTING

THE GRANT MEMORIAL

MCC MATERIALS, INC.

THE GRANT MEMORIAL MARBLE CONSOLIDATION TESTING

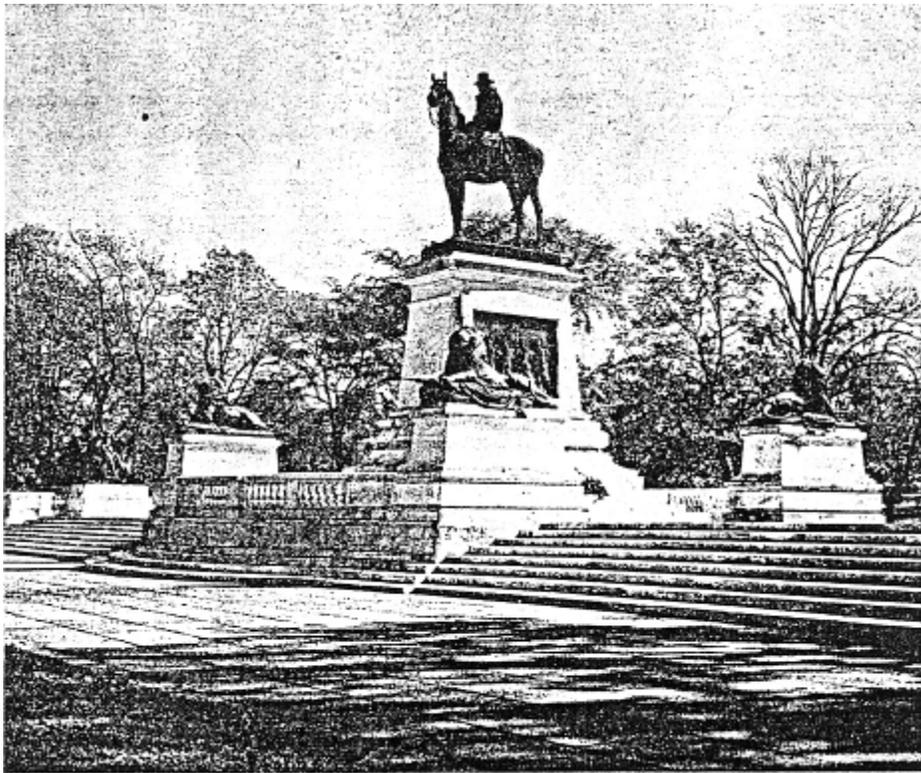
FIGURE 1. Grant Monument, Washington, D. C., from the southwest showing all but one of the bronze groups and the supporting marble.

“Several blocks have prominent brown stains, accompanied by cracking of the marble. The worst condition is shown in figure 3, but many blocks appear to be in good condition. The corner block under the south group is projecting considerably over the edge of the block below. This is believed to indicate that the injured block has undergone a swelling action.

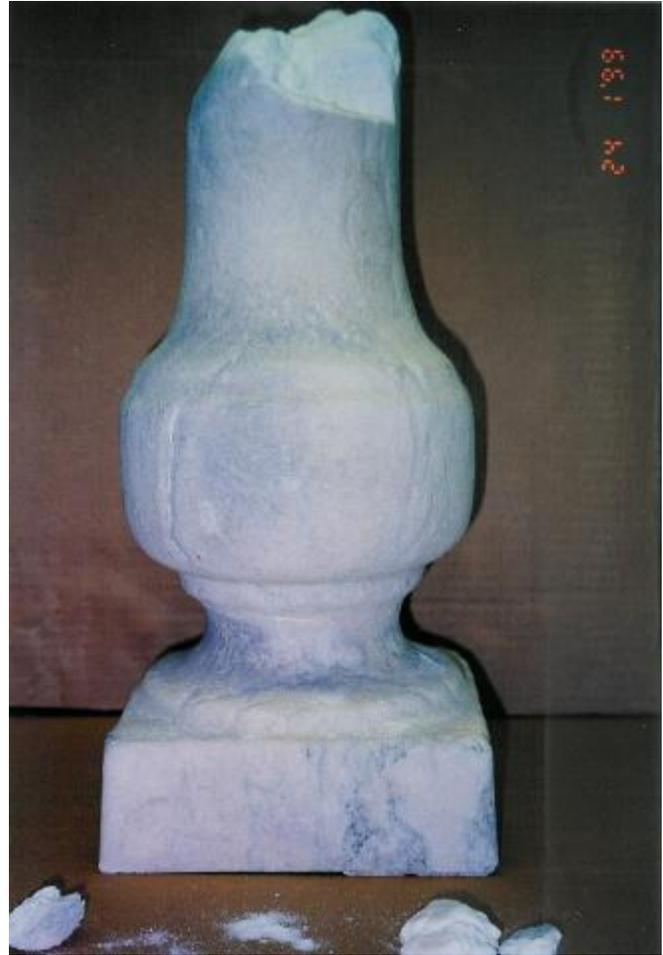
**The baluster fragment as received
in MCCM Laboratory**

A stone sample for analysis and testing was taken from the Memorial late last year, and shipped to MCC Materials' Connecticut laboratory. It was received on November 24, 1998. It is a large fragment of a baluster (lacking the uppermost portion), measuring 16½" in height. The 7¼" square base is 2½" high. The thickest part of the turned portion of the baluster is (similarly) 7¼" in diameter.

The entire fragment is heavily weathered and discolored. The upper one-third was fragile, with the topmost portion exhibiting extreme “sugaring” and losses. A considerable amount--550 grams--of loose debris was able to be collected. This material was run through a set of U.S. Standard Series sieves using a Tyler Ro-Tap shaker (Model B, Tyler Industrial Products, Mentor, OH). Separated into individual size fractions, the rock particles were examined under a Nikon SMZ-1 stereobinocular microscope at 7 to 30X magnification.

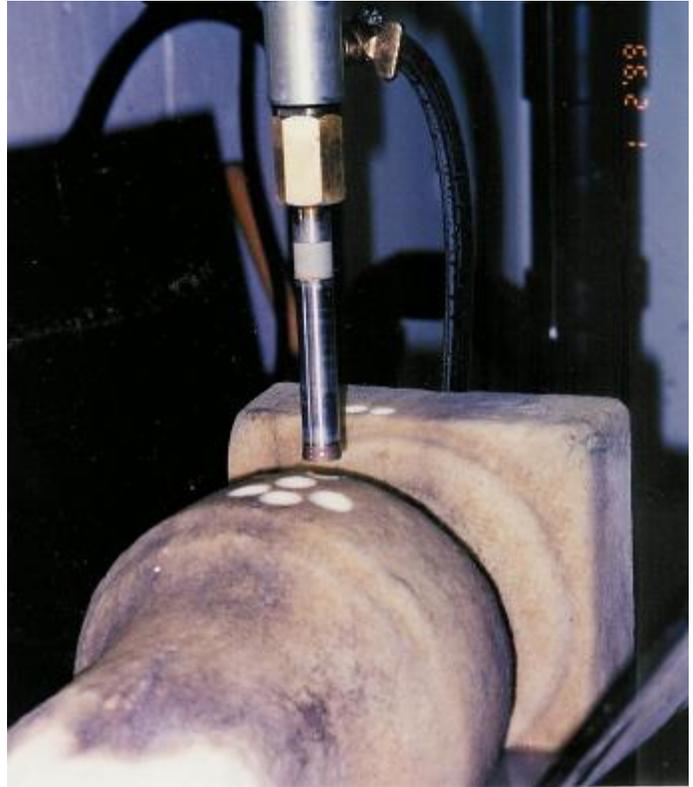
Drilling of cores from the center of the baluster

Coring of the base and the lower turned portion ("center") of the baluster was done with a standard 14" Delta bench-top drill press operating at 460 rpm (Delta Industrial Machinery Corp., Pittsburgh, PA). Our press is fitted with a 4" long by 14 mm. ID impregnated core drill by Lunzer Diamond Associates (Saddle Brook, NJ), attached via a water swivel chuck that permits bit cooling and flushing of cutting debris. Coring by this method yielded approximately 70 "mini-cores," each 13.7 mm. in diameter, typically 20 to 65 mm. in length.

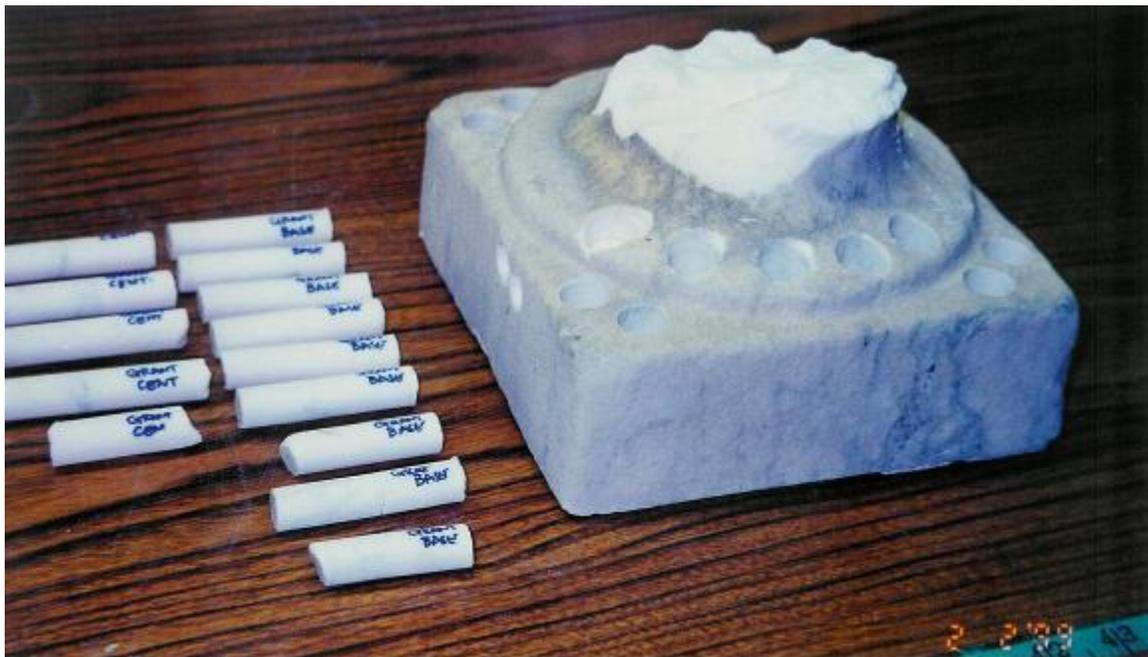
Cores taken from the base of the baluster

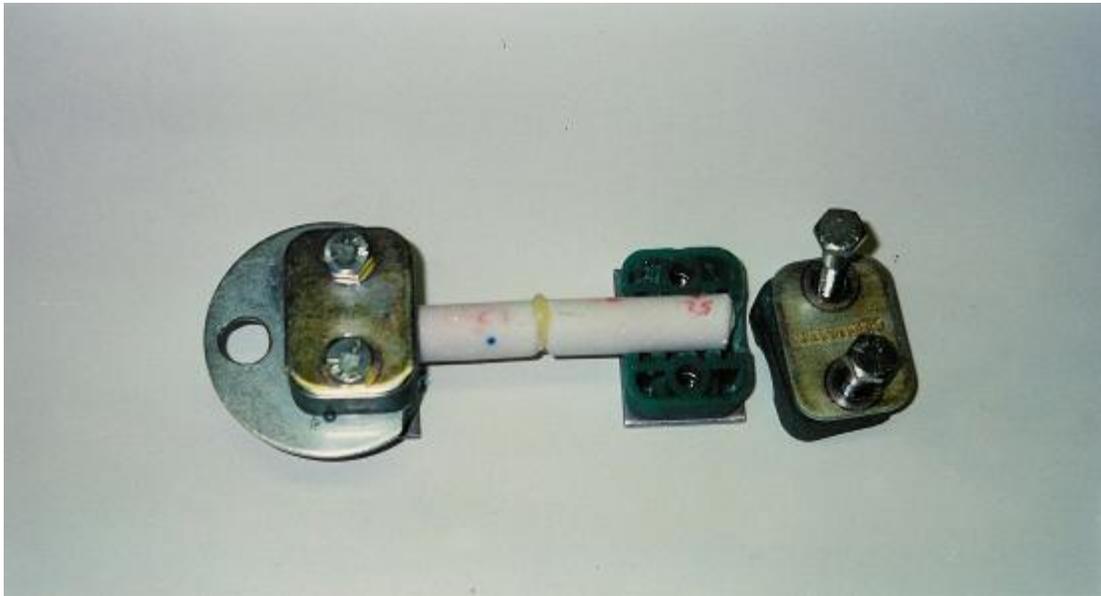
Surface-coupled cores secured with pipe clamps

Cores from the base and center of the baluster were then examined visually. If the weathered surfaces were largely intact (that is, they survived the coring process), pairs of cores were precisely aligned and adhered--surface to surface--with Abocast 8101-5, a two-part thixotropic epoxy adhesive (Abatron, Inc., Kenosha, WI). Each surface-coupled pair was then tested in tension to assess surface soundness. "Breaks" within 3 mm. of the glue line were considered to provide useful data. The average tensile force to cause failure in the base specimens was 7.7 ± 1.2 lbs. The more fragile center specimens failed at 4.4 ± 0.8 lbs.

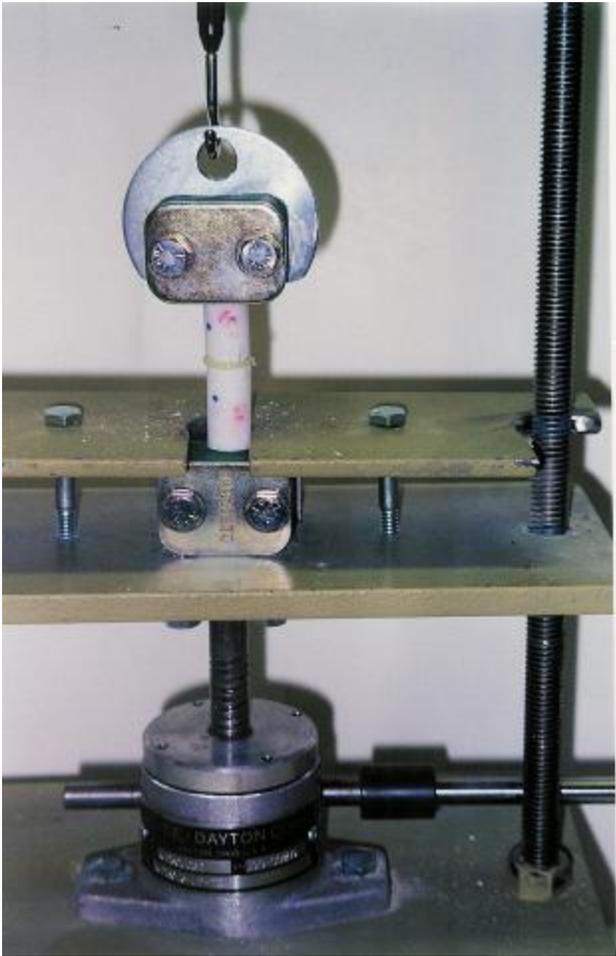
Coupled cores mounted on test stand

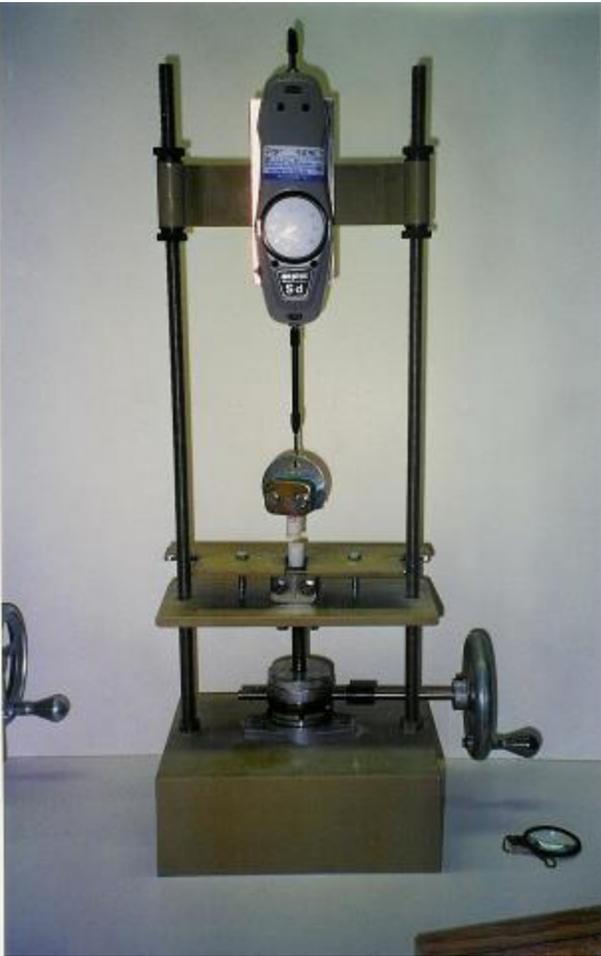
Testing surface-coupled cores in tensile failure

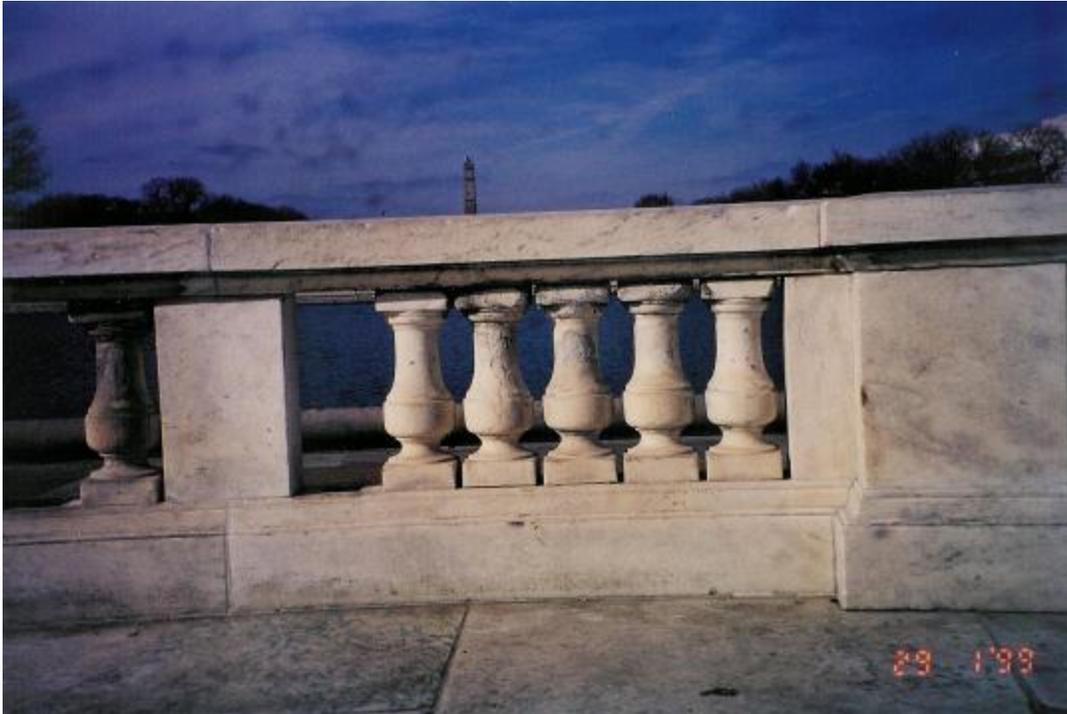
Sample area examined during our January 1999 site visit

We visited the site on January 29, 1999.²³ In the light of the encouraging laboratory research results of the past few months, we believe that we can now recommend that a well-documented prototype field treatment be undertaken. This should be done in one or more limited areas with the newer formulation. Details of the exact size and location of the installation would be worked out with National Capital Parks professional staff. Monitoring of quantities used during the field treatment will permit realistic evaluation of coverage; it was not possible to make such measurements with the mini-cores.
