MCC MATERIALS, INC.

## REIGATE STONE TRIALS

SEPTEMBER 2002

WINCHESTER PALACE  
HM TOWER OF LONDON  
WESTMINSTER ABBEY  
HAMPTON COURT PALACE

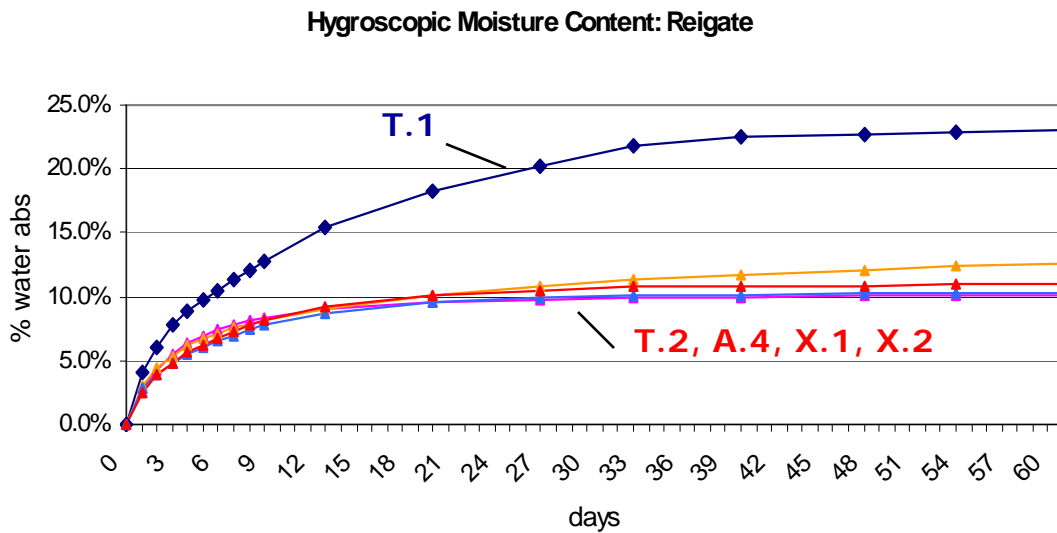
Figure 1

A larger study of hygroscopicity was done with triplicate specimens of five Reigate samples, T.1 and T.2, A.4, and X.1. and X.2. The data are graphically summarized in Figure 1. At seven days, the moisture content of Reigate T.1 was more than 50% higher than the mean value for all other samples. At 61 days, when the test was halted, the Reigate T.1 specimens were saturated (23.0%), at nearly twice the moisture content of T.2 (New Armouries).

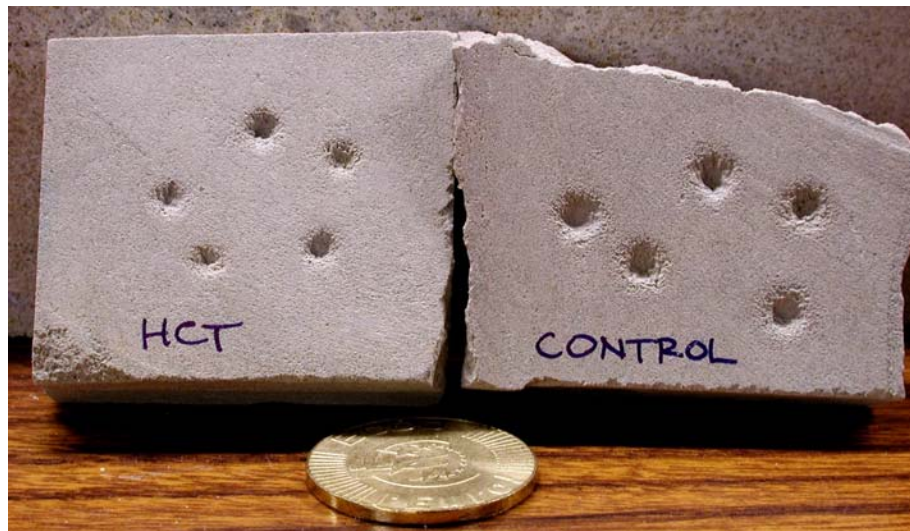
**Figure 2:** Microabrasion, 5 craters each specimen

This technique was first reported for the evaluation of conservation treatments by Phillips in 1982 (Phillips, Morgan W., "Acrylic precipitation consolidants", in Science and Technology in the Service of Conservation. London: IIC, 1982, pp. 56-60.). Our apparatus is the S.S. White Airbrasive Unit (Model-K). Fine alumina powder is carried in a narrow stream of air, resulting in measurable loss of stone by abrasion. The blasted area appears as a small crater (see Figure 2). To make the process reproducible, the orifice is positioned 20 mm from the surface of the specimen; a steel plate is used as a shield to control the precise time of the blast.

Data for five building stones (including Reigate T.1) currently being tested in our laboratory are presented in Table 3, which includes some other details of the experimental design. The mean weight loss (grams/crater) for the untreated (control) specimens is divided by the same value as measured for the HCT-treated specimens. This number, which we have called the “comparative soundness”, is a measure of the extent to which HCT enhances cohesion. The computed value for Reigate is 2.10, that is, the treated specimens are, on average, more than twice as resistant to abrasion than the controls.

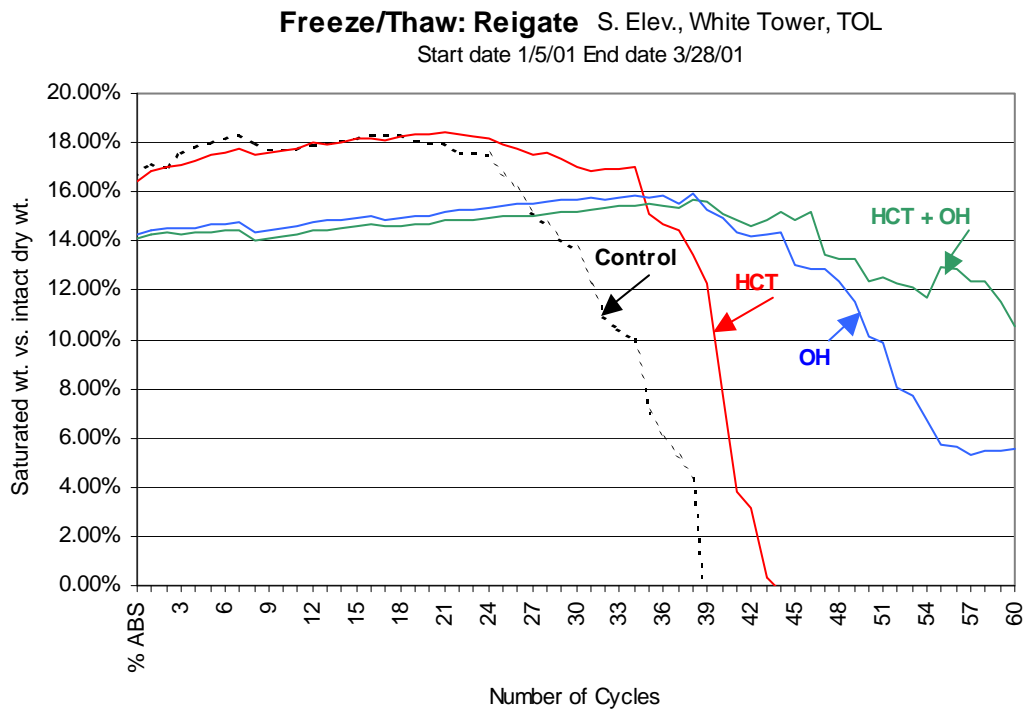
**Figure 3**

Figure 3 is a graphic representation of more than two months of data on Reigate T.1 in a laboratory freeze/thaw test program that we have developed. Specimens are four sets of 2.5 cm (1 inch) cubes: untreated controls, treated with HCT only, with OH only, and with HCT followed by OH. Those treated with OH are given 28 days for room temperature curing. After weighing, the dried specimens are submerged in water for 48 hours, and re-weighed. Surplus water is drained, and the wet specimens are placed in a freezer at  $-15^{\circ}\text{C}$  for 16 hours; thawing is for 8 hours in water at room temperature. Specimens are then re-weighed, and returned to the freezer for another cycle.

Y-axis values, plotted for each cycle, are computed as the mean wet weight (5 specimens) minus their original (i.e., intact) mean dry weight, divided by that dry weight, times 100. Thus, at the start of the test program, this value is simply the % water absorption (48 hours). As the test progresses, and specimens begin to exhibit some material losses from frost shattering, the diminishing specimen weights are seen as a descending curve.

What we observed initially for all sets is a relatively steady line. For the controls, the loss of material became quite dramatic by cycle 28. HCT-treated specimens did well for an additional 8 cycles, almost 30% longer. The best performance was exhibited by the set treated with HCT followed by OH, remaining relatively intact to beyond 50 cycles (see Figure 4), with the most gradual (i.e., the least dramatic) loss of material as the test was continued to 61 cycles.

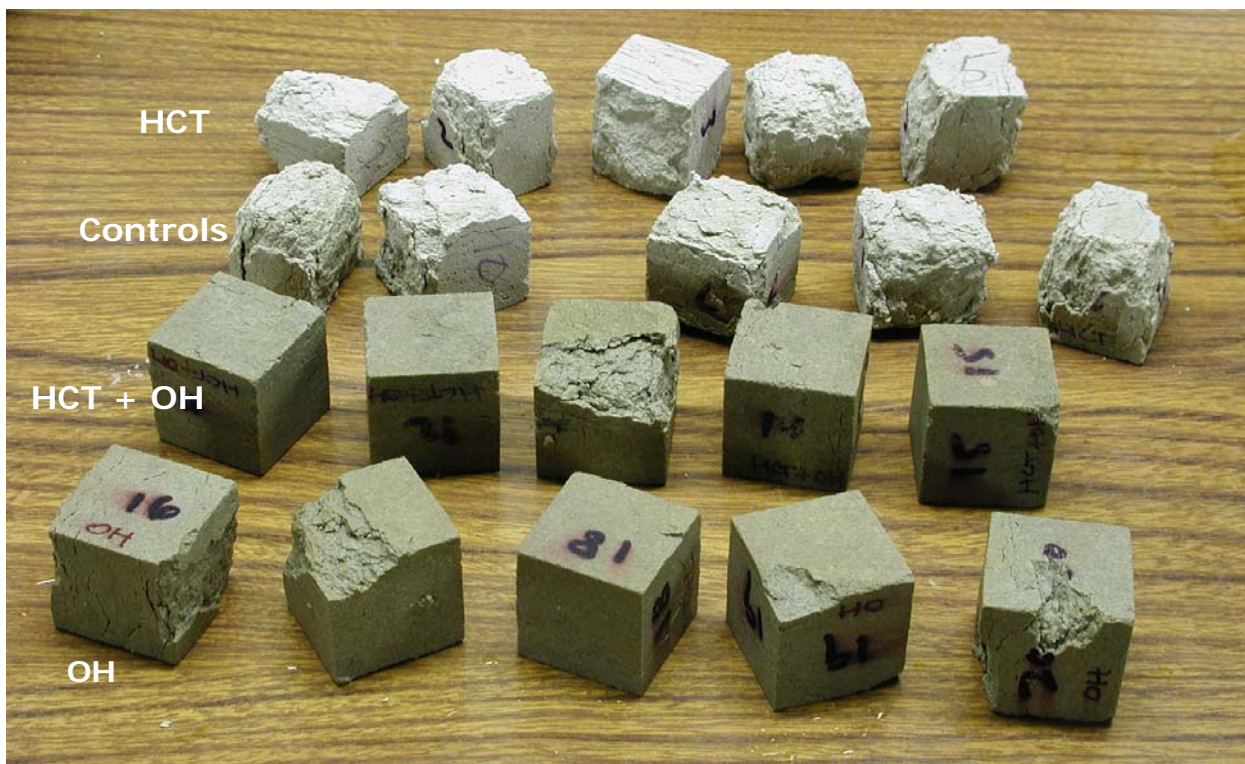
**Figure 4:** Back to front:  
HCT (dry) at cycle 34, controls (dry) at 26, HCT + OH (wet) at 50, OH (wet) at 50

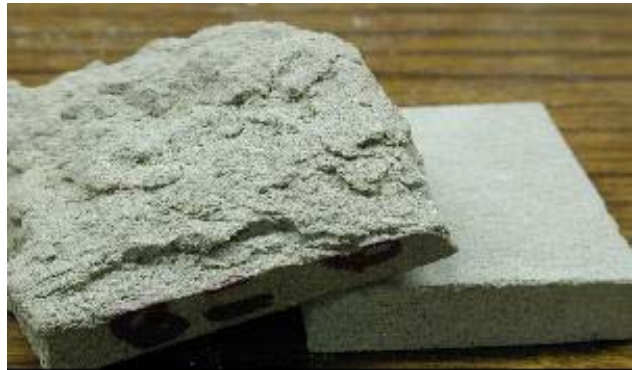
An important observation that we were able to make in our laboratory is that the appearance of specimens subjected to cyclical freeze/thaw is remarkably similar to that of deteriorated Reigate stone on buildings. This encourages us as to the value of our accelerated weathering testing.

Reigate T.1, laboratory induced scaling (freeze/thaw testing)

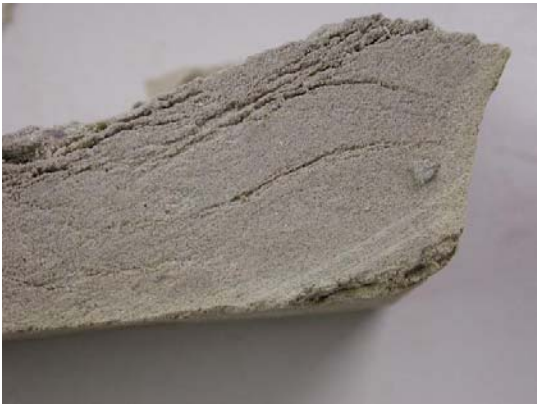
Reigate A.1, cross section showing incipient scaling

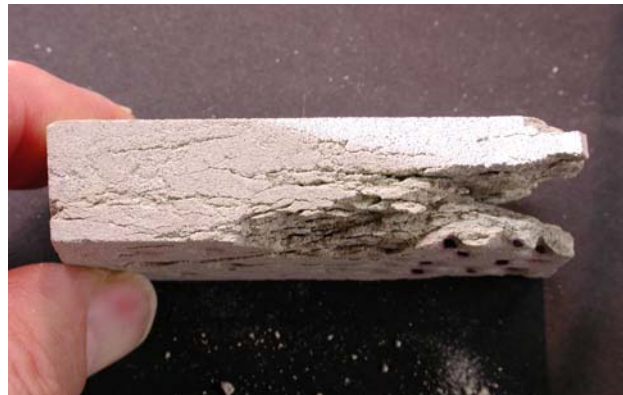
Reigate T.1, laboratory induced incipient scaling (freeze/thaw testing)

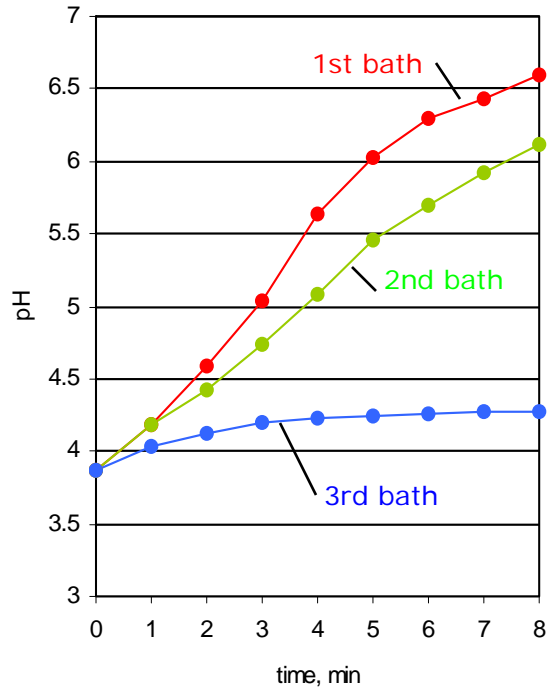
Increasing pH essentially represents neutralization of the HCT by reaction with the alkaline calcite. With repeated treatment on the same particles, the increase is progressively less, as there are fewer HCT-reactive sites left on the mineral surfaces, that is, the conversion treatment becomes more complete (see Figure 6).

**Figure 6:** pH monitoring of treatment

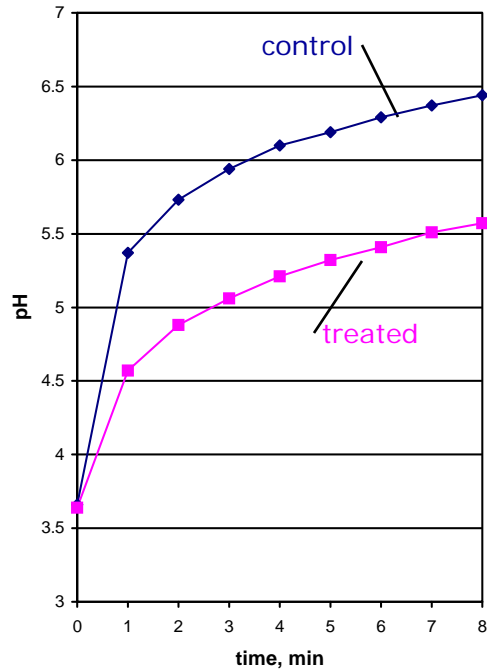
**Figure 7:** pH monitoring of acid rain simulant

Treated aggregate is then used to study the ability of the conversion layer (CTT) to impart some passivation to acid rain exposure. 4 g of treated and untreated (control) aggregates are separately stirred in 20 ml of an acid rain simulant (pH 3.6). Monitoring of pH (see Figure 7) now gives us a relative measure of the chemical resistance of treated aggregate to the simulant, which is dilute sulfuric acid saturated with respect to carbon dioxide. After 8 minutes, our data show a difference (treated vs. untreated) of 0.87 pH units. As pH is a measure of hydrogen ion activity on a base-10 log scale, this represents a reduction in sensitivity to acid exposure (via HCT treatment) by a factor of approximately 8.

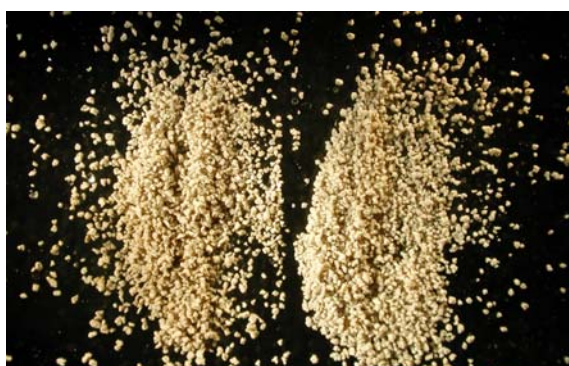
We have also had excellent (and dramatic) results re: acid resistance by another test method. Drops of 0.09 M sulfuric acid (pH 1.1) placed on HCT-treated Reigate aggregate show no reaction. By comparison, evolution of carbon dioxide gas--evidence of reaction of the acid with calcite--for untreated Reigate aggregate is vigorous (see Figure 8). More importantly, a difference between treated and untreated Reigate can be observed when drops of 0.09 M sulfuric acid are placed on larger specimens of stone.

Reigate aggregates, untreated on left, HCT-treated on right

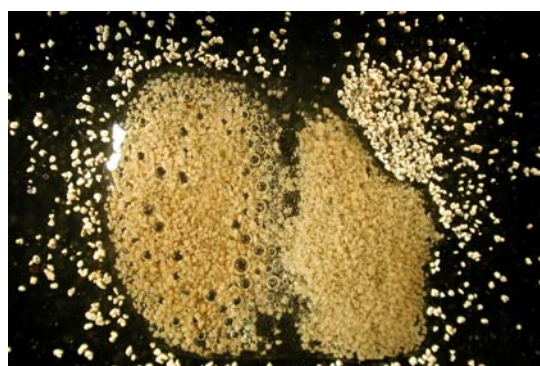
Reaction with .09M sulfuric acid, pH 1.1

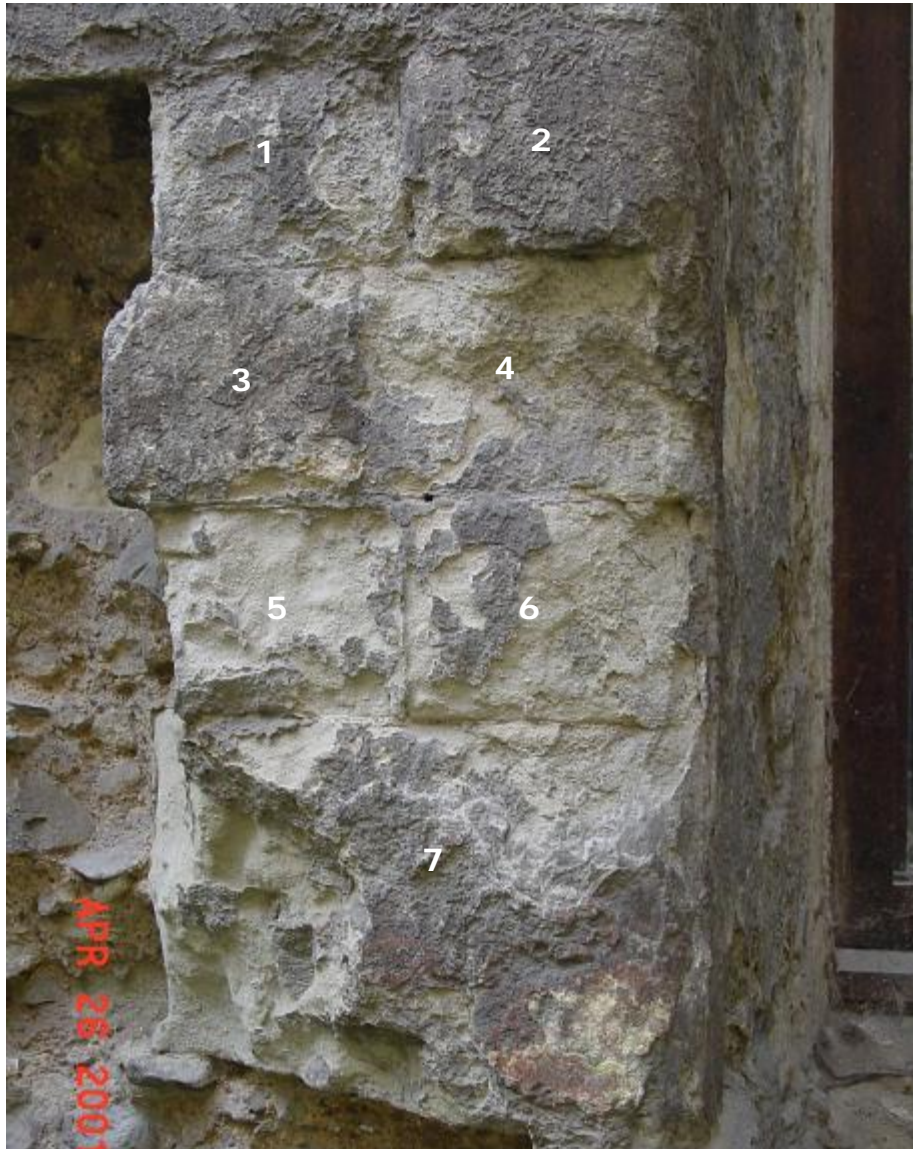
Description/Condition: Three (designated 5, 6 and 7) of the seven Reigate stones in the trial area to be treated with Conservare HCT. (This portion of the area is approx. 45 by 50 cm.) Stones 1 and 7 to be treated with Conservare OH; 2, 3 and 4 to serve as (untreated) controls. Color: all are pale grey-green, with considerable surface discoloration. Ancillary wall materials: Caen stone, brick/concrete repairs. Previous conservation treatment: there is no documentary record, but the hardness of the (flaking) surface crust suggests some prior chemical treatment. In some areas, the crust is mechanically unstable; flakes could be detached with the slightest manual pressure. Much of the lighter-colored stone beneath the crust (and where it has been lost) is friable and "sugary".

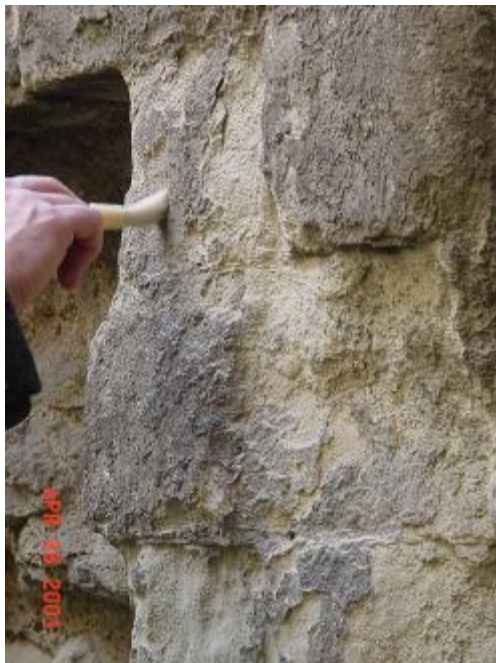
Removing loose surface material  
by lightly brushing

Surface preparation: Loose crusts and granular stone debris were removed from the surface with a long-fibered brush. Brushing was carried out slowly and with very light pressure, the process referred to by EH staff as “rationalizing” the surface. This work was done on all seven stones until a finger placed directly on the surface did not cause the loosening of any additional grains. Surface conditions made it very difficult to determine ultrasound pulse velocity. Only stone 5 permitted proper placement of the transducers, providing transit time data that could be compared with post-treatment values (see entry for 2 November, 2001, below).

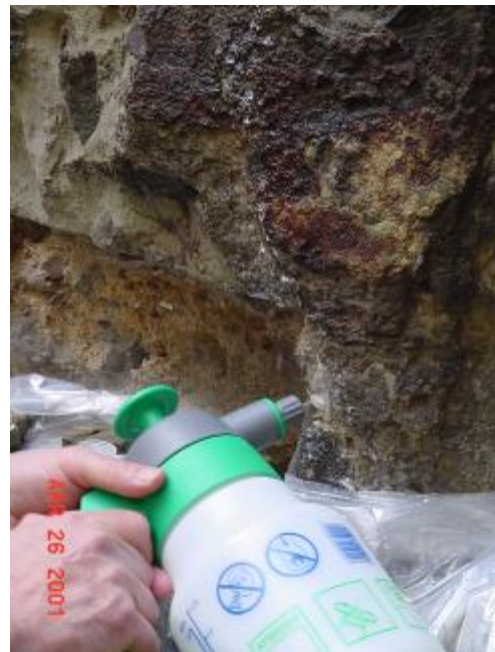
Applying treatment with low  
pressure spray

Treatment application: Conservare HCT Hydroxylating Conservation Treatment, 1:00 to 3:50 PM. 16 to 22°C, 54% RH; unstable weather with brief periods of rain. Three saturating applications, initially by brush, but switching almost immediately to low pressure spray. Drying times of 1 to 1 and ½ hours between applications, with 25 minutes after the third application. Conservare HCT Finishing Rinse, one saturating application by low pressure spray, 4:15 to 4:16 PM. All seven stones were then washed down with water; runoff from the untreated portion of the trial area appeared to contain minute particles of stone.

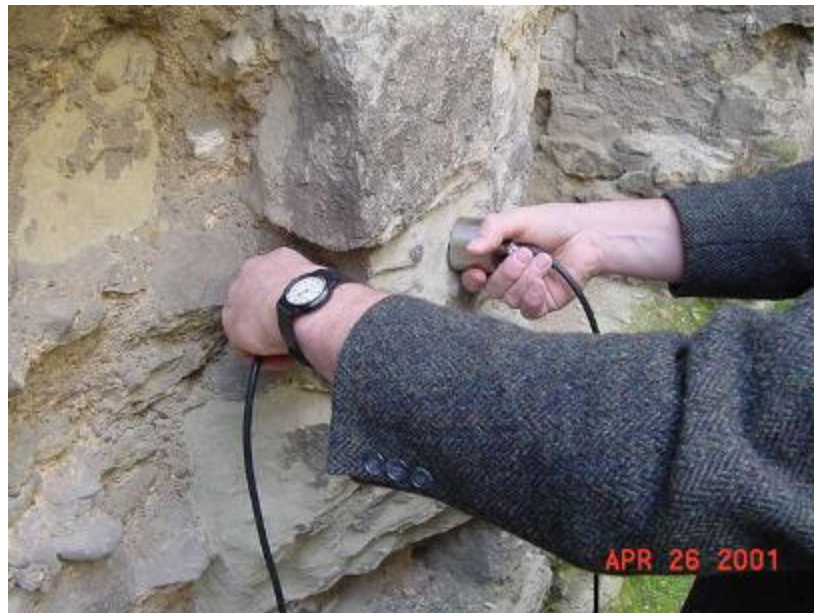
Inspection/Evaluation: Present: Irving Slavid and Norman Weiss. Inspection was by touch, with a 10X lens and a 30 X field microscope, and with ultrasound. Control stone 4 was somewhat fragile to the touch after 6 months of weathering. Stone 1, treated with OH only, was only in slightly better condition. Stones 5, 6 and 7 were considerably sounder than 4, with 7 the best of the group. There was no discernable alteration of surface appearance (color, gloss) as a result of treatment. Summary of ultrasonic testing, stone 5: transducer distance is 126 mm. Apparatus is portable PUNDIT.

Treated Reigate stone (5) shows a mean velocity increase of 36%.

Measuring ultrasonic transit time with PUNDIT

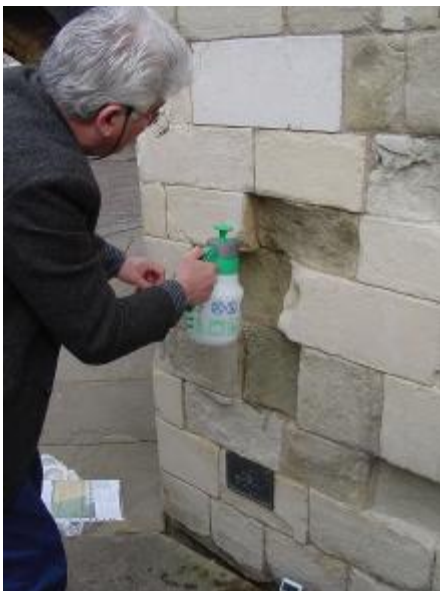
Application of treatment with  
low pressure spray

Treatment application: Conservare HCT Hydroxylating Conversion Treatment, 8:30 to 11:24 AM. 12°C, 43% RH; partly cloudy to sunny. Three saturating applications done by low pressure spray, with approximately 1 hour drying time between applications. Stone 5 was "masked" with small volumes of fresh water to prevent absorption of run-down. Conservare HCT Finishing Rinse, one saturating application by low pressure spray, 12:00 noon to 12:02 PM. All stones (including 1 and 5) rinsed with fresh water, low pressure spray, 12:10 PM.

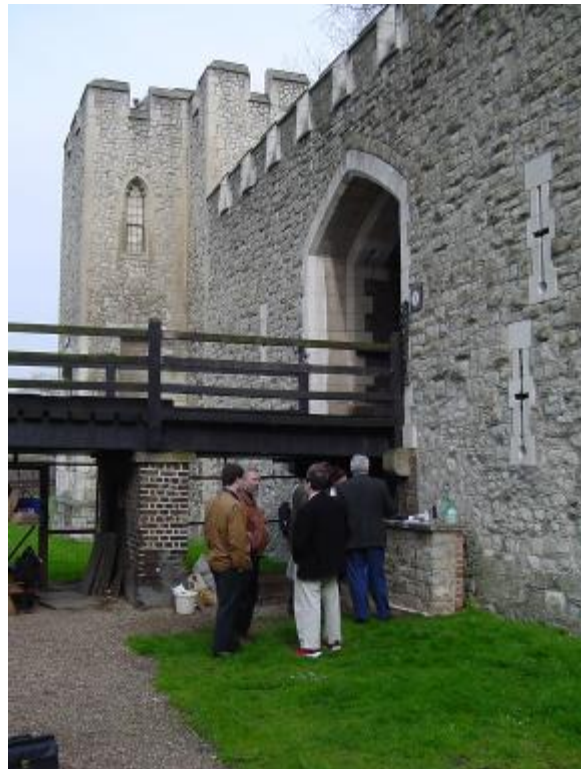
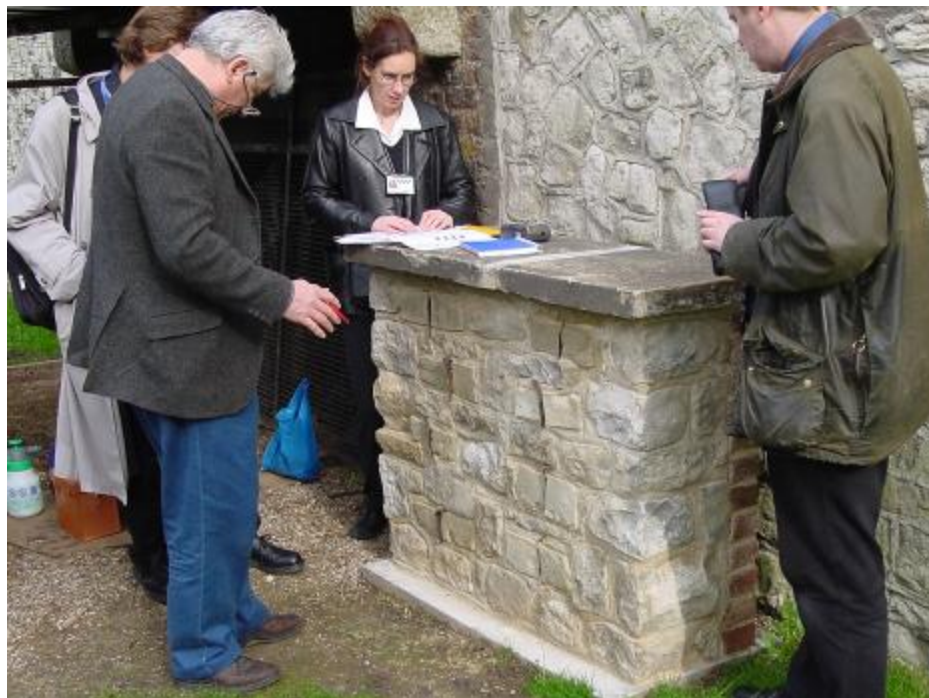
Description: Eight Reigate stones (designated 1 through 8) were incorporated in the rubble stone wall (Kentish rag, with brick back-up). Prior to installation, each stone was cut vertically. The halves (designated a and b) were installed with a semi-rigid membrane in between, to permit application of different treatments to portions a and b of the same stone. Construction of the wall is described in a drawing ("Research Panel 2") prepared by HRP. Average surface dimensions of the Reigate stones are given therein as 6 by 23 cm. Stones 1a, 2a, 3a and 4a to serve as (untreated) controls.

A mock-up wall (incorporating Reigate stone from an interior wall of the New Armouries), constructed several weeks earlier, was inspected by the team assembled to do the HCT treatment on the Bell Tower. It displayed variable and excessive moisture. There was agreement that the mock-up wall be allowed to dry more fully before carrying out treatments.

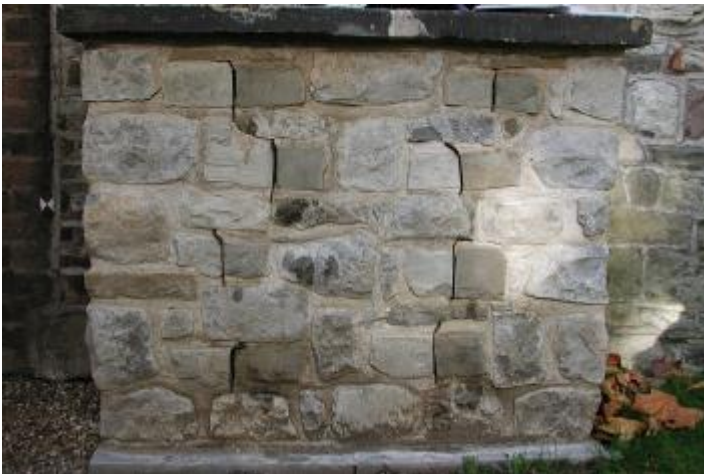
After HCT treatment (b of all stones), 3 November 2001, still wet

Treatment application: Conservare HCT Hydroxylating Conversion Treatment, 11:37 AM to 1:21 PM. 14°C, 66% RH. Three saturating applications done by brush, with at least 30 minutes drying time in between. Application was to the b (right-hand) portion of all Reigate stones. Conservare HCT Finishing Rinse, one saturating application by brush, 2:28 to 2:30 PM. Conservare OH (ethanol as solvent), 11:42 AM to 2:36 PM; 2 and 2/3 "cycles" (i.e., eight saturating applications) by brush, to stones 5a, 6a, 7a and 8a. (As designed, this field test was to include OH treatment of stones 5b, 6b, 7b and 8b by HRP; that work was never accomplished.)

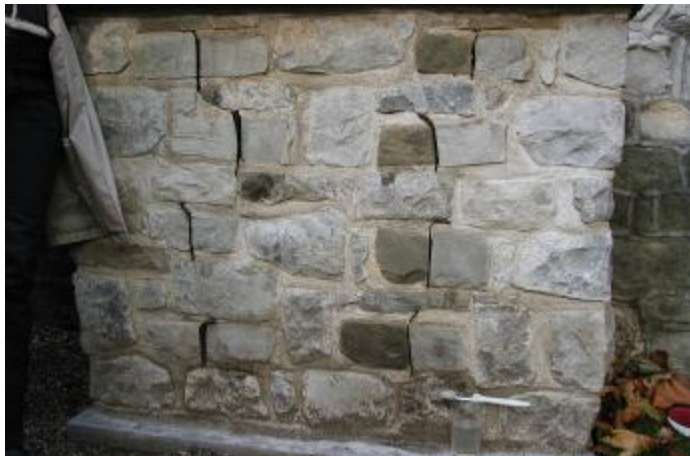
After OH treatment (5a-8a), 3 November 2001, still wet

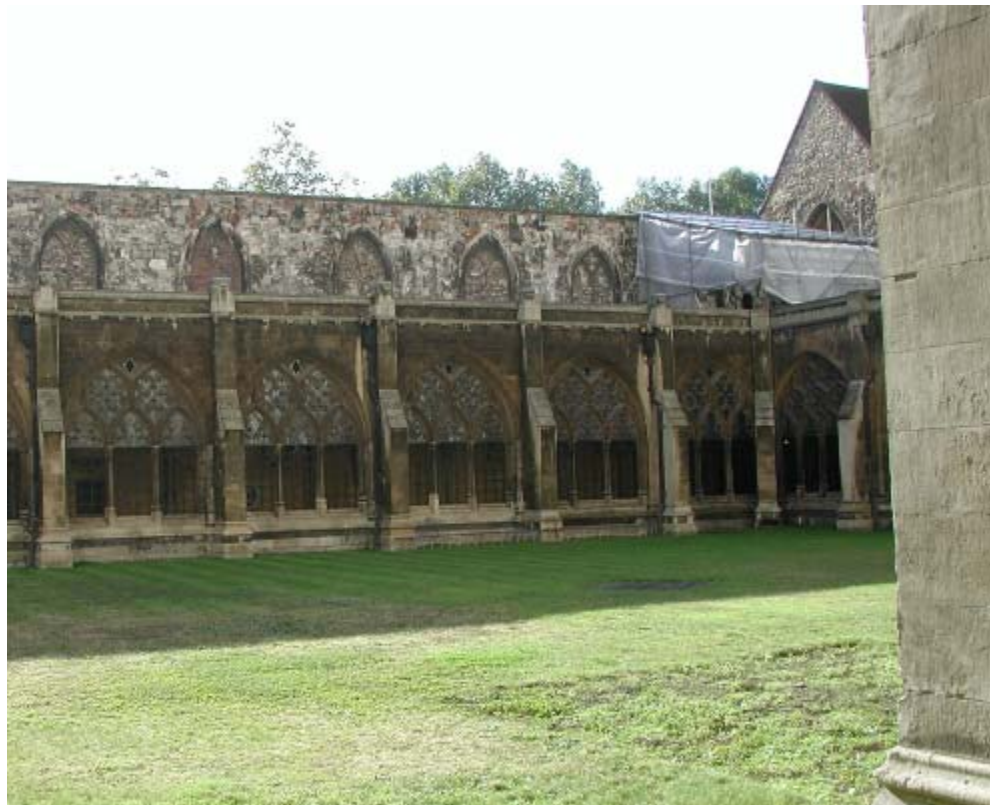
Covered trial area at upper right

Trial area was at the west end of the wall above the south Cloister roof, on the north face of the wall. This area has been protected from rain with corrugated plastic sheet since December 2000. Reigate stones designated for treatment are to the right of the door opening. HCT treatment was carried out by: Vanessa Simeoni (Westminster Abbey); Irving Slavid and Norman Weiss; and David Boyer. Also present as observers were: Richard Roberts, Jo Thwaites, Sarah Ferraby (Historic Royal Palaces) and Jeremy Ashbee; Robin Sanderson and Keith Garner; and Jagoba Mariscal.

Description/Condition: Three contiguous Reigate stones (designated 1, 2 and 3), constituting the right-hand edge of the doorway. Smaller Reigate stone blocks immediately above (designated A, B and C) to serve as controls. Approx. depth of stones 13 cm. Color: all are pale grey-green, with some brown discoloration thought to be iron oxide. Ancillary wall materials: Caen stone, flints, brick. Previous conservation: there is no clear physical evidence or documentary record of prior chemical treatments. The three stones differ in condition. Stone 1 (top) is uniform in appearance, with a friable surface. Stone 2 (middle) also has a similar surface, with a thin weathering crust over approx. 40% of its area. Stone 3 (bottom) has the crust over approx. 25% of the surface and is somewhat concave, possibly due to backsplash from the surface of the roof immediately below.

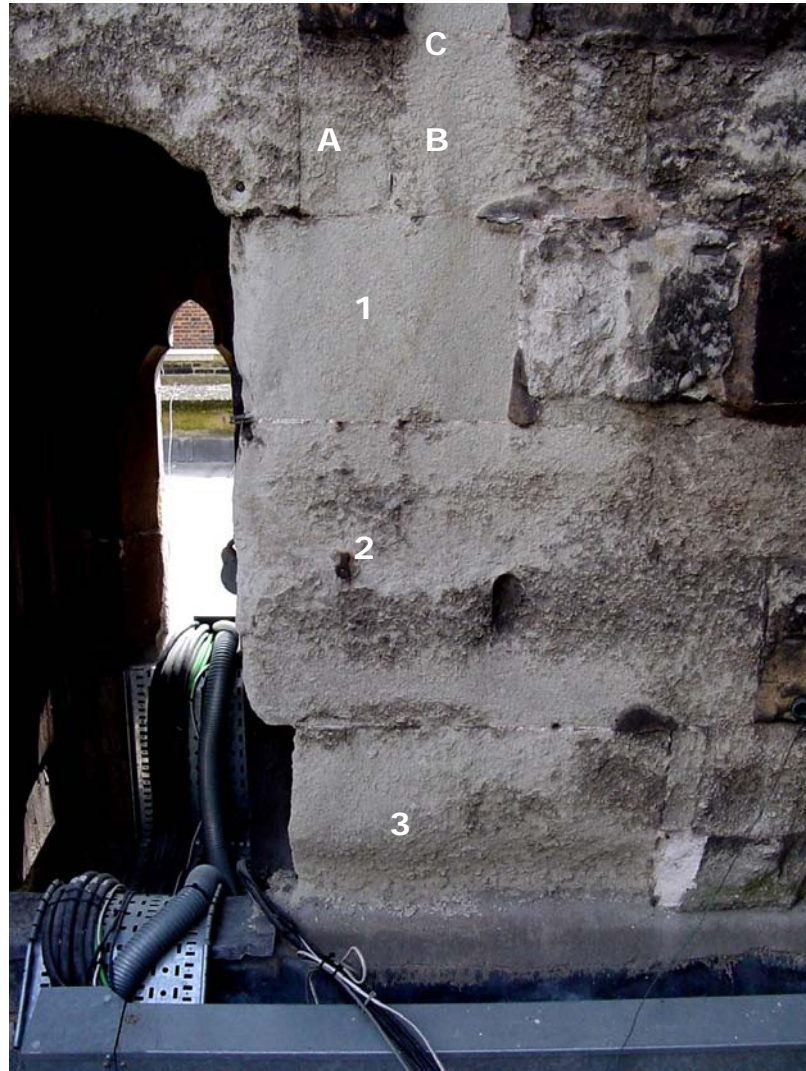
Detail of trial area

A, B, & C are controls; 1, 2, 3 are to be treated

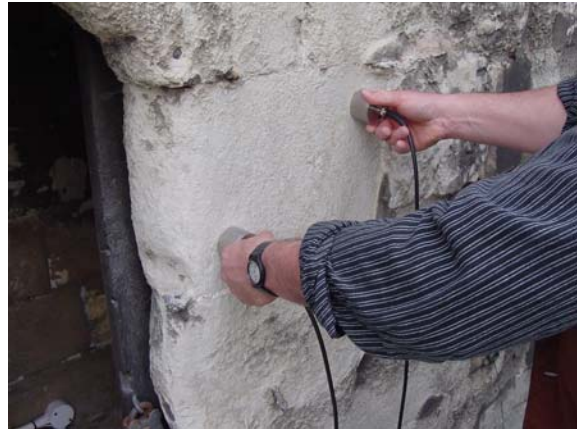
Loose grains and other debris were removed from surface of the test stones and adjacent control stones with a soft, long-fibered dusting brush. The area of stone 1 was visually "divided" into four quadrants. Ultrasonic transducers placed in the center of each quadrant were used to determine pre-treatment pulse velocity in the two lateral and two diagonal directions. (These data are shown in the entry for 1 November 2001, below.)

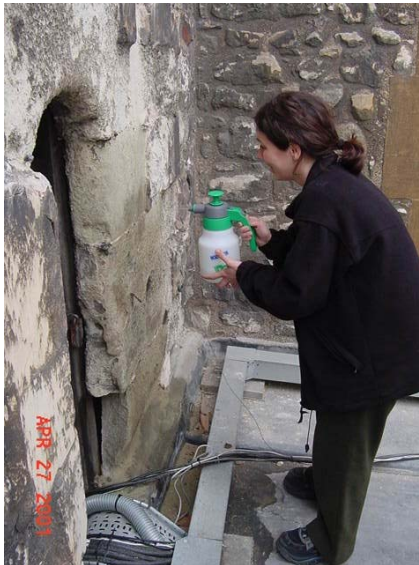
Application of HCT

Treatment application: Conservare HCT Hydroxylating Conversion Treatment, 2:40 to 5:00 PM. 12°C, 44% RH; clear day, becoming overcast. Three saturating applications done by low pressure spray, with approx. 30 minutes drying time between applications. Total volume used approx. 2.5 liters

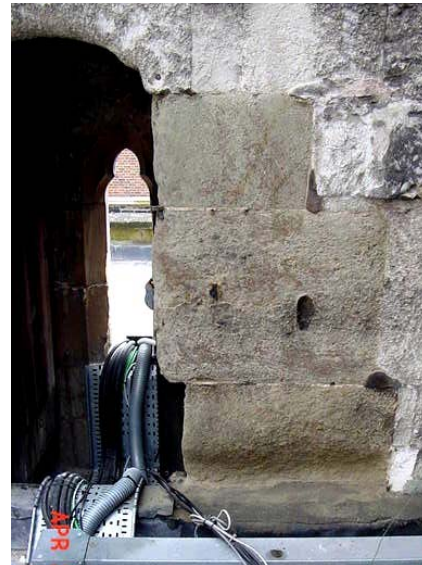
Treated stones (wet)

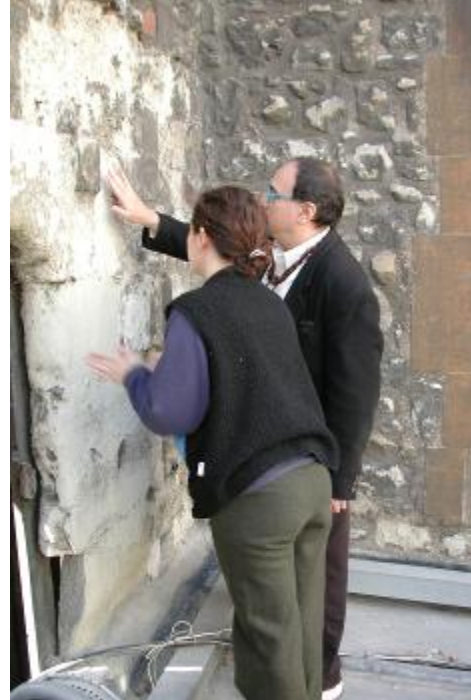
Summary of ultrasonic testing, stone 1: a-b , c-d transducer distances are 230 mm; a-d, b-c distances are 270 mm. Apparatus is portable PUNDIT.

Pulse velocity (km/sec), before treatment		1 November data	
a-b	.91		1.40
a-d	.90		1.33
c-d	.89		1.16
b-c	.95		1.23
<b>mean =</b>	<b>.91</b>	<b>mean =</b>	<b>1.28</b>

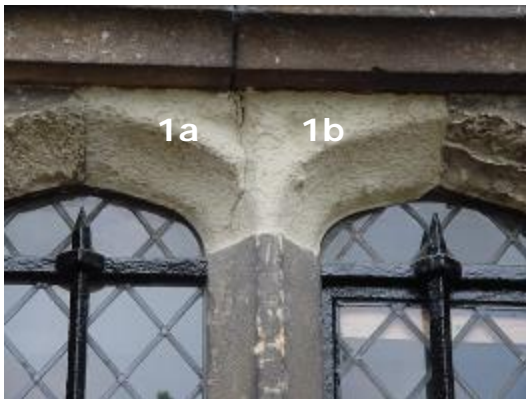
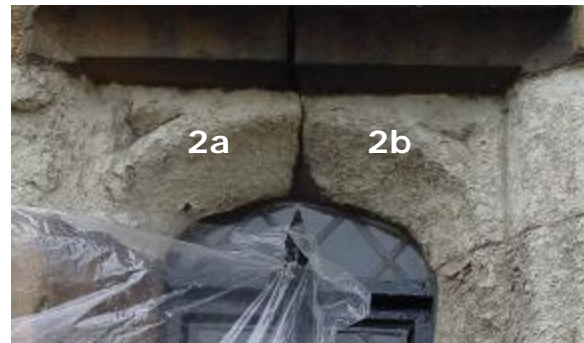
Surface preparation: Stones 1a and 1b were "rationalized" with a soft, long-fibered dusting brush. 2a and 2b were prepared with the brush and a small plastic spatula.

Description/Condition: Two Reigate stones, individual elements of two arched window heads. Stones designated 1b and 2a to be treated with Conservare HCT; adjacent stones 1a and 2b to serve as controls. HCT-treated stones to be treated subsequently with Conservare OH. Color: all are pale grey-green. Ancillary wall materials: Bath stone, brick. Previous conservation: considerable stone replacement. No documentary record of prior chemical treatments, but the initial difficulty in treating No. 1b may be indirect evidence of some residue. The two stones are in generally similar condition. Both exhibit considerable erosion; surfaces are friable and "sugary", with some curled crusts.

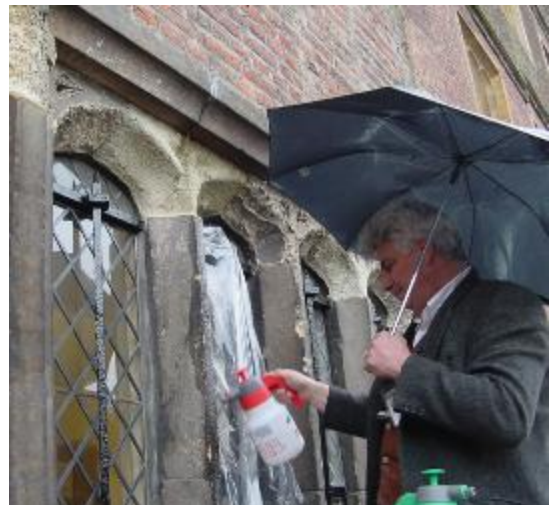
Inspection/Evaluation: Present: Irving Slavid and Norman Weiss; Richard Roberts: Keith Garner and Robin Sanderson. Inspection was by touch and with 10X lens and 30X field microscope. Consensus was that treated surfaces appeared to be significantly consolidated.
