# TOMB PLAQUE REPORT

MOUNT VERNON  
MOUNT VERNON, VIRGINIA

STONE INVESTIGATION

RESTORATION OF TOMB WALL PLAQUE

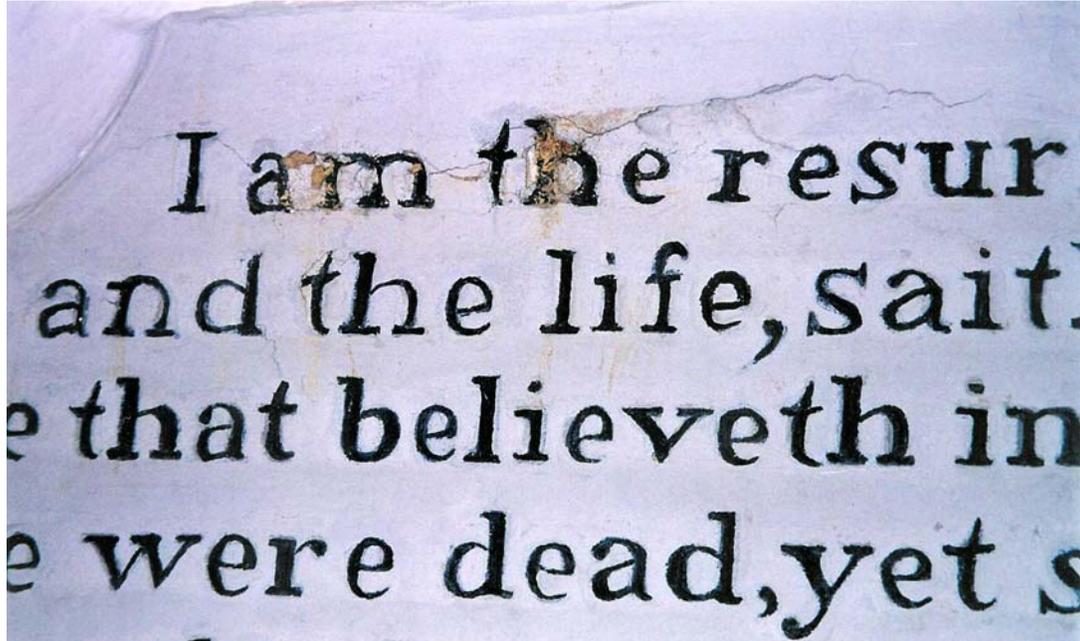
Condition of the raised field as first observed in December, 1998.

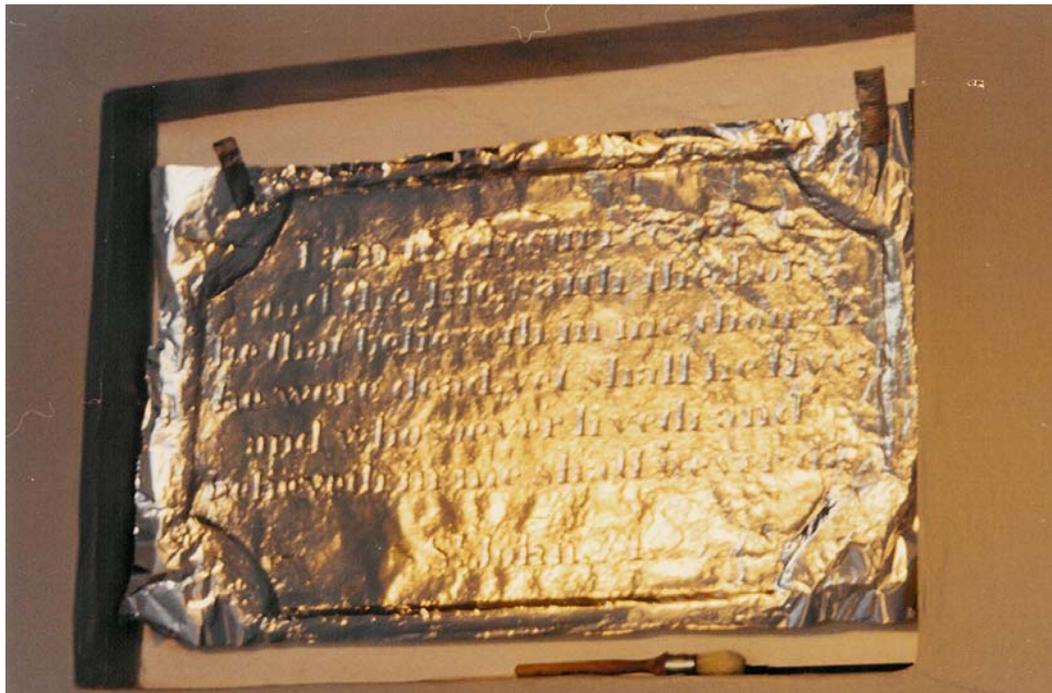
Our first site work was on March 11 and 12, 1999. We began with some general photography, to supplement the close-ups shot on December 10. The first significant procedure was the preparation of a metal foil impression of the raised field, which was used immediately to create an on-site plaster cast. By this means, no three-dimensional information concerning the pre-treatment condition would risk being lost as we commenced exploratory work.

Metal foil impression (in place) of the raised field.

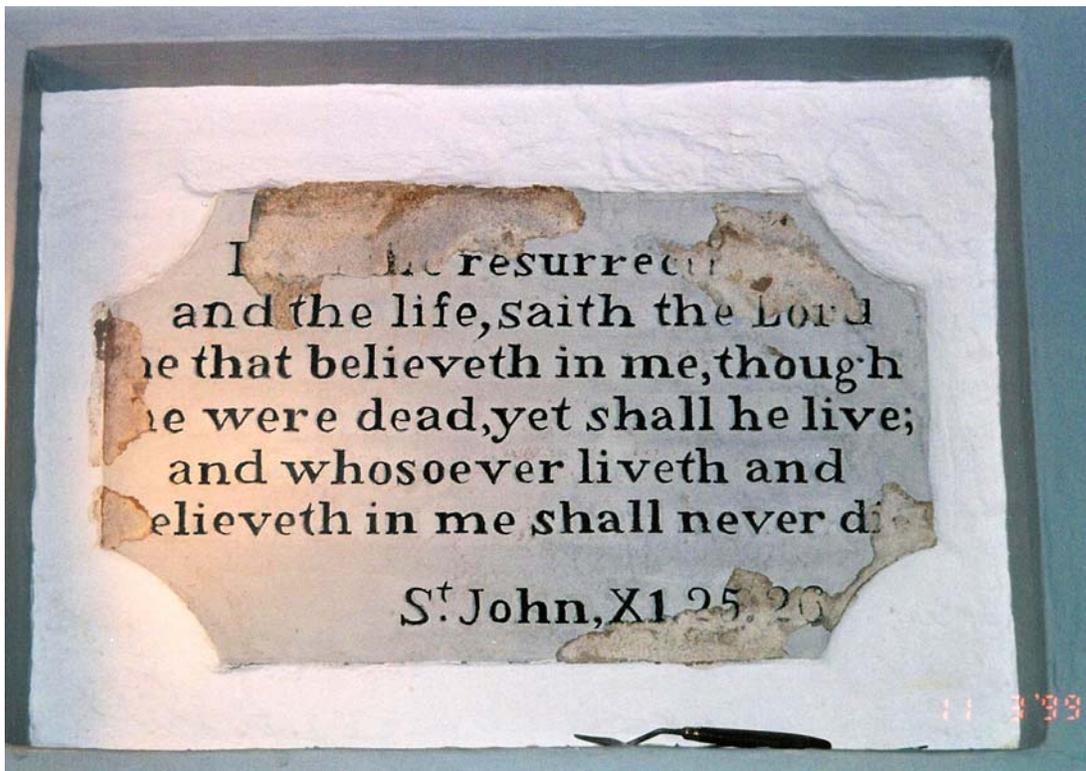
Several areas of stucco--most of them quite loose--were removed with scalpels and palette knives. These were along the top, the left-hand edge, and the curve at the lower right. The overlap of some of these repair materials on to the border made it quite clear to us at this stage that the raised (lettered) field and the border were a single piece of stone, and that the stone was, indeed, Aquia Creek sandstone. It now also seemed that most of the severe deterioration visible at individual locations of paint perforation was associated with failed repairs, although the largely well-adhered paint made any further observations concerning stone condition impossible.

Plaque after removal of loose stucco fills.

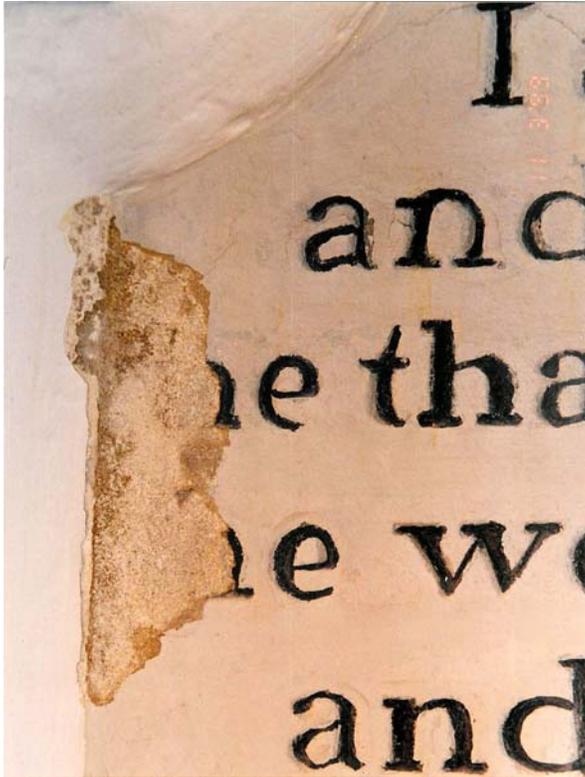
Detail, left edge of field.

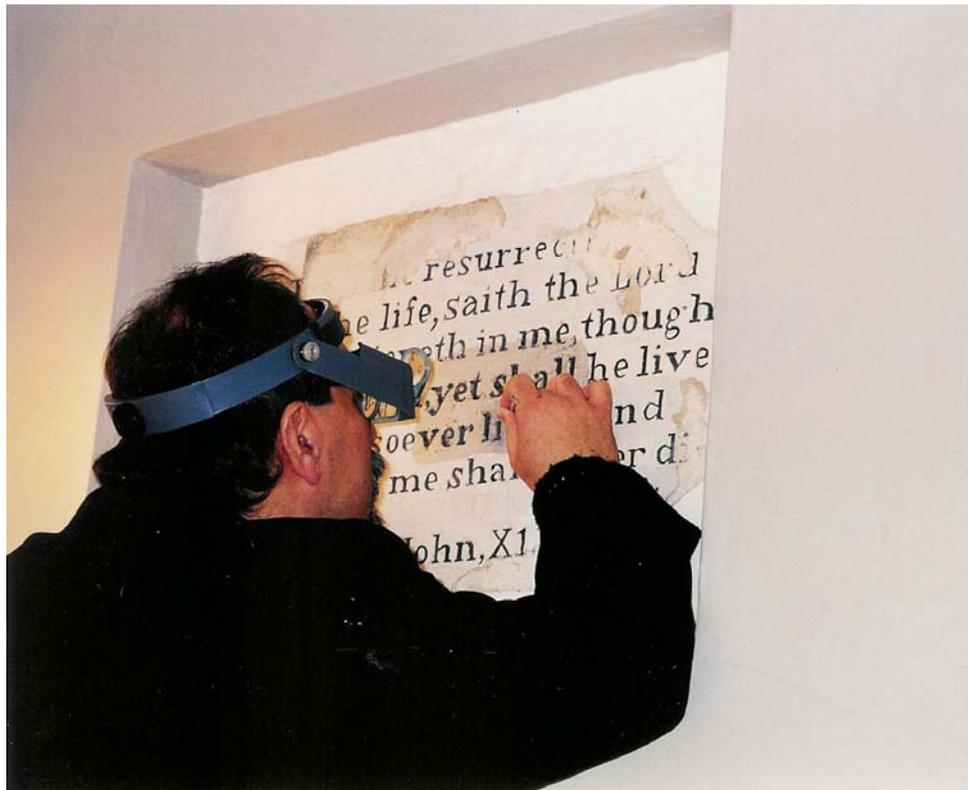
Initial testing of paint stripping.

After small-scale testing, removal of paint from the field was begun with "Peel Away 7" (Dumond Chemicals, New York, NY). This product is a thickened solvent-based stripper that is applied in conjunction with a micro-perforated synthetic membrane that aids in the disposal of the softened paint and excess product. Despite the incompleteness of stripping, even a single treatment of 20-25 minutes resulted in a noticeable sharpening of the lettering, attributable to the removal of much of the paint, and (most especially) the elimination of the slovenly pencilling that overlaps the most recent gray.

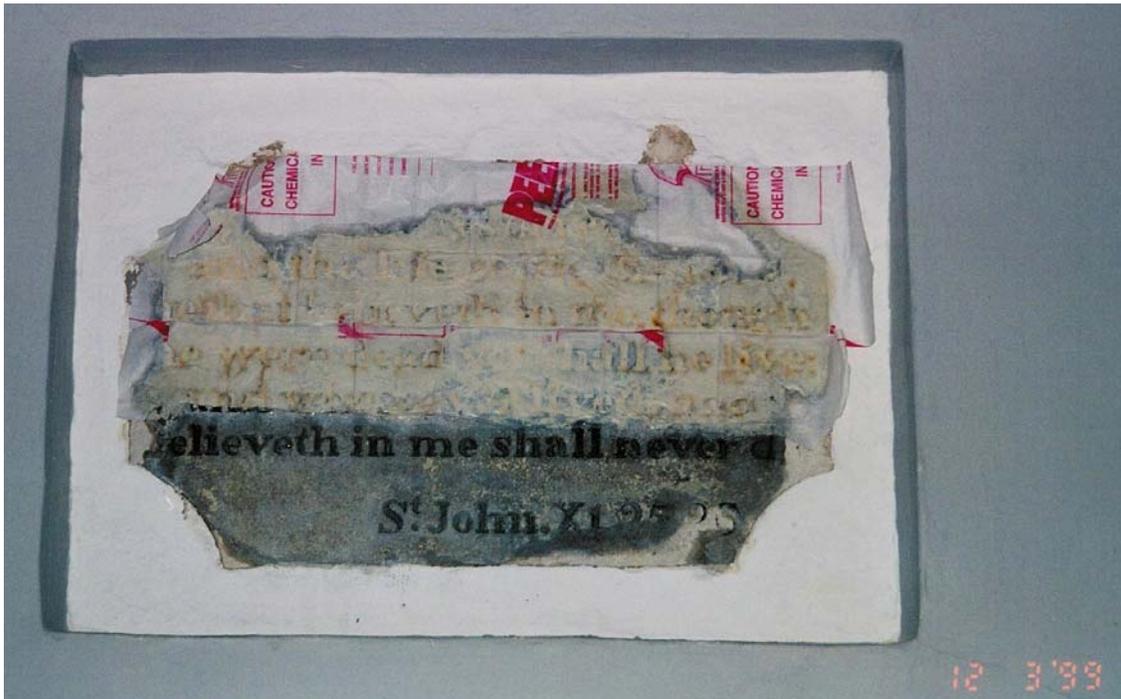
Application of "Peel Away 7" to upper portion of field.

Longer application times (up to 3 hours) were more successful, but always resulted in a smearing of both the pale yellow and the gray.<sup>7</sup> Much of this could be eliminated with brush application (and blotting) of ethanolic ammonium hydroxide, which revealed an earlier layer of black pencilling. The latter has survived in reasonably good condition, appears to pre-date the first repairs, and is almost certainly original.

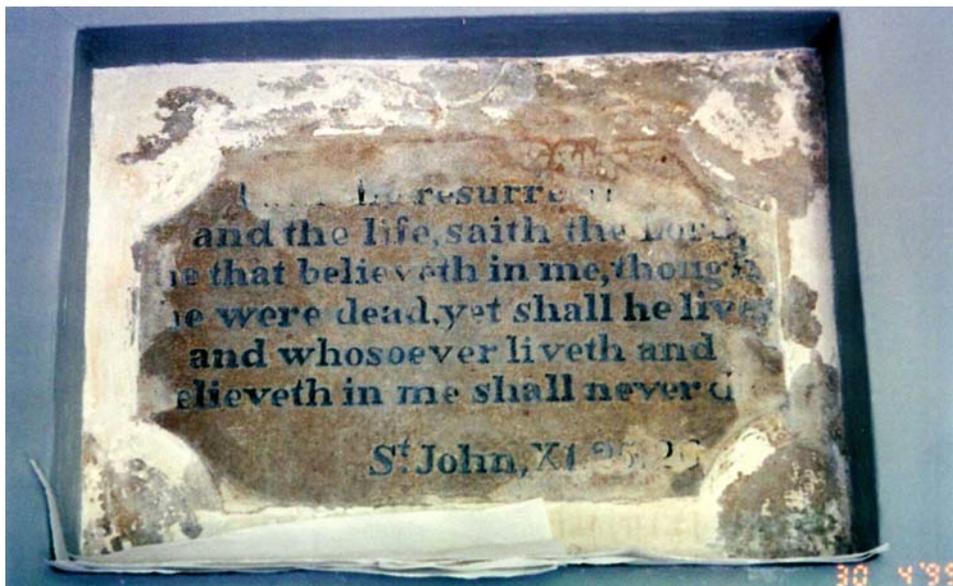
Completion of paint removal from field.

Final cleaning of the lettered field was done on April 29, combining chemical methods with the careful use of stainless steel dental tools. Stripping continued with three short (15-20 minute) applications of "Rock Miracle" (Samax Enterprises, Inc.), an ammoniated methylene chloride-based gel. Each of these applications was followed with a water rinse, using a hand-held mister. Repeated scrubbing with ethanolic ammonium hydroxide enhanced the cleaning, but could not entirely eliminate the grayish haze of partially solublized paint.

The heaviest individual areas of this residue were slowly cleaned with an "AEC AirEraser" (Paasche Airbrush Company, Harwood Heights, IL) running at 85 psi tank pressure.

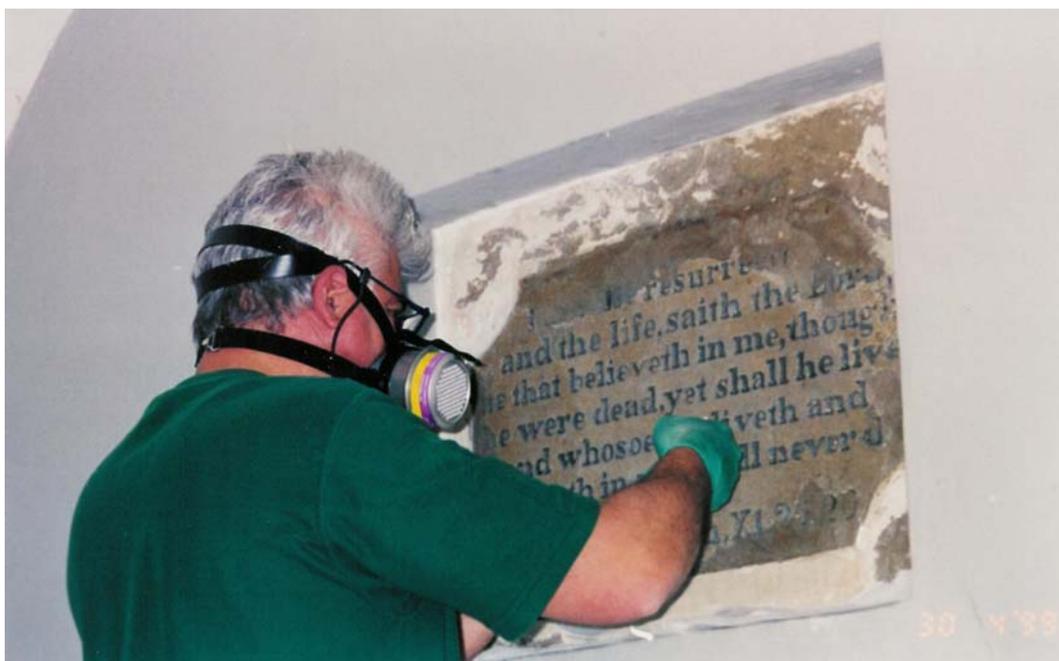
Application of "Conservare OH" consolidant

Consolidation treatment of the entire plaque with ethyl silicate<sup>10</sup> was performed on April 30, after testing (both in vitro and on the wall) to determine that there would be no softening of the paint remaining on the border.

Treatment was repeated brush application of an ethanol-based version of "Conservare OH" (ProSoCo, Inc., Kansas City, KS), in three "cycles" of three applications each. Each application involves flooding the stone surface to a condition of saturation. Drying time between applications was 10-25 minutes for the first two cycles and up to 35 minutes in the third cycle. Time between cycles was 45 minutes, then 90 minutes. The surface was brushed with ethanol--to remove any excess consolidant--about 30 minutes after the final application. Total treatment time was approximately 5 hours.

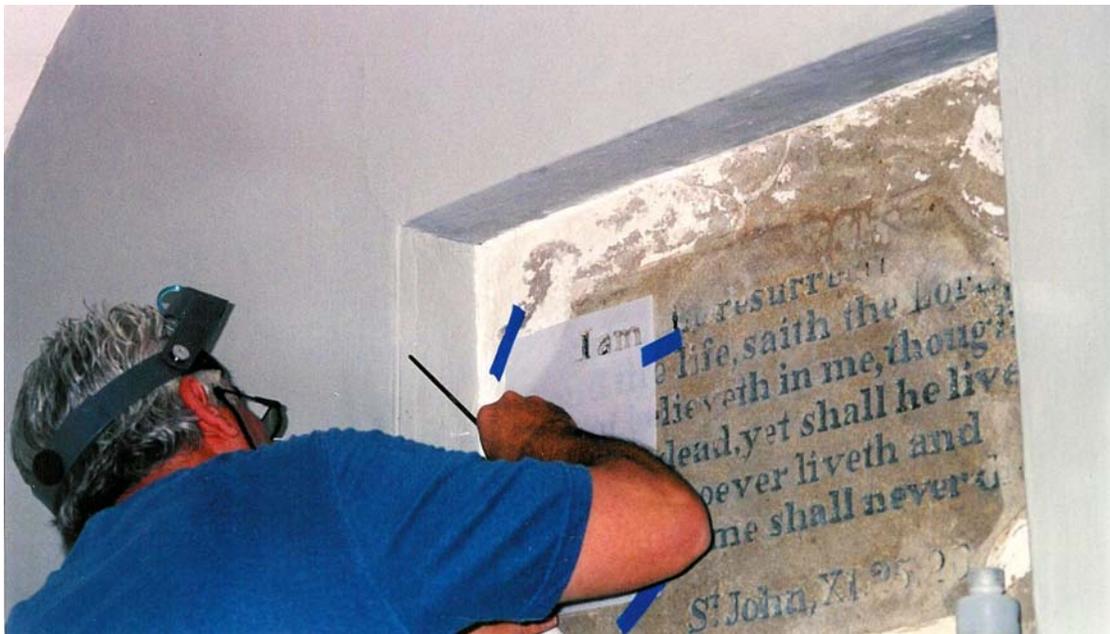
Use of stencils to apply isolating layer.

Instead, we developed a method for the re-creation of the missing portions of the inscription in a thin, lightly pigmented layer of an acrylic coating that could be re-solublized in the future, and required no mechanical pre-treatment of the stone surface. This was made possible by execution of a wax rubbing (on paper) of the necessary letters from the cleaned plaque on April 29. This work, in turn, permitted the preparation (during the month of May) of 4 sheets of stencils in our laboratory, utilizing the plaster cast done on March 11 to establish letter spacing and positioning.

Field execution of the selected method was on June 3. Using the stencils, an isolating layer (conforming precisely to the shape of each of the missing letters) of "Liquitex Soluvar Matte Varnish" (Binney & Smith Inc., Easton, PA) was brush applied, at a dilution of 4 parts varnish to 1 part mineral spirits.<sup>12</sup> This treatment was also performed to the surviving black pencilling exposed by our cleaning. Drying time was approximately 30 minutes.

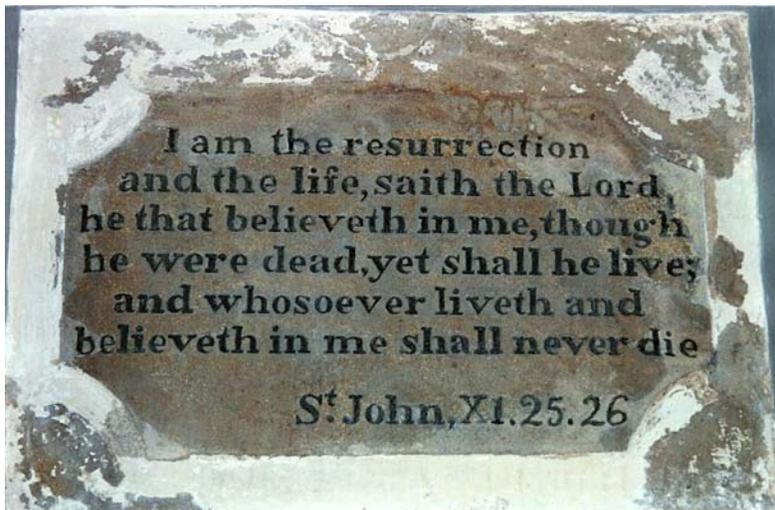
Completion of conservation treatments.

For the letters being re-created, a second layer of pigmented "Soluvar" was applied freehand. The pigment used was "BayFerrox 330", a black synthetic iron oxide (Bayer Corp., Pittsburgh, PA). Dispersion of the pigment was with the brush, on an aluminum palette. Use of colorant in the upper layer only will prevent the unwanted contact of pigment particles with the stone surface during removal, should that ever prove to be necessary.

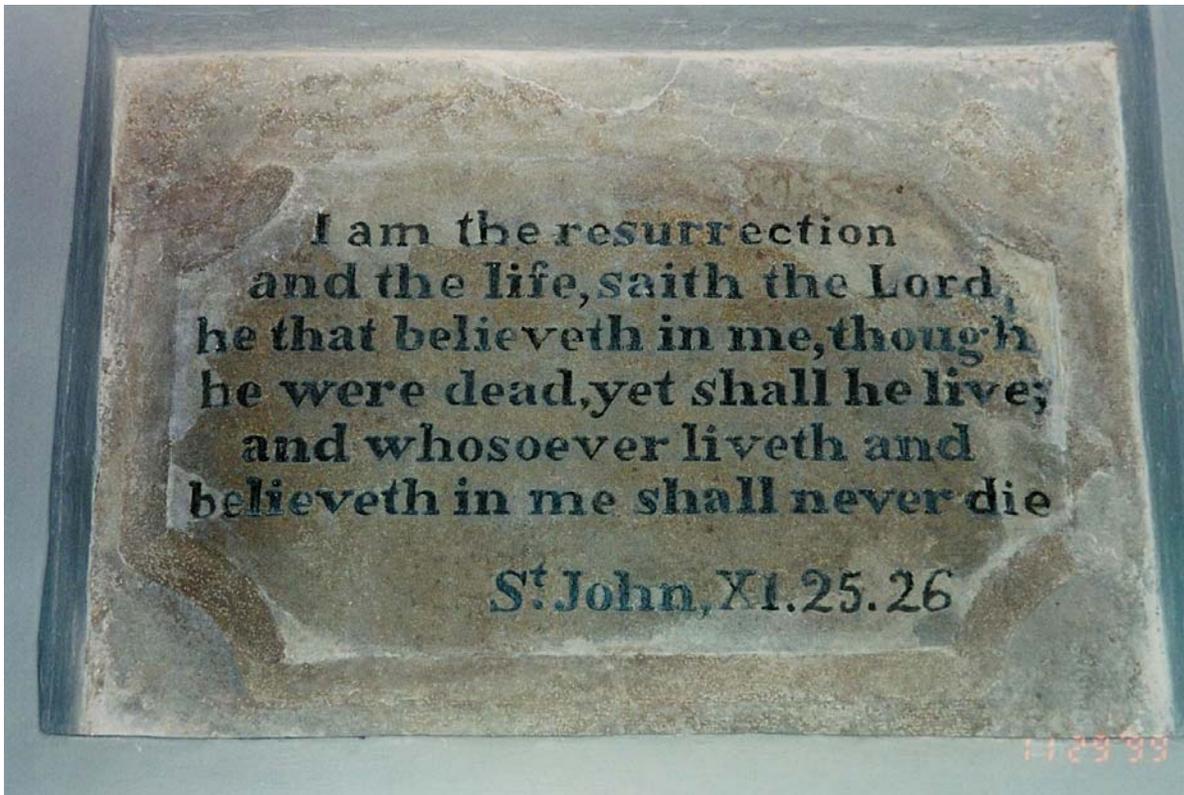
After air drying, November 29, 1999

On November 29, we undertook the final work on the border. After complete drying with warm air, we were able to bring the old repair toward the present stone color with scumbled brush application of a simple, field-pigmented glaze (black and yellow ochre) based on Soluvar.

We then carried out mechanical removal of small lines of paint residue, mostly at the outer edges of the border. This was done by hand with dental tools and small wood chisels. Finally, unpigmented Soluvar, diluted 4 parts to 1 part mineral spirits (v/v), was used to tone in a number of lighter areas of deteriorated stone. The work was judged to be completed satisfactorily after several hours of normal drying.
