## Satala Cemetery restoration underway

SATALA CEMETERY RESTORATION TREATMENT REPORT June/July 2010  
Monument Conservation Collaborative LLC, Norfolk, CT 06058

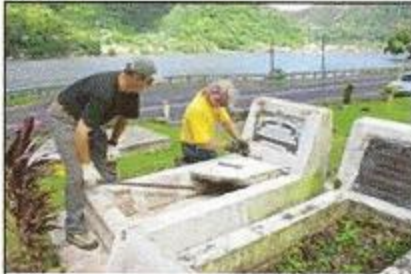
Martin Johnson (left) and Karl Munsum (right) of Monument Conservation Collaborative, a restoration company from Connecticut, seen here working to restore one of 60 grave monuments damaged by the September 29, 2009 tsunami. (Courtesy Photo)

The conservators will collect the broken and displaced pieces of the various damaged grave markers and reassemble them in such a way that they will retain their historic character. The conservators, who are here for the second time, will use photographs from a 2005 ASHPO-funded survey and assessment of the cemetery to ensure that their restoration is historically accurate.

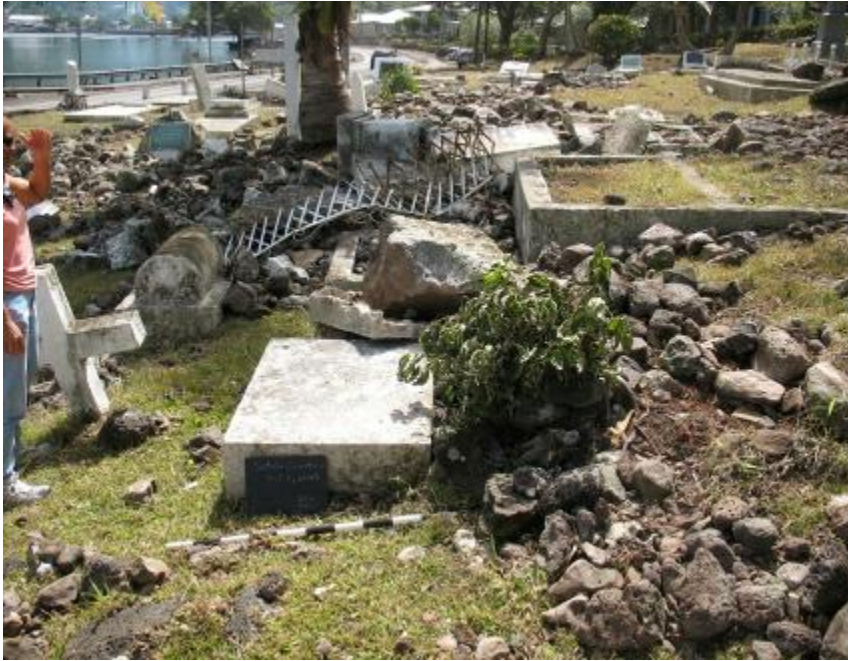
Oct 1, 2009, Two days after the Tsunami

The Satala Cemetery, one of the few public cemeteries in the territory, was badly damaged during the tsunami of September 29, 2009. Sitting along the coast as it does, it took a formidable hit from the destructive waters, which had the power to throw boats ashore, rip homes apart and lodge trucks in the branches of trees.

The severe damage to head stones and grave monuments in the small cemetery, along with broken and cracked graves being knocked off their foundations, has been a cause for concern among families and members of the village and community since that fateful day.

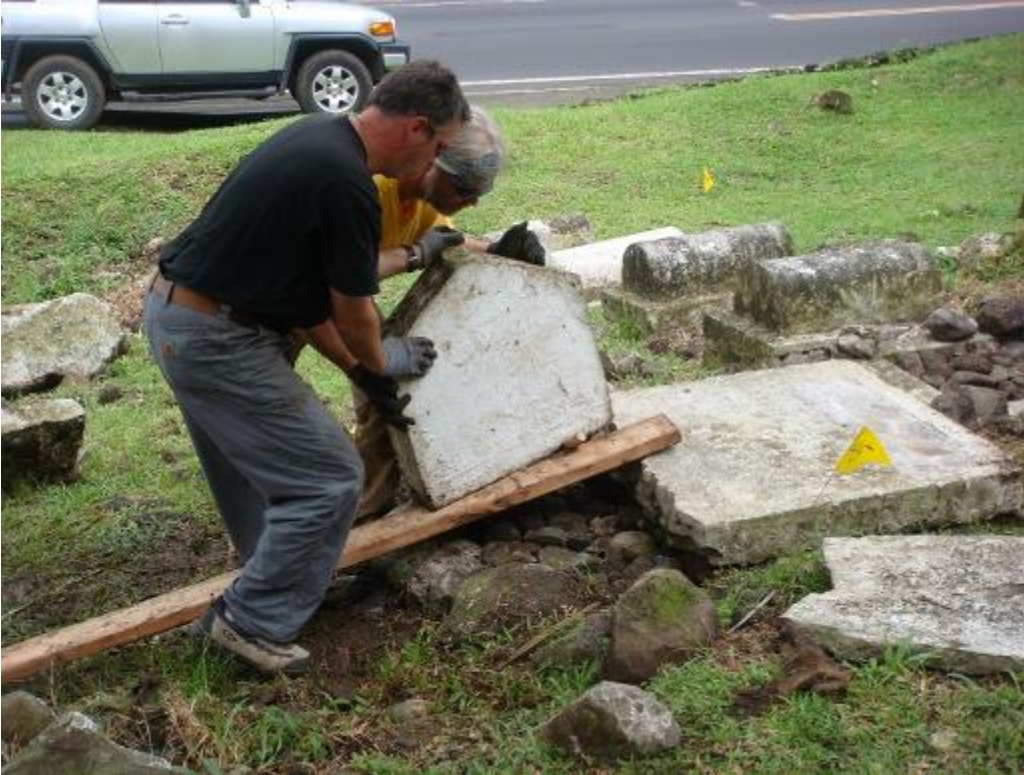
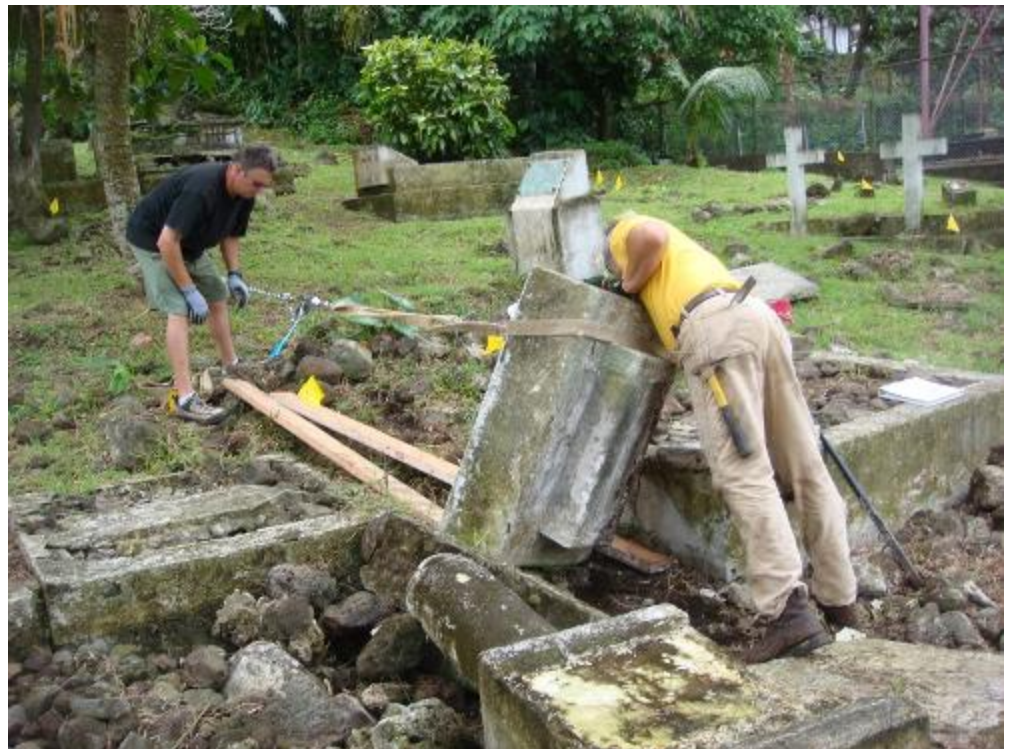
Monuments and fragments were found to be scattered over the entire cemetery site.

These pieces were sorted and identified and then moved into location by hand.

Larger fragments were moved with rollers on planks, sometimes assisted with a mechanical advantage such as a come-along or hydraulic jacks.

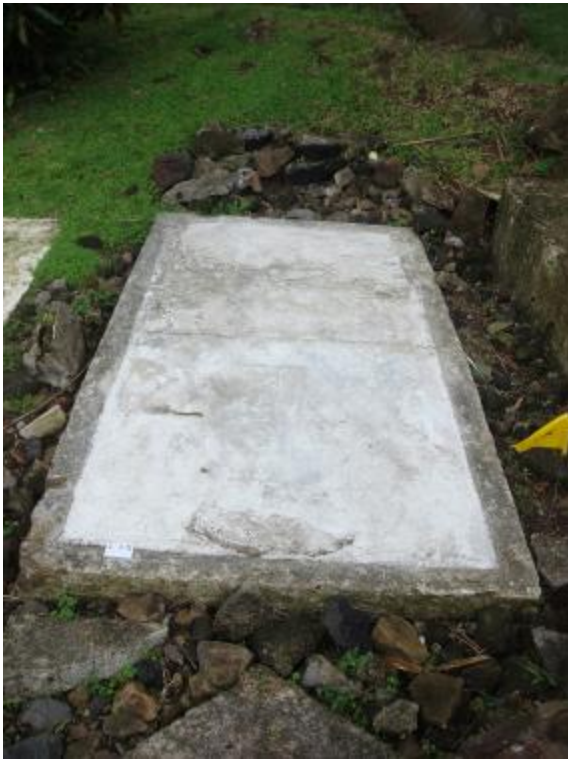
#135 As found (top slab missing)

With the exception of small missing pieces, which may be buried or have shattered, fragments were eventually located for almost all losses.

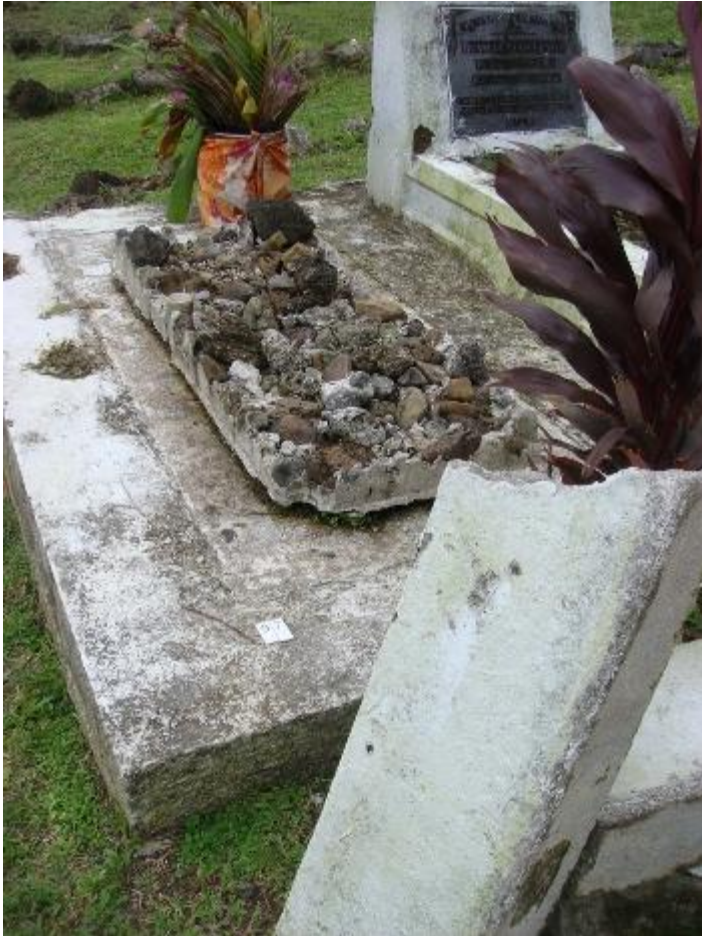
#97A As found

Many large missing fragments were discovered a distance away under rubble and other fragments. The slippery wet mud, the slope of the site, and rubble made moving the larger fragments precarious. As in a giant jig-saw, all of the fragments were eventually reset in place.
