CONDITION ASSESSMENT OF THE
CARTER TOMBS

Foundation for Historic Christ Church

IRVINGTON, VA

MARCH, 2003

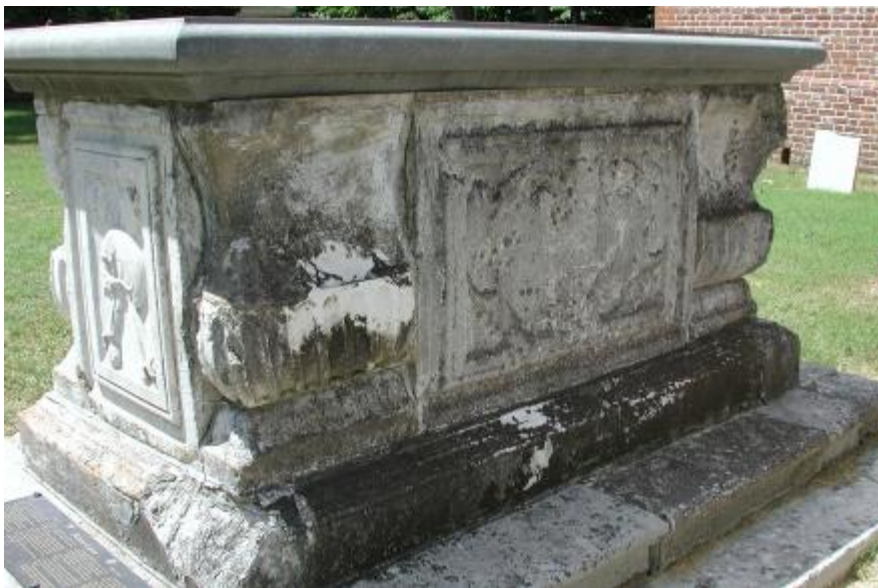
**Robert Carter,
north and east
elevations, August 8,
2002**

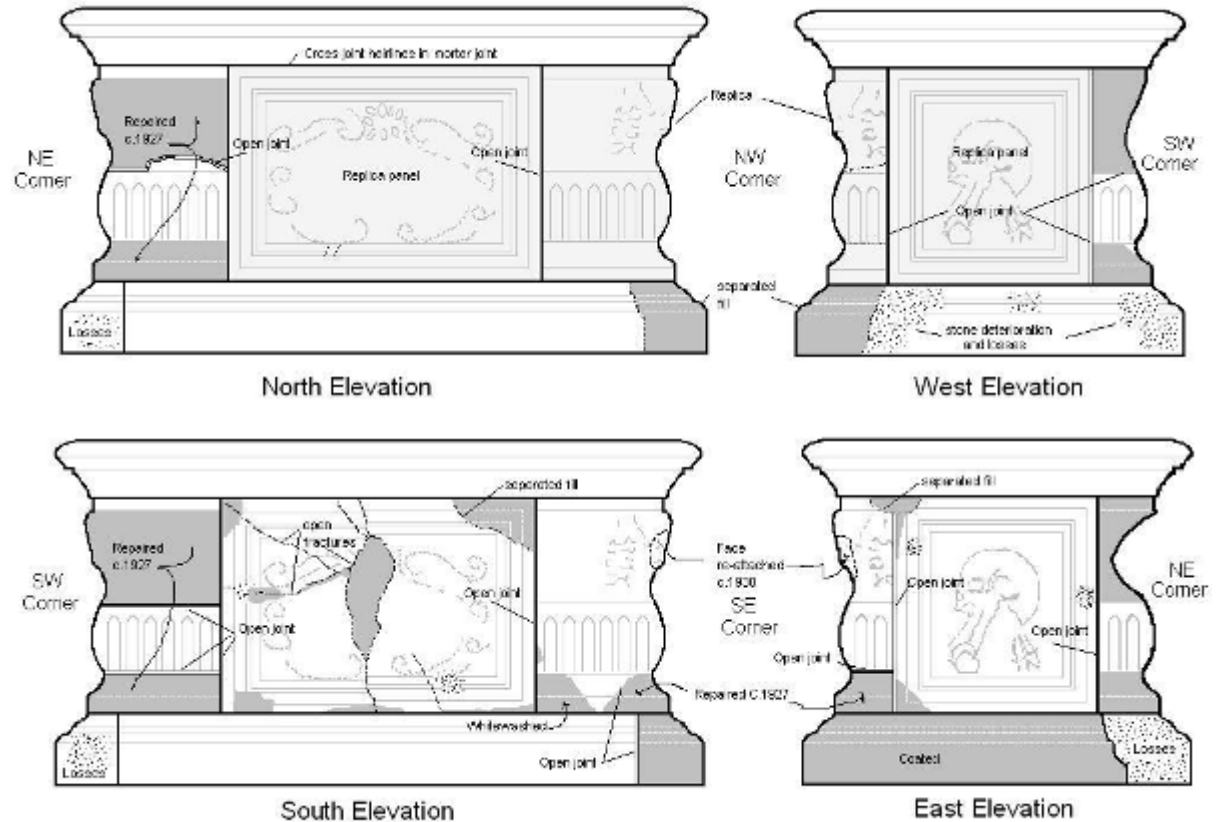
3.1 Robert Carter

North (long), cast cementitious replica (but not identical to south panel), 1927. Open vertical mortar joint at right edge, and cross-joint hairline fractures in horizontal mortar joint along upper edge.

South (long), white marble, pre-1927. Prominent fractures and fills, with fragments poorly fit, as seen in 1927 photograph (#0005). 1927 fills have weathered, discolored and separated; some fractures are open. Two small areas of active surface deterioration. Open vertical mortar joints at left and right edges.

East (short), white marble, pre-1927. Small losses at upper and lower left; a patch at upper left is separated. Two small areas of surface deterioration; open vertical mortar joint along right edge. Large gap along upper half of left edge.

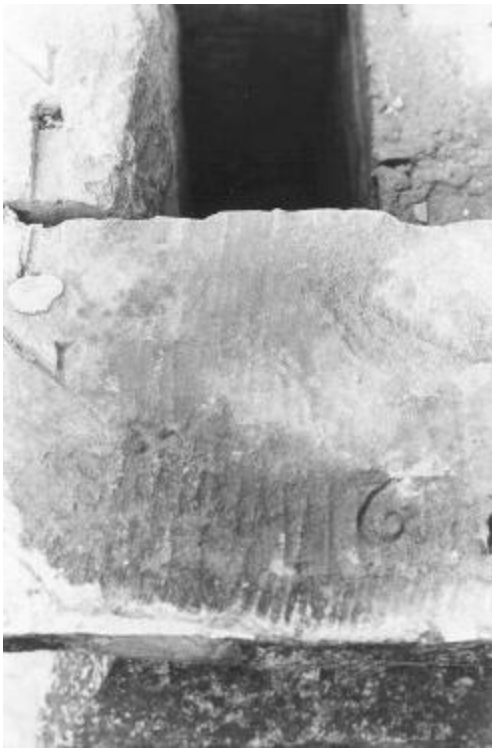
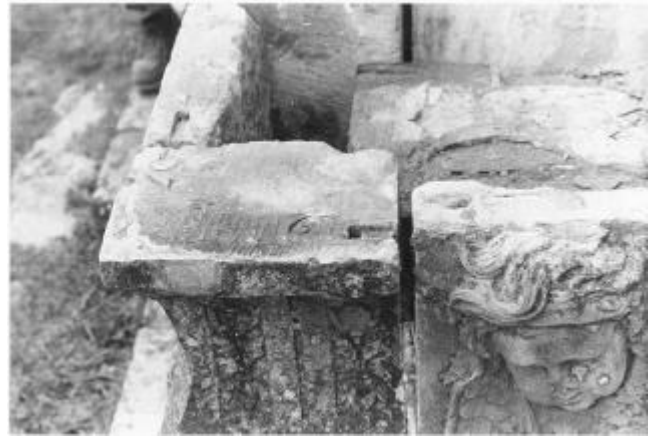
Our second assumption is that the surviving elements were probably re-assembled correctly in 1927. Each tomb has at least one long panel, one short panel and one corner pre-dating 1927, and matching each other (for each tomb) in height. These vertical dimensions are slightly different from tomb to tomb, and there is no obvious evidence of alteration to permit reconstruction. (For Judith, this seems to be confirmed by the presence of original mason’s numerals on the upper surfaces of the NE corner and east panel, as seen in photographs #0077 and 0078, taken in 1980).

#0077 and #0078, Judith Carter, lid removed, August, 1980

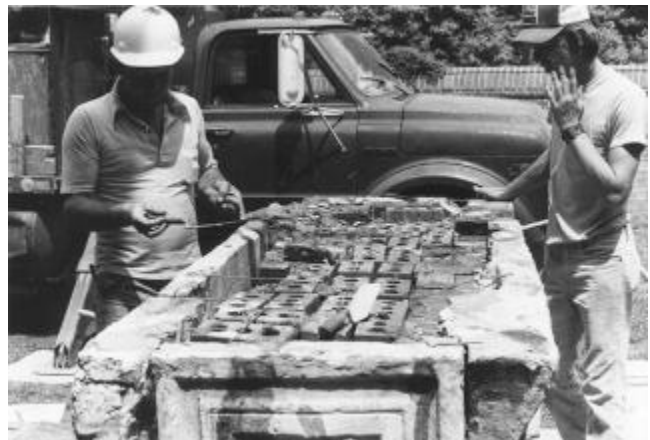
Finally, there is the question of whether to accomplish the work in place, or to disassemble the tombs, conserve and re-build. The photographic documentation of the work done in 1980 in conjunction with the replacement of the lids (e.g., #0065) shows the extent to which the individual elements have been attached to back-up brickwork and to each other. This argues strongly against disassembly, which could cause serious damage to weakened, historic stone.

#0065, Betty Carter, lid removed, August, 1980

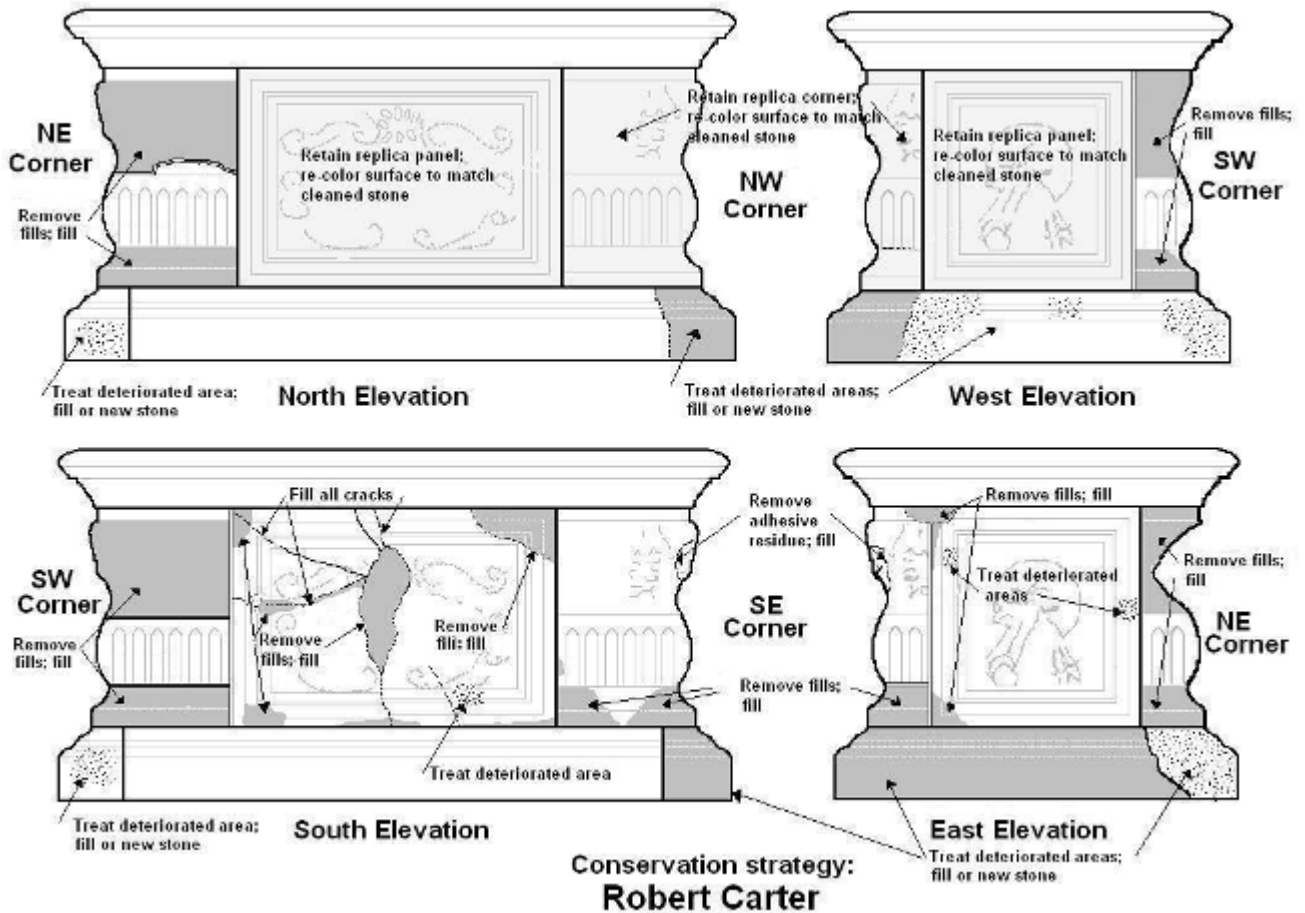
There are two stone panels (south and east), and two cast replicas. The south panel is in poor condition. It will require the removal and replacement of old fills, crack filling, and localized chemical treatment. Anticipated visual improvement for the south panel, which is particularly prominent, is considerable. Much less work is required for the east panel.

One (SE) corner is essentially complete; two survive only as single fragments, and one (NW) is a cast replica. The majority of work on these elements will be the removal and replacement of the large fills on the SW and NE corners, which will result in a significant visual improvement. All surviving marble of the corners, although mechanically damaged, is in sound condition.

The east and west base moldings are in poor condition. They require (either) extensive chemical treatment and filling (especially to re-establish profiles in the area beneath the NE corner), or the installation of replacement elements of new stone.

Overall condition of the Robert Carter tomb is poor.
