The Abbey Memorial, Enfield, Connecticut
Condition Assessment and Conservation Recommendations June, 2011

Introduction

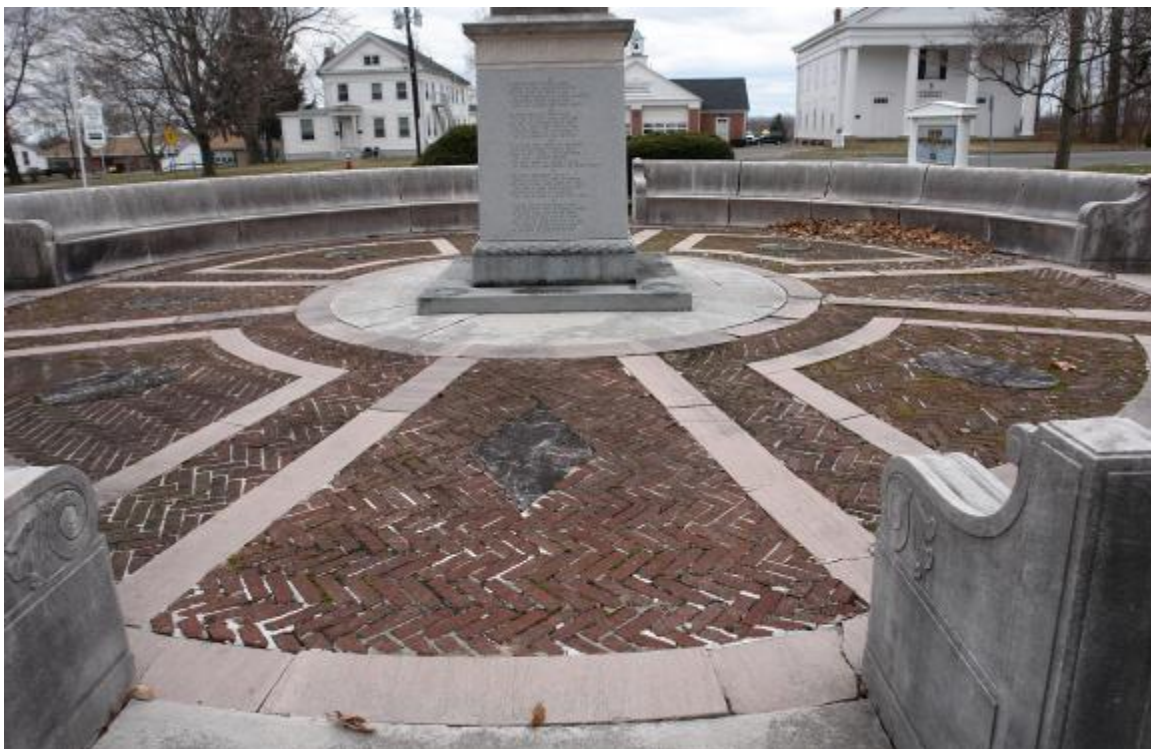
View of pavement from East entrance

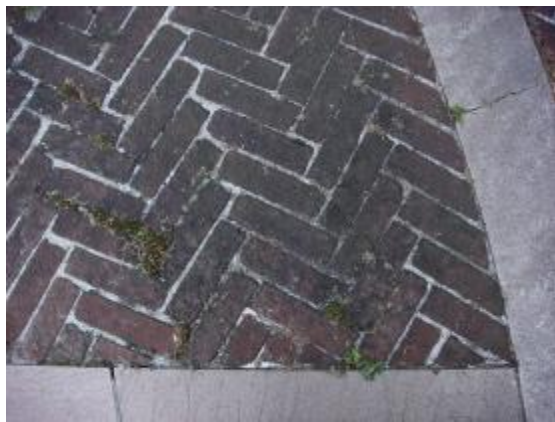
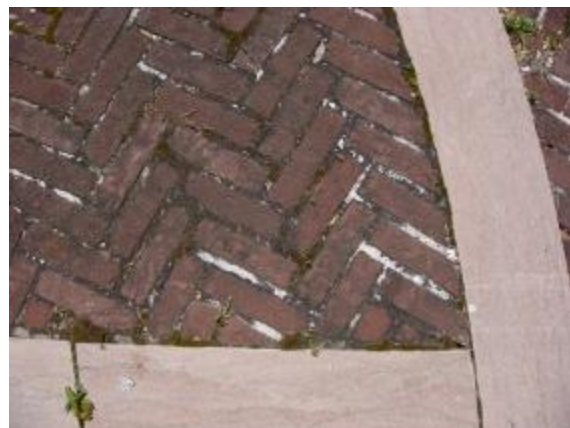
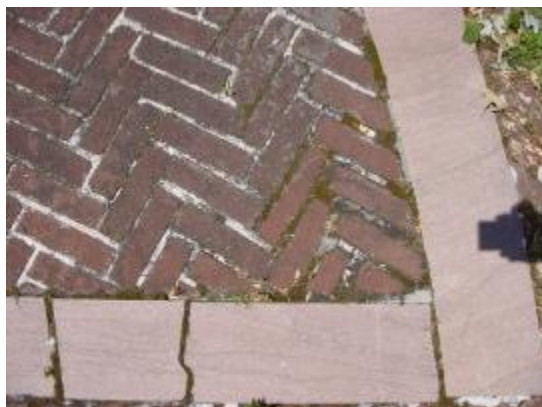
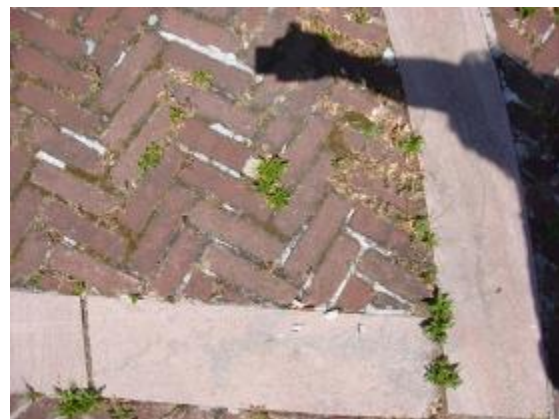
Photos above and below are details of the same location in each section containing an oval serpentine plaque. While it appears that the perimeter bricks and pattern are identical with minor variations, every effort should be made to reset the bricks in their original position.

1. Marble exedra to be kept in place while restoring pavers.
2. Disassembling and re-assembling brick and stone pavers to be done in quadrants. Bricks along edges of pattern should be documented and stored in original setting position until ready to reset.
3. All existing mortar to be removed from pavers with hand tools
4. Temporary (removable) marks and measurements of the location and pattern of existing radii to be well established before disassembly.

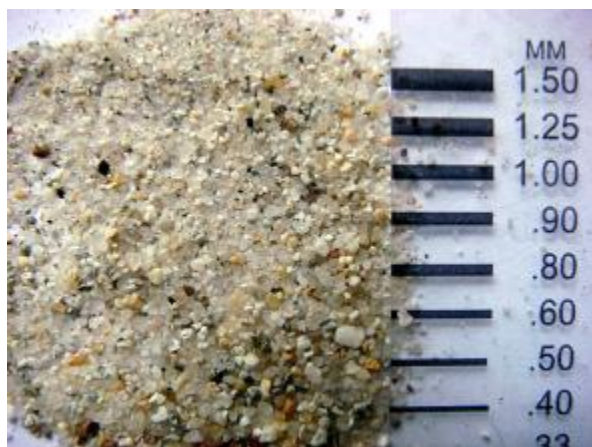
Range of aggregate size of exist pointing mortar in mm. for pavers.

Graded aggregate should be fully rinsed with water to remove any dust and dried before using.

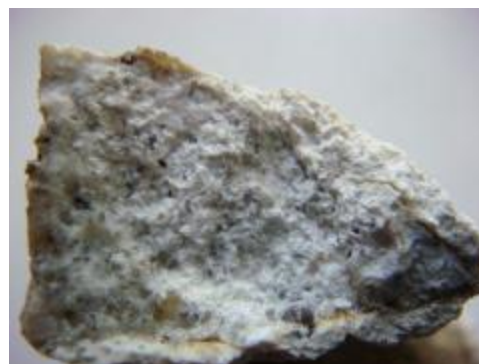
Cross section of existing pointing mortar

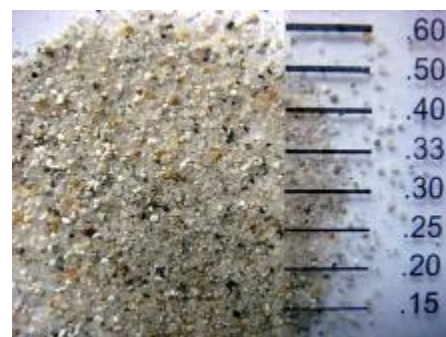
Range of aggregate size of existing pointing mortar in mm. for exedra.

Graded aggregate should be fully rinsed with water to

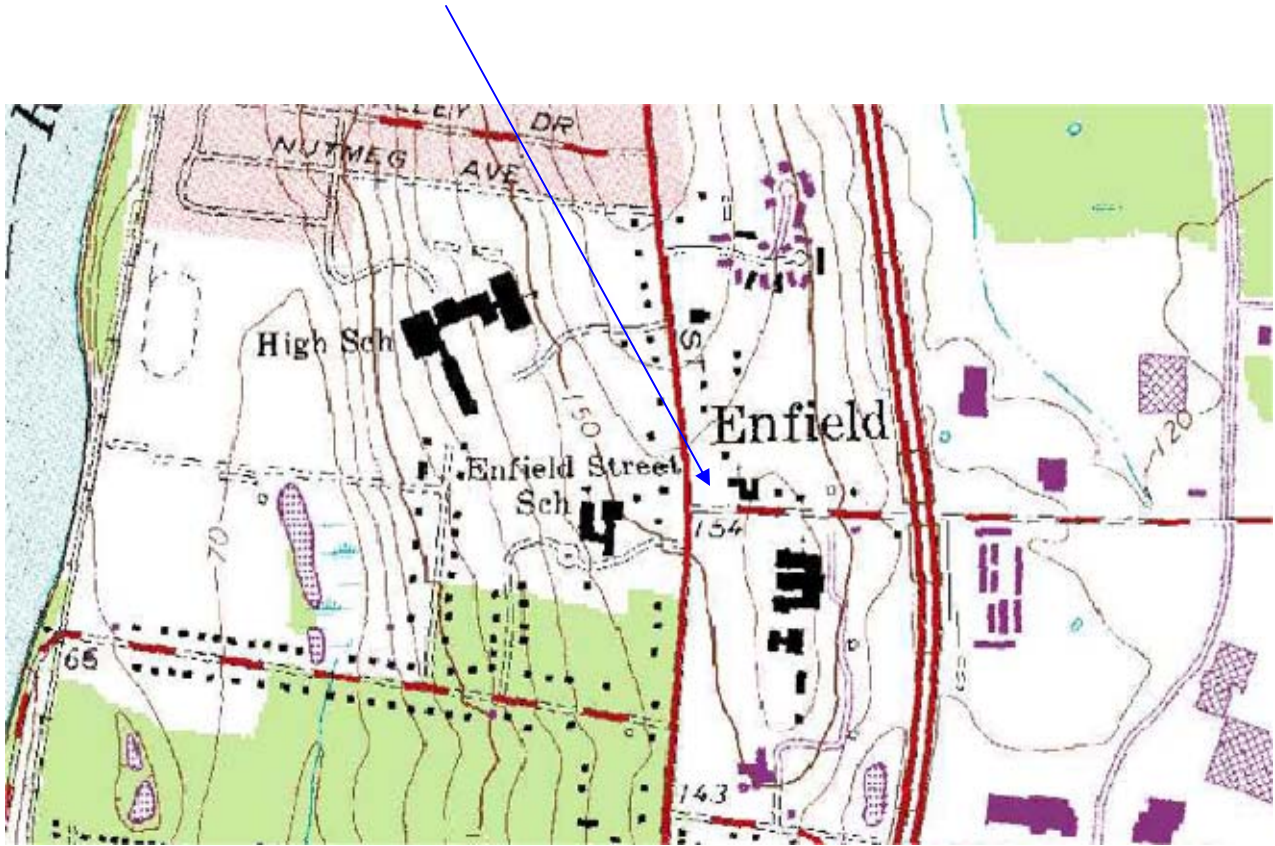
Monument location

Of major significance is the differential settling of the stone and brick paving. This condition creates a trip hazard and a continued failure of the joints. The lack of evidence of frost shattering to the bricks suggests that they were well chosen high fired pavers. However there has been considerable movement and fracturing of many of the paving elements, primarily on the Northern half. This seems to be associated with cyclical frost heaving, associated with excessive water which may have entered the paved area due to the surrounding topography. See page Appendix 23 for topography map detail of the area.
