CONDITION ASSESSMENT OF THE
CARTER TOMBS

Foundation for Historic Christ Church

IRVINGTON, VA

MARCH, 2003

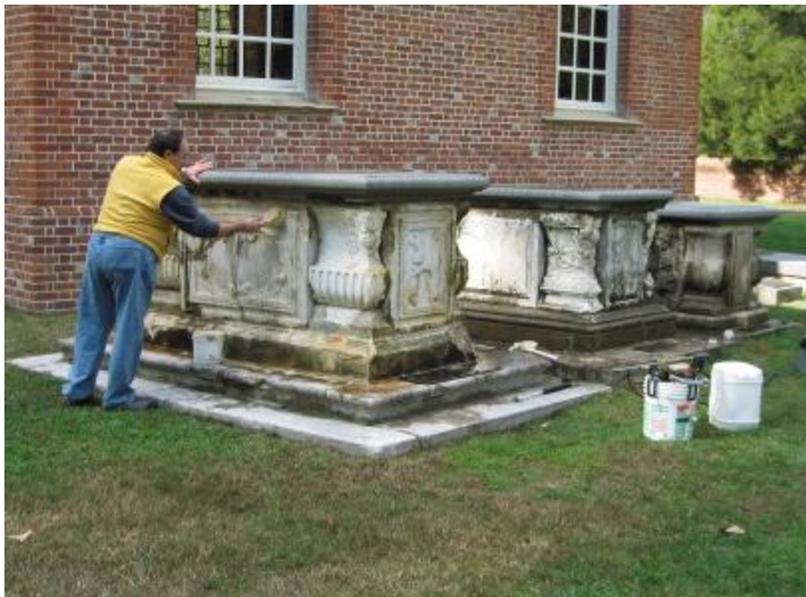
Removal of biological soiling to facilitate inspection, November 4, 2002

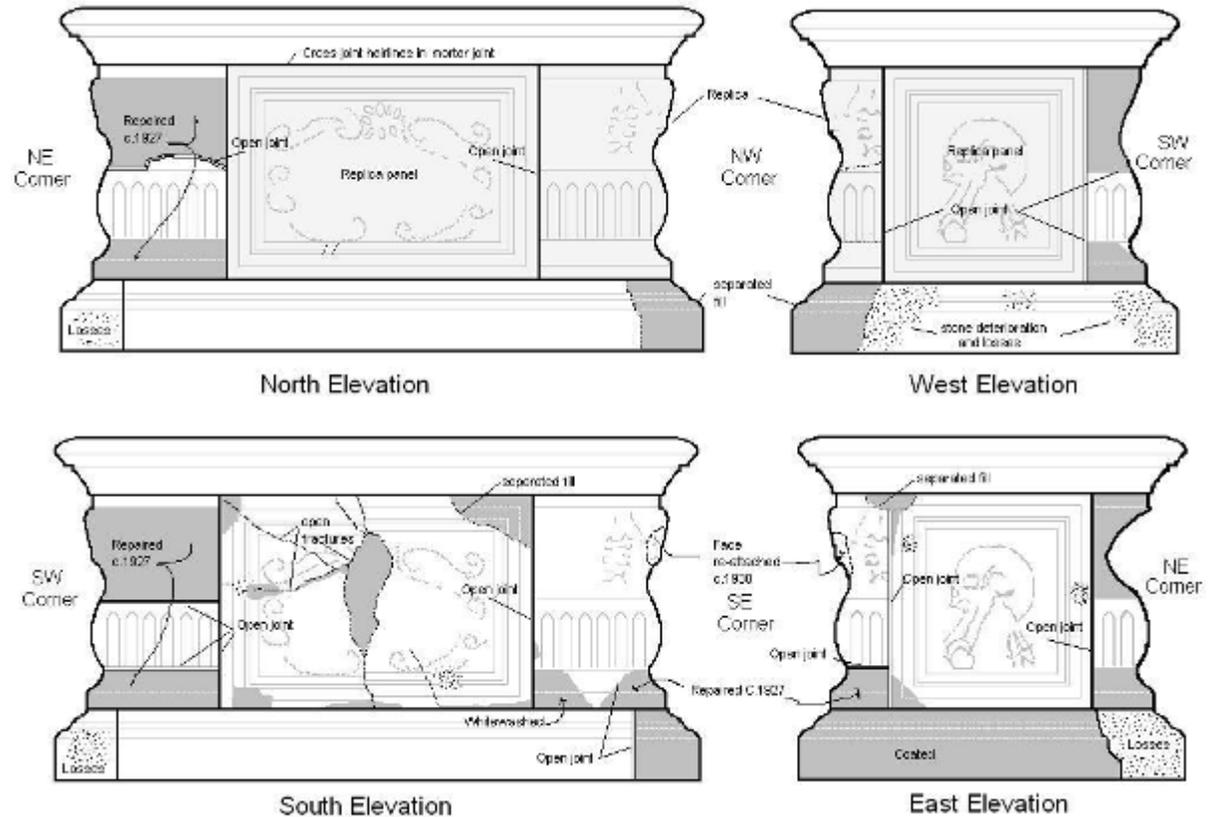
3.1 Robert Carter

North (long), cast cementitious replica (but not identical to south panel), 1927. Open vertical mortar joint at right edge, and cross-joint hairline fractures in horizontal mortar joint along upper edge.

South (long), white marble, pre-1927. Prominent fractures and fills, with fragments poorly fit, as seen in 1927 photograph (#0005). 1927 fills have weathered, discolored and separated; some fractures are open. Two small areas of active surface deterioration. Open vertical mortar joints at left and right edges.

East (short), white marble, pre-1927. Small losses at upper and lower left; a patch at upper left is separated. Two small areas of surface deterioration; open vertical mortar joint along right edge. Large gap along upper half of left edge.

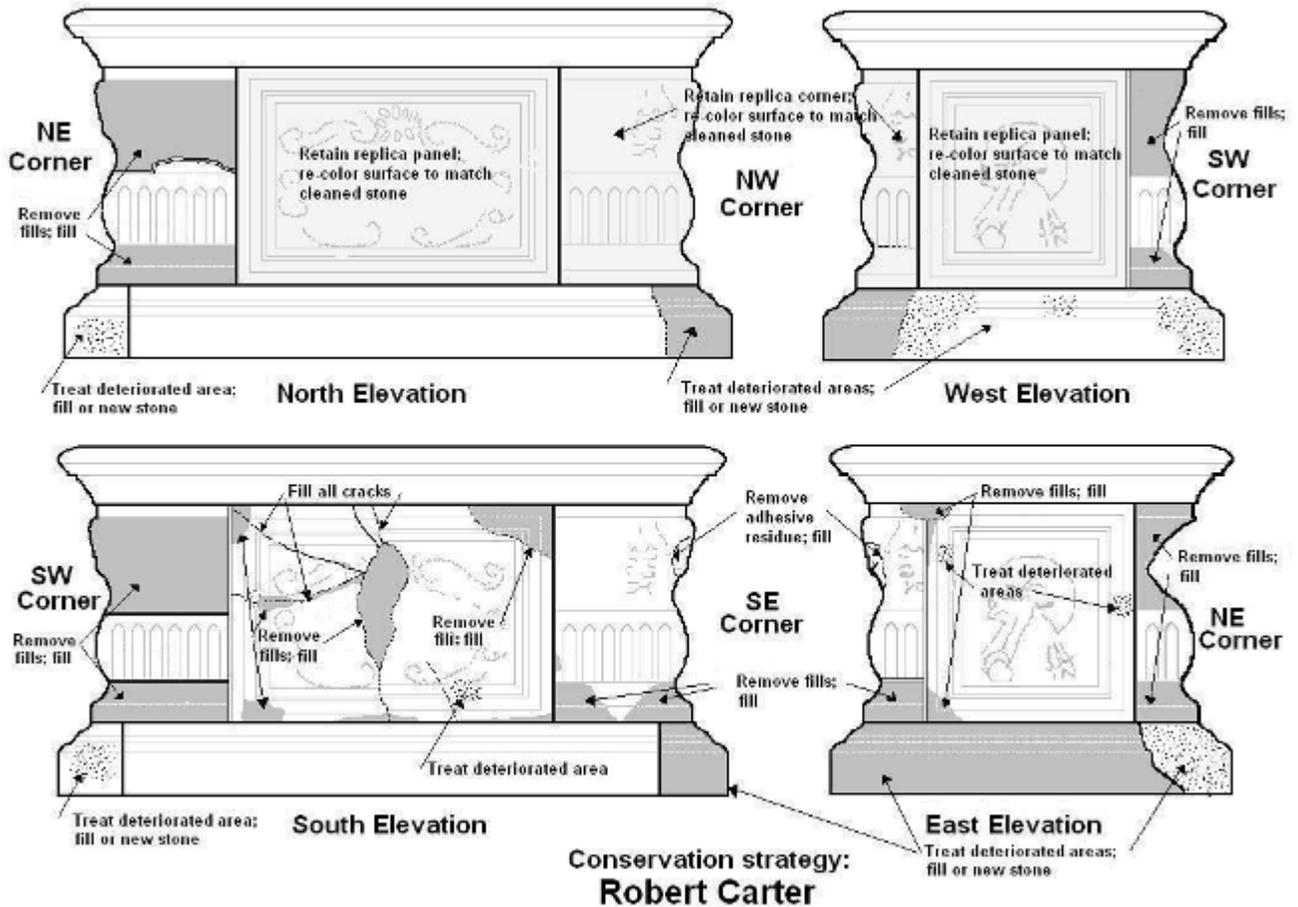
East, Portland limestone. Deterioration, with considerable loss at north end. Most is fill, with some whitewash.

**Robert Carter, east elevation,
November 5, 2002, showing
deterioration of base molding**

Overall condition of the Robert Carter tomb is poor.

The east and west base moldings are in poor condition. They require (either) extensive chemical treatment and filling (especially to re-establish profiles in the area beneath the NE corner), or the installation of replacement elements of new stone.
